# Visual Site Inspection Report

<b>Project Name</b> H-600 Pipeline Spread H		<b>AFE</b> 124300138	<b>Spread</b> H-600 Pipeline Spread H
<b>Contractor</b> Precision		<b>Report #</b> 6127	
<b>Inspector</b> Pat Davis		<b>Date/Time</b> 8/10/2018 6:05 PM	
<b>Permit #</b> TBD	<b>Inspection Type</b> VA SWPP	<b>Station Begin</b>	+0
<b>State</b> VA	<b>Inspection Area</b> Partial	<b>Station End</b>	+0
<b>County</b> Montgomery	<b>Ground</b> Damp	<b>Temperature (°F)</b>	80.00
<b>Municipality</b> N/A	<b>Weather</b> Cloudy	<b>Rain Gauge (in)</b>	0.00
<b>GPS Location</b> 37.2703686962251, -80.1214138046653		<b>Rain Accumulation Time (days)</b>	0.00

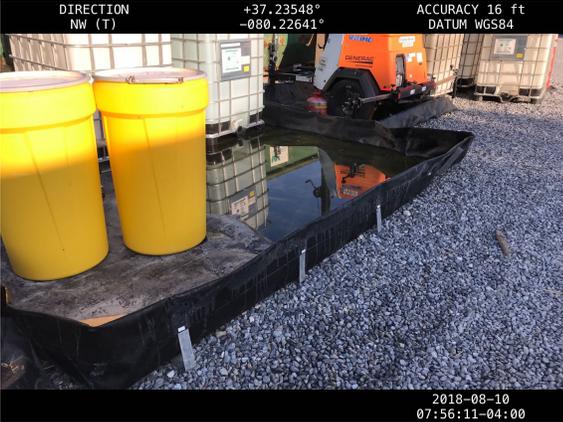
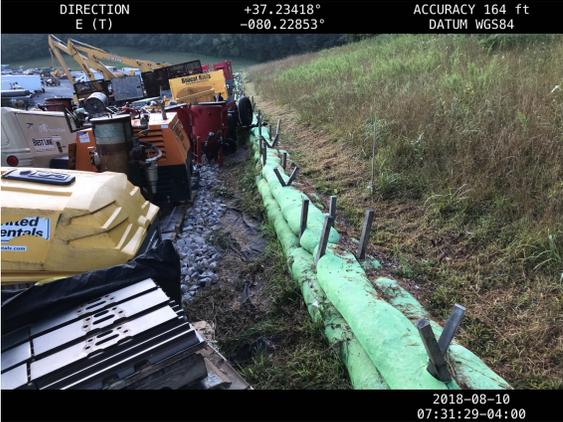
<p>DIRECTION E (T) +37.23418° -080.22853° ACCURACY 164 ft DATUM WGS84 2018-08-10 07:31:29-04:00</p>
<b>GPS Location</b> 37.2702715080579, -80.121552944258	<b>GPS Location</b> 37.2702715080579, -80.121552944258
<b>Description</b> MVP-PY-006_081018. Secondary containment with some storm water. No sheen present. Looking NW. See photo for gps data.	<b>Description</b> MVP-PY-006_081018 loose items and tall grass removed from the compost filter sock. Looking E. See photo for gps data.

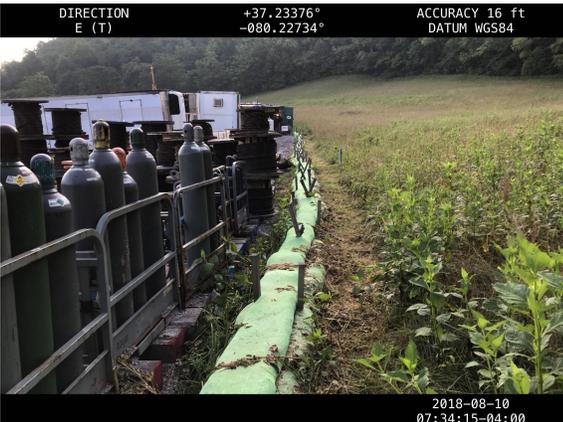
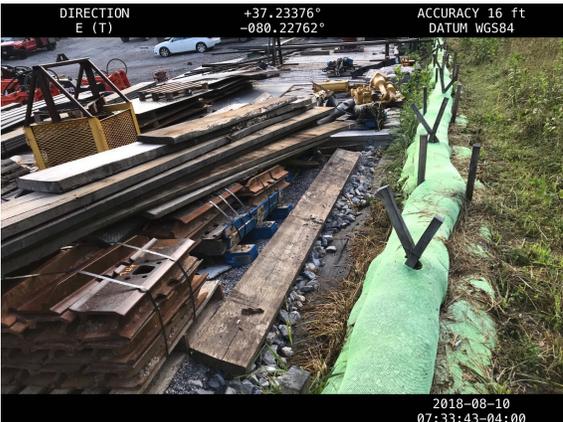
<b>Description</b> MVP-PY006_081018 weeds and tall grass cleared from filter sock. Looking E. See photo for gps data.	<b>Description</b> MVP-PY-006_081018 lumber removed from filter sock. Looking E. See photo for gps data.

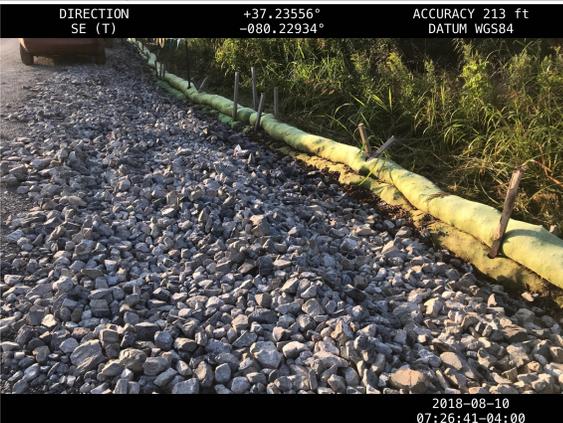
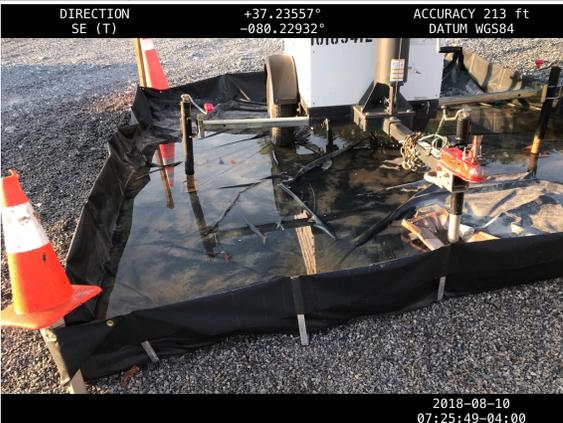
<p>DIRECTION SE (T) +37.23557° -080.22932° ACCURACY 213 ft DATUM WGS84 2018-08-10 07:25:49-04:00</p>
<b>GPS Location</b> 37.2702898644258, -80.1215771679581	<b>GPS Location</b> 37.2702898644258, -80.1215771679581
<b>Description</b> MVP-PY-006_081018 stones removed from filter sock. Looking SE. See photo for gps data.	<b>Description</b> MVP-PY-006_081018 secondary containment with storm water no sheen present. Looking SE. See phot for gps data.
