Visual Site Inspection Report

Project Name	H-600 Pipeline Spread H	AFE	124300138	Spread	H-600 Pipeline Spread H
Contractor	Precision			Report #	6146
Inspector	Pat Davis			Date/Time	8/10/2018 6:02 PM
Permit #	TBD	Inspection Type	VA SWPP	Station Begin	+0
State	VA	Inspection Area	Partial	Station End	+0
County	Roanoke	Ground	Damp	Temperature (°F)	80.00
Municipality	N/A	Weather	Cloudy	Rain Gauge (in)	0.00
GPS Location	37.2702898644258, -80.1215771679581			Rain Accumulation Time (days)	0.00

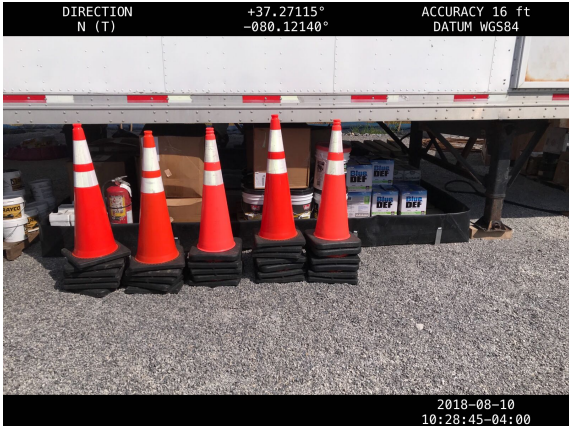
GPS Location	37.2704466898341, -80.1215458196403	GPS Location	37.2704004217286, -80.1215431374313		
Description	MVP-LY-049_081018 secondary containment under light plant free of liquid. Looking NW. See photo for gps data.	Description	MVP-LY-049_081018 secondary containment under porta toilets. Looking N. See photo for gps data.

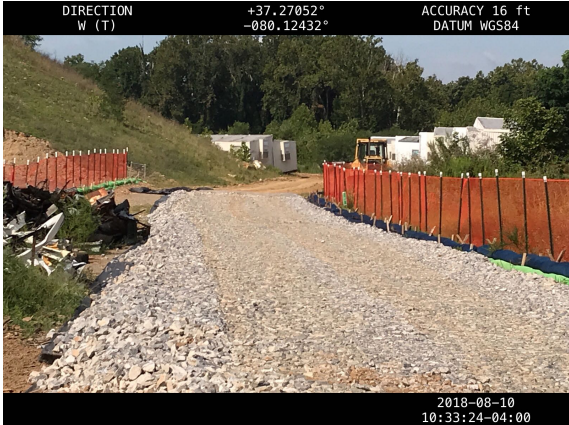
GPS Location	37.2703074245129, -80.1215731446446	GPS Location	37.2703074245129, -80.1215731446446		
Description	MVP-LY-049_081018 secondary containment under Northern Clearing's Trailer. Looking N. See photo for gpa data.	Description	MVP-LY-049_081018 safety fence and compost filter sock along boundary. Looking SW. See photo for gps data.
