Visual Site Inspection Report

Project Name H-600 Pipeline Spread H		AFE 124300138	Spread H-600 Pipeline Spread H
Contractor Precision		Report # 7028	
Inspector Pat Davis		Date/Time 8/28/2018 6:22 AM	
Permit # TBD	Inspection Type VA SWPP	Station Begin	+0
State VA	Inspection Area Partial	Station End	+0
County Montgomery	Ground Wet	Temperature (°F)	91.00
Municipality N/A	Weather Cloudy	Rain Gauge (in)	0.00
GPS Location 37.0790792172883, -80.0558056843909		Rain Accumulation Time (days)	0.00

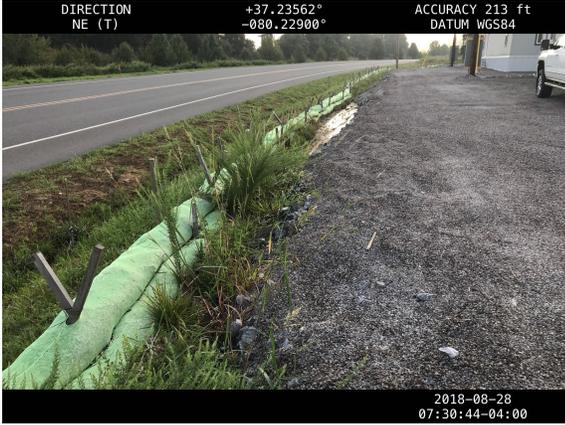
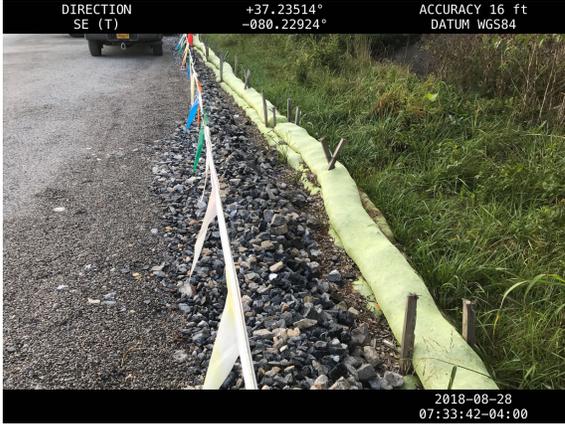
GPS Location	37.0778929121427, -80.0566148368763	GPS Location	37.0778929121427, -80.0566148368763
Description	MVP-PY-006_082818 triple stack filter sock on the north boundary. Looking NE. See photo for gps data.	Description	MVP-LY-006_082818 triple stack filter sock along drive. Looking SE. See photo for gps data.

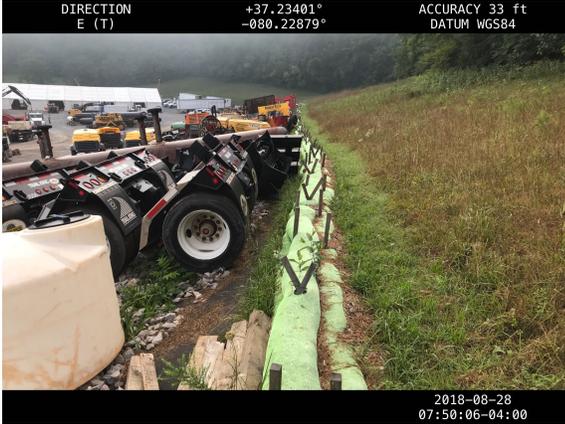
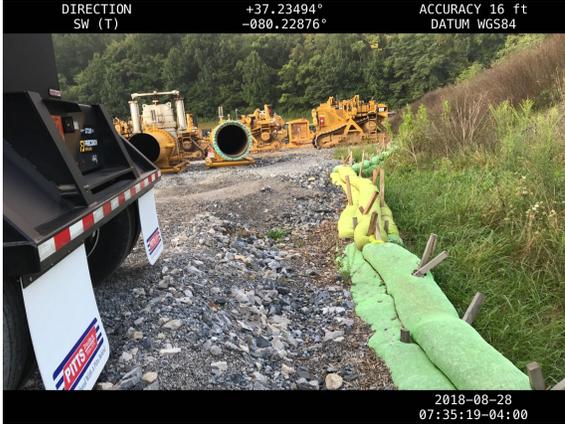
GPS Location	37.0778929121427, -80.0566148368763	GPS Location	37.0778894230293, -80.0566172167234
Description	MVP-PY-006_082818 triple stack filter sock on south boundary. Looking E. See photo for gps data.	Description	MVP-PY-006_082818 triple stack filter sock on west boundary. Looking SW. See photo for gos data.

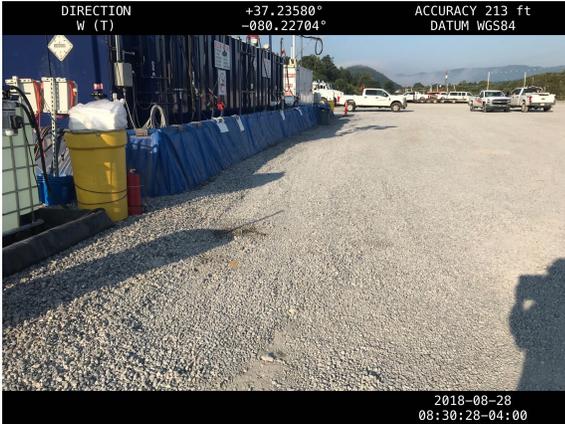
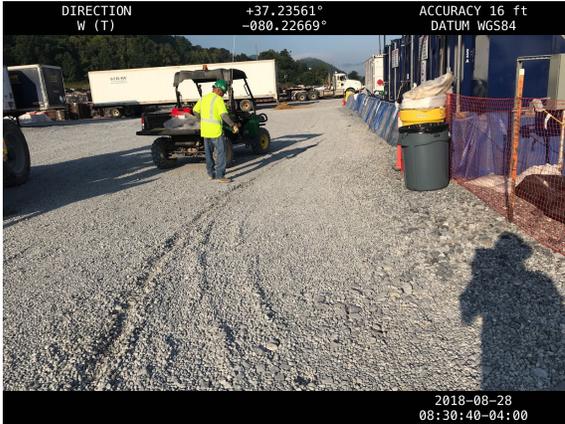
GPS Location	37.0804608289618, -80.0713021170756	GPS Location	37.0804608289618, -80.0713021170756
Description	MVP-PY-006_082818 no fluid deposits on the north side of the bulk fuel tanks. Looking W. See photo for gps data.	Description	MVP-PY-006_082818 crew cleaning up a fluid deposit on the south side of bulk fuel tanks. Looking W. See photo for gps data.

Crews have cleaned up the fluid deposits around the bulk fuel tanks. Crews have picked up and removed loose trash in the yard. The secondary containment's have been pumped out after the last rain event.
