Visual Site Inspection Report

Project Name	H-600 Pipeline Spread H		AFE	124300138	Spread	H-600 Pipeline Spread H	
Contractor	Precision				Report #	7057	
Inspector	Pat Davis				Date/Time	8/28/2018 3:21 PM	
Permit #	TBD	Inspection Type	VA SWPP		Station Begin	+0	
State	VA	Inspection Area	Partial		Station End	+0	
County	Roanoke	Ground	Damp		Temperature (°F)	91.00	
Municipality	N/A	Weather	Cloudy		Rain Gauge (in)	0.00	
GPS Location	37.0779284557878, -80.0568474457355				Rain Accumulation Time (days)	0.00

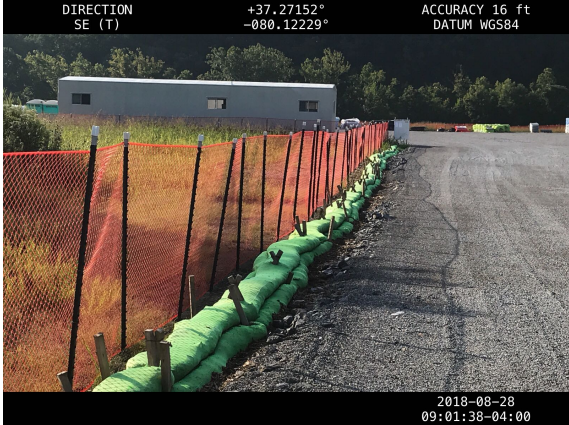
<p>DIRECTION SE (T) +37.27152° -080.12229° ACCURACY 16 ft DATUM WGS84</p> <p>2018-08-28 09:01:38-04:00</p>

<p>DIRECTION NE (T) +37.27157° -080.12055° ACCURACY 16 ft DATUM WGS84</p> <p>2018-08-28 09:05:39-04:00</p>		GPS Location 37.0779284557878, -80.0568474457355	
Description MVP-LY-049_082818 triple stack filter sock along the driveway. Looking SE. See photo for gps data.		Description MVP-LY-049_082818 containment under porta toilets on north boundary. Looking NE. See photo for gps data.		GPS Location 37.0779284557878, -80.0568474457355

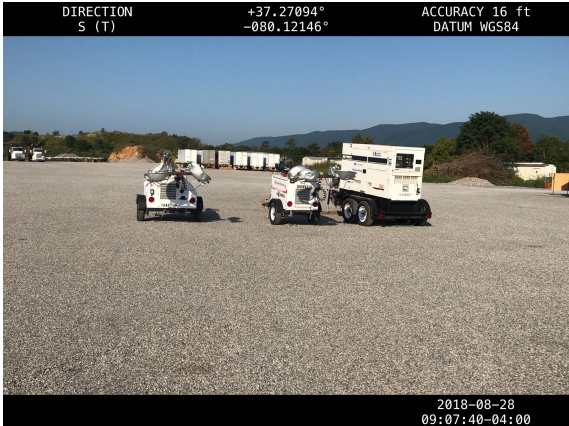
<p>DIRECTION SE (T) +37.26925° -080.12401° ACCURACY 16 ft DATUM WGS84</p> <p>2018-08-28 09:09:17-04:00</p>		GPS Location 37.0779284557878, -80.0568474457355	
Description MVP-LY-049%_082818 generator and light plants ready for transport. Looking S. See photo for gps data.		Description MVP-LY-049_082818 containment under porta toilets in SW corner. Looking SE. See photo for gps data.		GPS Location 37.0779284557878, -80.0568474457355

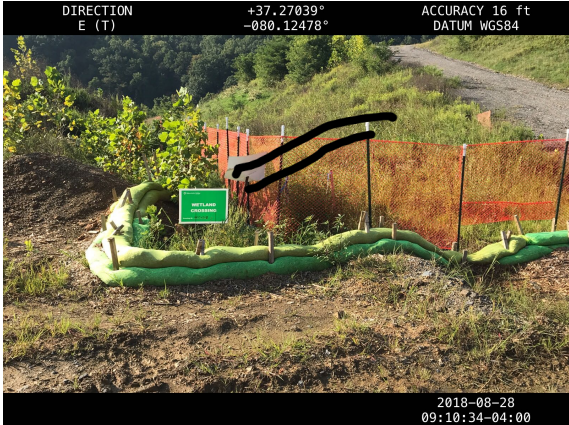
<p>DIRECTION SW (T) +37.27161° -080.12309° ACCURACY 16 ft DATUM WGS84</p> <p>2018-08-28 09:12:15-04:00</p>		GPS Location 37.0779284557878, -80.0568474457355	
Description MVP-LY-049_082818 safety fence at W-CV21B. Looking E. See photo for gps data.		Description MVP-LY-049_082818 animal damage to safety fence. Looking NE. See photo for gps data.		GPS Location 37.0779284557878, -80.0568474457355
