Visual Site Inspection Report

Project Name	H-600 Pipeline Spread H	AFE	124300138	Spread	H-600 Pipeline Spread H
Contractor	Precision			Report #	7317
Inspector	Pat Davis			Date/Time	9/4/2018 7:25 PM
Permit #	TBD	Inspection Type	VA SWPP	Station Begin	+0
State	VA	Inspection Area	Partial	Station End	+0
County	Montgomery	Ground	Dry	Temperature (°F)	91.00
Municipality	N/A	Weather	Sunny	Rain Gauge (in)	0.00
GPS Location	37.2788163297797, -80.028971005012			Rain Accumulation Time (days)	0.00

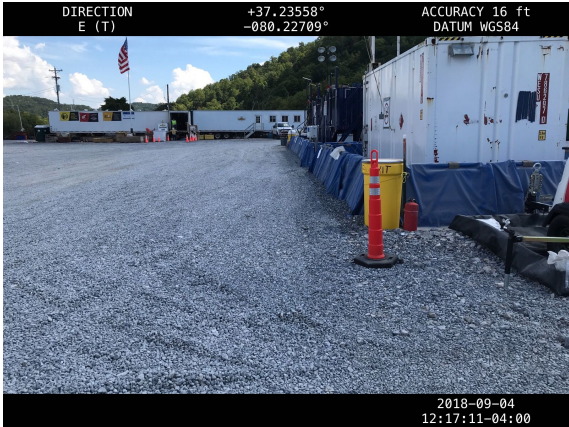
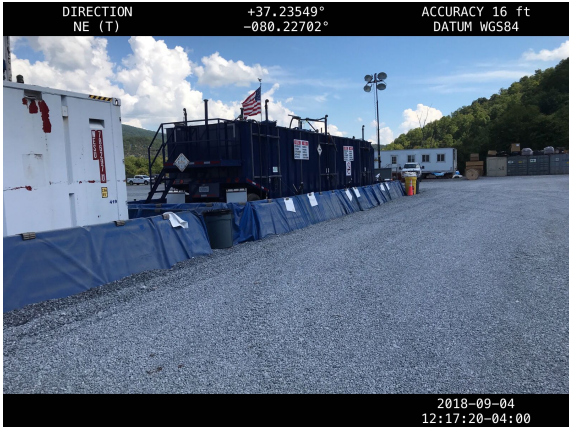
GPS Location	37.278922051226, -80.0288707204908		GPS Location	37.278922051226, -80.0288707204908	
Description	MVP-PY-006_090418 no fluid deposits on the north side of the bulk fuel tanks. Looking E. See photo for gps data.		Description	MVP-PY-006_090418 no fluid deposits on the south side of the bulk fuel tanks. Looking NE. See photo for gps data.

7. Identify all remedial measures that have been taken since the previous inspection was conducted. Crews have cleaned up the fluid deposits around the bulk fuel tanks. Crews have picked up and removed loose trash in the yard. The secondary containment's have been pumped out after the last rain event.					
Comments (Reference above questions as appropriate.) (Summary Spread 9). Checked rain gauge in the yard MVP-PY-006 and found 0.0 inch of rainfall in the raingauge. EI preformed SWPPP Inspection on the MVP-PY-006. EI walked the boundary of the LOD and observed the compost filter sock around the boundary was installed and in good condition. EI observed no misc trash in the yard. Secondary containment's were pumped out into containers after the last rain events. EI observed no fluid deposits on the stone on either side of the bulk fuel tanks. No other environmental issues were noted during today's inspection

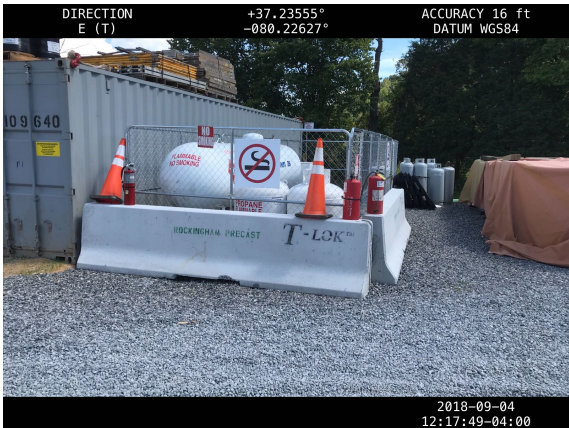
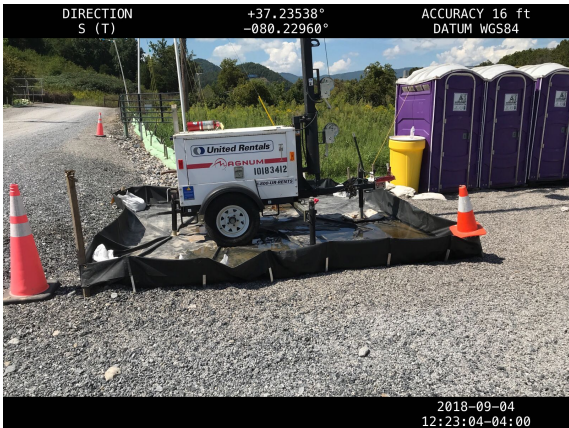
GPS Location	37.2788855061282, -80.028789332211		GPS Location	37.2788213933651, -80.028826783569	
Description	MVP-PY-006_090418 propane tank are free of trash. Looking E. See photo for gps data.		Description	MVP-PY-006_090418 containment under light plant. Free of stormwater. Looking S. See photo for gps data.

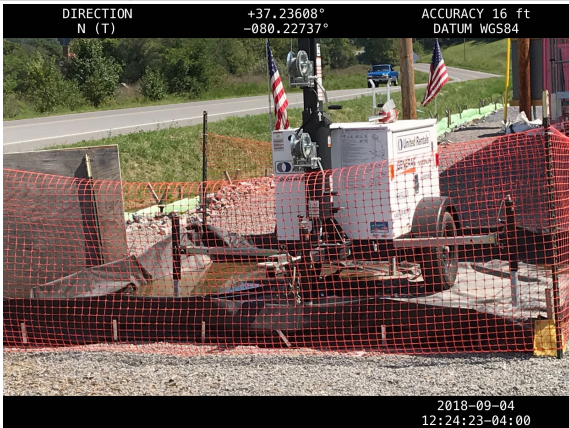
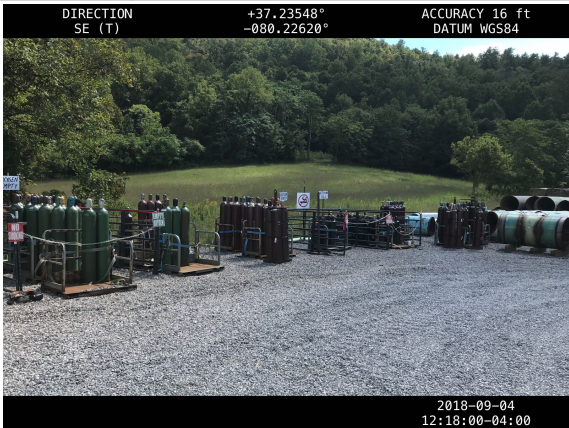
GPS Location	37.2788248893079, -80.028825888781		GPS Location	37.2788533509487, -80.0290063493744	
Description	MVP-PY-006_090418 containment under light plant. Looking N. See photo for gps data.		Description	MVP-PY-006_090418 bottle area free of trash. Looking SE. See photo for gps data.
