Visual Site Inspection Report

Project Name	H-600 Pipeline Spread H	AFE	124300138	Spread	H-600 Pipeline Spread H
Contractor	Precision			Report #	7318
Inspector	Pat Davis			Date/Time	9/4/2018 7:29 PM
Permit #	TBD	Inspection Type	VA SWPP	Station Begin	+0
State	VA	Inspection Area	Partial	Station End	+0
County	Roanoke	Ground	Dry	Temperature (°F)	91.00
Municipality	N/A	Weather	Sunny	Rain Gauge (in)	0.00
GPS Location	37.2789053712387, -80.0287833810598			Rain Accumulation Time (days)	0.00

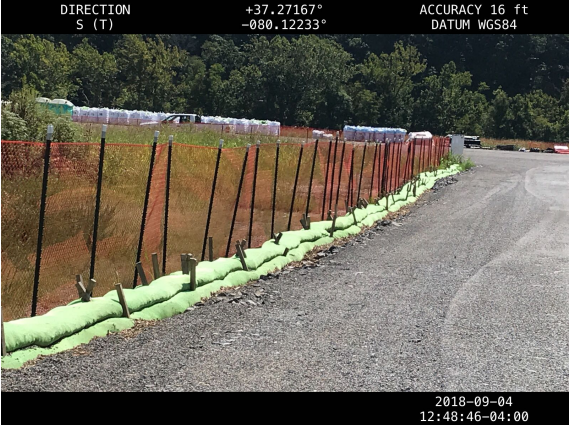
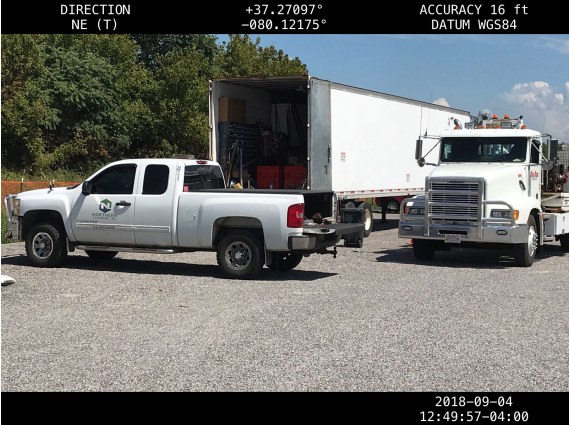
GPS Location	37.2787981475495, -80.0289745246171	GPS Location	37.278886878657, -80.0289191873107		
Description	MVP-LY-049_090418 ECD's and safety fence along drive. Looking S. See photo for gps data.	Description	MVP-LY-049_090418 Northern Clearing setting up trailer. Looking NE. See photo for gps data.

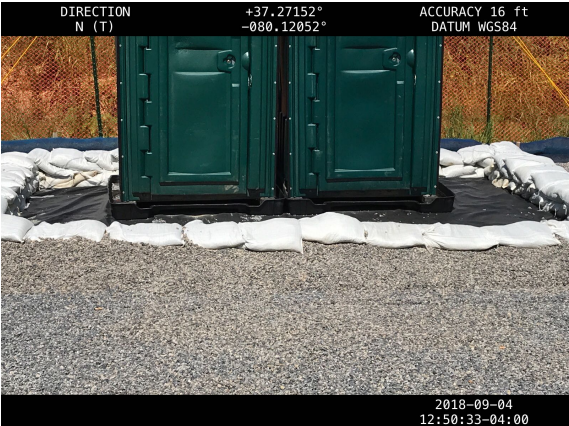
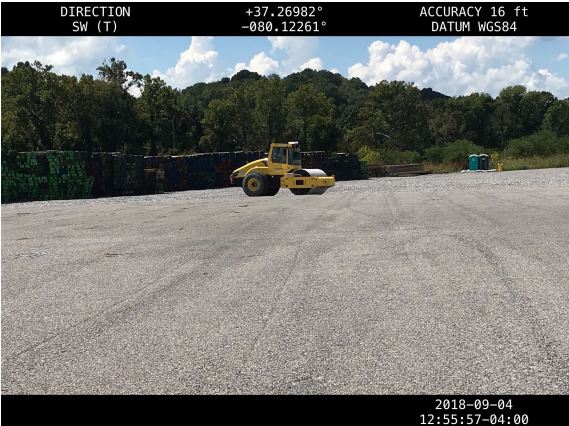
GPS Location	37.2791406931703, -80.0291748997569	GPS Location	37.2791505419065, -80.0291706249863		
Description	MVP-LY-049_090418 containment's under porta toilets. Looking N. See photo for gps data.	Description	MVP-LY-049_090418 crew performing yard maintenance. Looking SW. see photo for gps data.

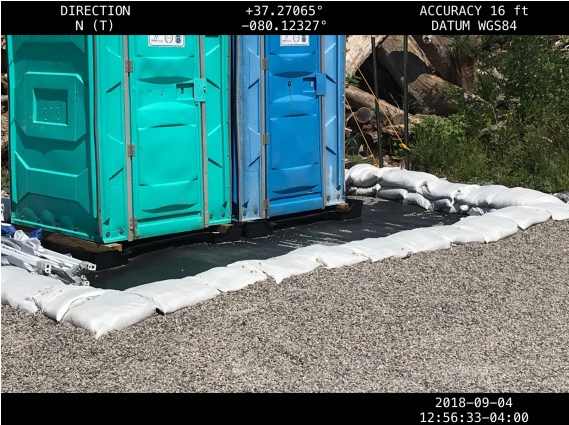
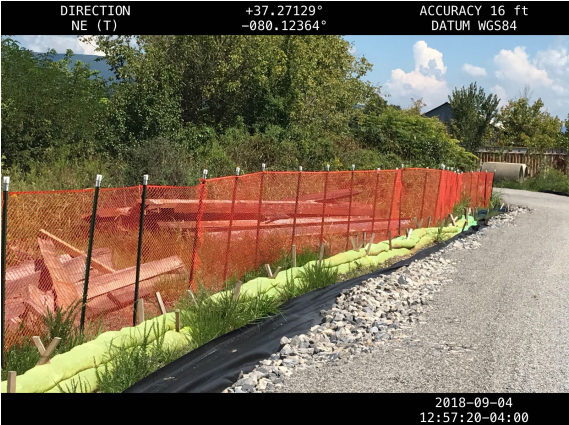
GPS Location	37.2789468891905, -80.0288267863988	GPS Location	37.2791681019936, -80.0289544557035		
Description	MVP-LY-049_090418 containment's under porta toilets. Looking N. See photo for gps data.	Description	MVP-LY-049_090418 ECD's and safety fence along north side of drive. Looking NE. See photo for gps data.
