# Visual Site Inspection Report

<b>Project Name</b>	H-600 Pipeline Spread H	<b>AFE</b>	124300138	<b>Spread</b>	H-600 Pipeline Spread H
<b>Contractor</b>	Precision			<b>Report #</b>	7493
<b>Inspector</b>	Pat Davis			<b>Date/Time</b>	9/7/2018 3:03 PM
<b>Permit #</b>	TBD	<b>Inspection Type</b>	VA SWPP	<b>Station Begin</b>	13197+64
<b>State</b>	VA	<b>Inspection Area</b>	Partial	<b>Station End</b>	13315+70
<b>County</b>	Franklin	<b>Ground</b>	Dry	<b>Temperature (°F)</b>	88.00
<b>Municipality</b>	N/A	<b>Weather</b>	Sunny	<b>Rain Gauge (in)</b>	0.00
<b>GPS Location</b>	37.1214127634066, -80.0664811582119			<b>Rain Accumulation Time (days)</b>	0.00

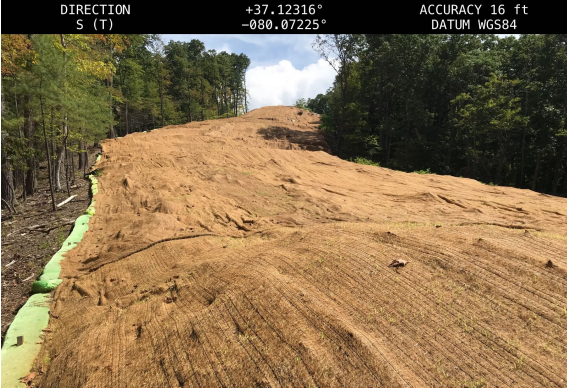
13203+98      2018-09-07 row condition      13:23:30-04:00		<b>GPS Location</b> 37.1213980531666, -80.0665089861304	
<b>Description</b> 13203+98_090718 row condition with erosion control blanket installed. Looking W. See photo for gps data.		<b>Description</b> 13203+98_090718 for condition with erosion control blanket installed. Looking E. See photo for gps data.			
DIRECTION S (T)      +37.12313°      ACCURACY 33 ft -080.06767°      DATUM WGS84

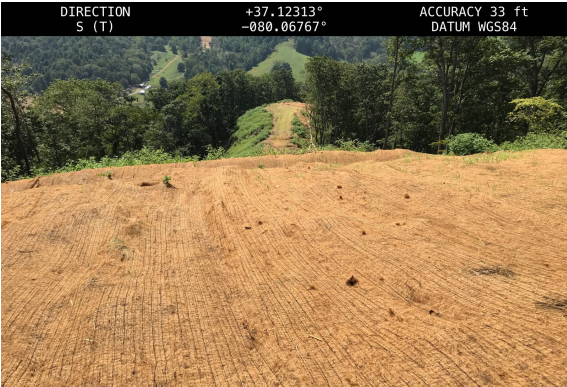
<b>Description</b> 13219+00_090718 row condition with erosion control blanket installed. Looking S. See photo for gps data.		<b>Description</b> 13223+00_090718 row condition with erosion control blanket installed. Looking SE. see photo for gps data.			
DIRECTION S (T)      +37.12114°      ACCURACY 16 ft -080.06671°      DATUM WGS84

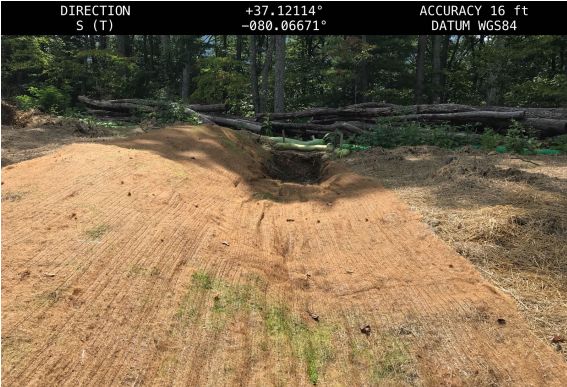
2018-09-07 15:47:23-04:00		<b>GPS Location</b> 37.1213822113696, -80.0665399153531	
<b>Description</b> 13227+00_090718 waterbar and sump with erosion control blanket installed. Looking S. See photo for gps data.		<b>Description</b> 13249+37_090718 row condition with erosion control blanket installed. Looking E. See photo for gps data.
