Visual Site Inspection Report

Project Name	H-600 Pipeline Spread H	AFE	124300138	Spread	H-600 Pipeline Spread H	
Contractor	Precision			Report #	7506	
Inspector	Pat Davis			Date/Time	9/7/2018 7:03 PM	
Permit #	TBD	Inspection Type	VA SWPP	Station Begin	+0	
State	VA	Inspection Area	Partial	Station End	+0	
County	Roanoke	Ground	Dry	Temperature (°F)	88.00	
Municipality	N/A	Weather	Sunny	Rain Gauge (in)	0.00	
GPS Location	37.2787895752464, -80.0288799405843			Rain Accumulation Time (days)	0.00

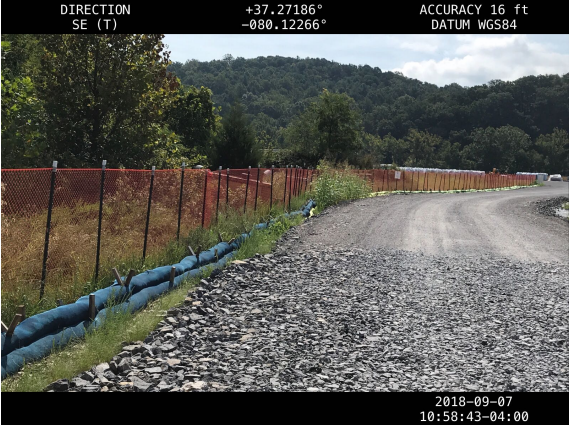
2018-09-07 10:59:23-04:00			
GPS Location	37.2788066743289, -80.0288414676488	GPS Location	37.2787913773556, -80.0288147293777		
Description	MVP-LY-049_090718 ECD's and safety along drive. Looking SE. See photo for gps data.	Description	MVP-LY-049_090718 porta toilets in containment. Looking N. See photo for gps data.		
DIRECTION NE (T) +37.27063° ACCURACY 16 ft -080.12324° DATUM WGS84

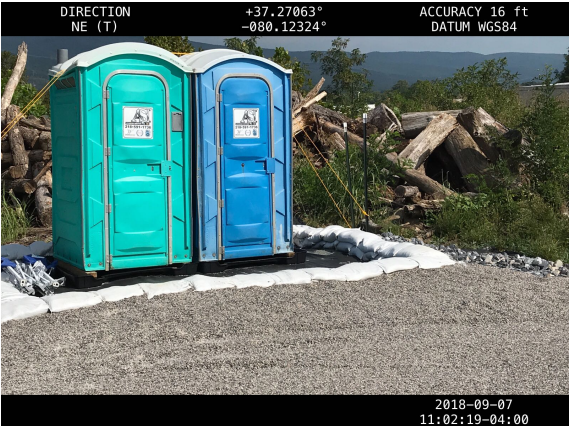
2018-09-07 11:03:12-04:00			
GPS Location	37.278875531895, -80.0288813303026	GPS Location	37.2788289701913, -80.0287960377336		
Description	MVP-LY-049_090718 ports toilets in containment. Looking NE. See photo for gps data.	Description	MVP-LY-049_090718 W-CV21B ECD's at feature. Looking S. See photo for gps data.

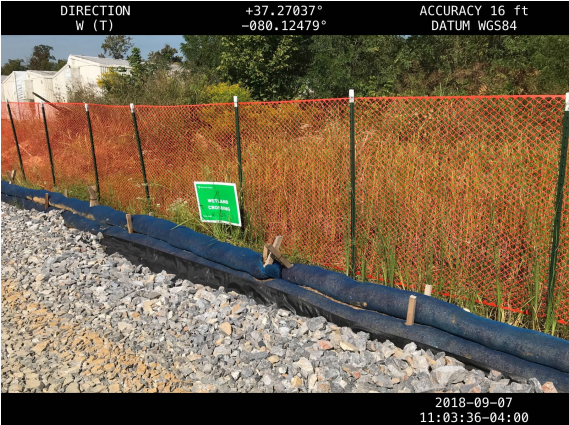
2018-09-07 11:05:24-04:00			
GPS Location	37.2788616596137, -80.0287959539146	GPS Location	37.2788607795139, -80.0287897513062		
Description	MVP-LY-049_090718 W-CV21A ECD's at feature. Looking W. See photo for gps data.	Description	MVP-LY-049_090718 ECD's and safety fence along north side of drive. Looking N. See photo for gps data.
