Visual Site Inspection Report

Project Name	H-600 Pipeline Spread H	AFE	124300138	Spread	H-600 Pipeline Spread H
Contractor	Precision			Report #	7812
Inspector	Pat Davis			Date/Time	9/13/2018 7:51 PM
Permit #	TBD	Inspection Type	VA SWPP	Station Begin	13197+55
State	VA	Inspection Area	Partial	Station End	13415+50
County	Franklin	Ground	Muddy	Temperature (°F)	81.00
Municipality	N/A	Weather	Cloudy	Rain Gauge (in)	0.10
GPS Location	37.0943701453852, -80.0180340931565			Rain Accumulation Time (days)	0.00

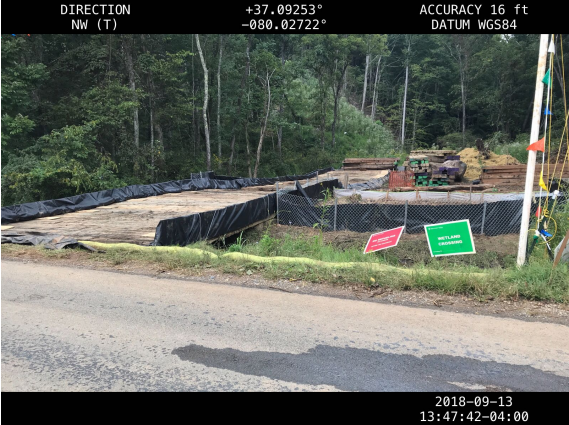
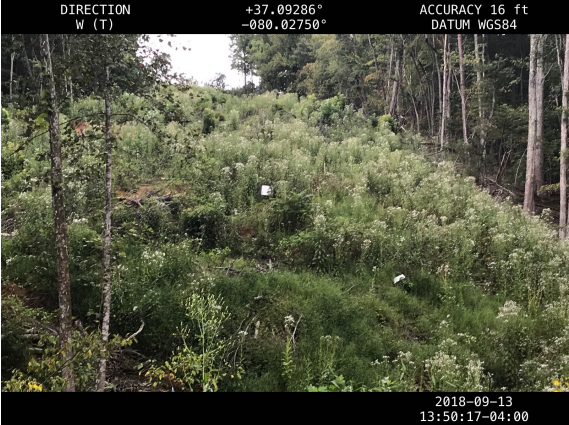
GPS Location	37.094330666213, -80.0180350989849	GPS Location	37.0943504898223, -80.0180198439211		
Description	Cahas Mtn Road_091318 13415+50 mat bridge and ECD's installed. Looking NW. See photo for gps data.	Description	13413+01_091318 vegetation on steep slope. Looking W. See photo for gps data.

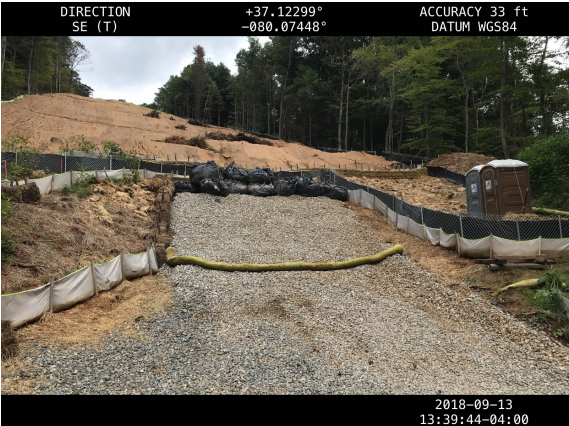
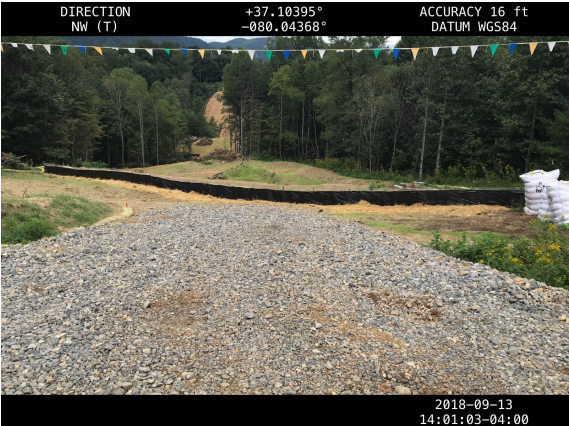
GPS Location	37.0943638170483, -80.0180220232159	GPS Location	37.0943539683121, -80.0180148985982		
Description	Dillion's Mill Road_091318 super sandbags installed before weather event. Looking SE. See photo for gps data.	Description	13341+50_091418 super silt fence installed across ROW before weather event. Looking NW. See photo for gps data.

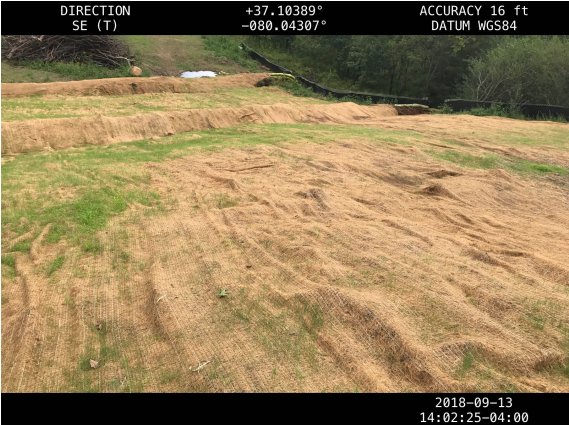
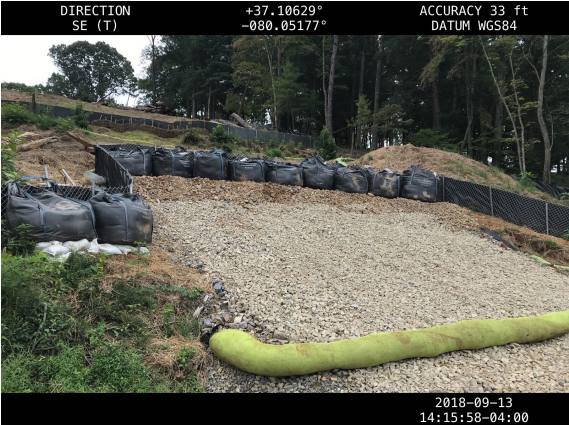
GPS Location	37.0943882922056, -80.0179995597154	GPS Location	37.094411719625, -80.0179781020433		
Description	13346+19_091318 Erosion Control Blanket on ROW. Looking SE. See photo for gps data.	Description	Wades Gap_091318 13316+34 super sandbags installed before weather event. Looking SE. See photo for gps data.
