Visual Site Inspection Report

Project Name	H-600 Pipeline Spread H	AFE	124300138	Spread	H-600 Pipeline Spread H
Contractor	Precision			Report #	8082
Inspector	Pat Davis			Date/Time	9/19/2018 6:21 AM
Permit #	TBD	Inspection Type	VA SWPP	Station Begin	13331+11
State	VA	Inspection Area	Partial	Station End	13371+50
County	Franklin	Ground	Muddy	Temperature (°F)	89.00
Municipality	N/A	Weather	Sunny	Rain Gauge (in)	0.00
GPS Location	37.2787799402218, -80.0287748136137			Rain Accumulation Time (days)	0.00

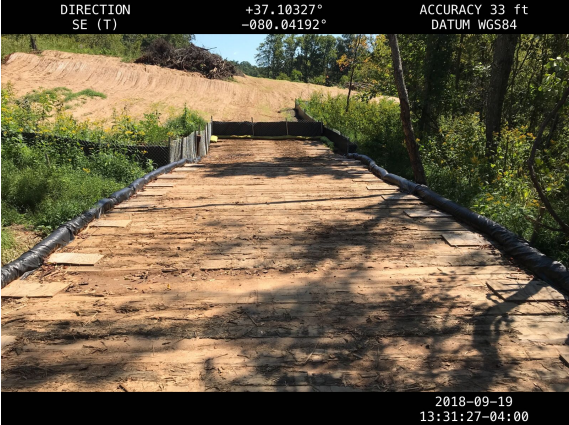
GPS Location	37.278865668435, -80.0286848915605	GPS Location	37.2788316304996, -80.0288572336318		
Description	13348+46_091918 S-RR08 bridge clean with no stream impact. Looking SE. See photo for gps data.	Description	13352+23_091918 S-RR09 bridge clean with no stream impact. Looking E. See photo for gps data.

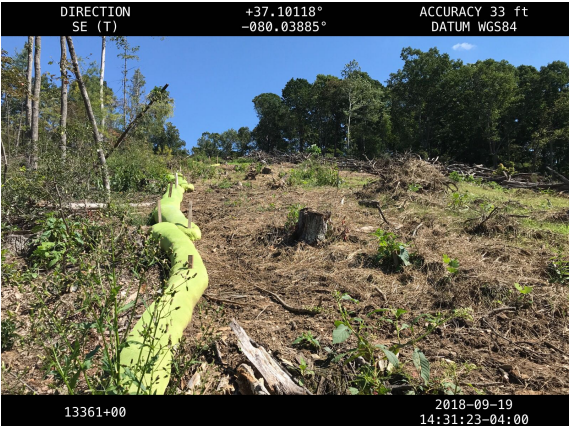
GPS Location	37.2788304566788, -80.0288604635555	GPS Location	37.2788556265053, -80.0288503280906		
Description	13361+00_091918 condition of ROW. Looking SE. see photo for gps data.	Description	13362+50_091918 compost filter sock needs cleaned out. Looking W. See photo for gps data.

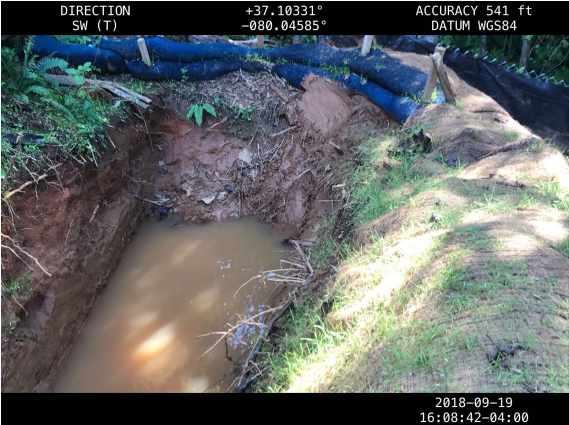
GPS Location	37.2787582760869, -80.0289427573797	GPS Location	37.2787681197869, -80.0289360280039		
Description	13334+67_091918 undermined J hook corrected. Looking SW. See photo for gps data.	Description	13337+13_091918 S-GH9 mat bridge shifted about 2 feet south. Looking W. See photo for gps data.
