Visual Site Inspection Report

Project Name	H-600 Pipeline Spread H	AFE	124300138	Spread	H-600 Pipeline Spread H
Contractor	Precision			Report #	8351
Inspector	Pat Davis			Date/Time	9/24/2018 3:01 PM
Permit #	TBD	Inspection Type	VA SWPP	Station Begin	13262+66
State	VA	Inspection Area	Partial	Station End	13342+67
County	Franklin	Ground	Muddy	Temperature (°F)	65.00
Municipality	N/A	Weather	Light Rain	Rain Gauge (in)	0.30
GPS Location	37.1156542282897, -80.0597209018469			Rain Accumulation Time (days)	0.00

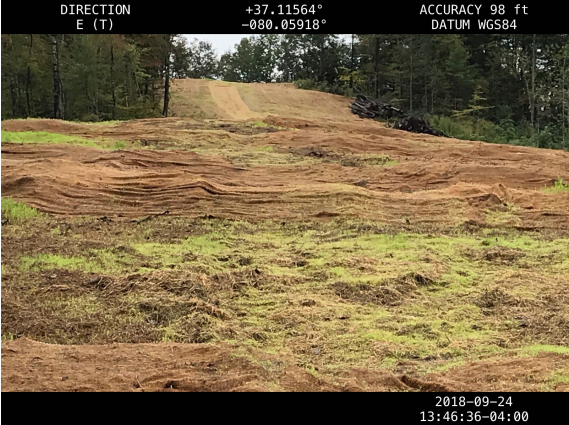
2018-09-24 13:57:25-04:00			
GPS Location	37.1156445471916, -80.059684105292		GPS Location	37.1155742230239, -80.059811007306	
Description	13263+45_092418 condition of the ROW. Looking E. See photo for gps data.		Description	13274+63_092418 condition of the ROW. Looking S. See photo for gps data.	
DIRECTION W (T) +37.11461° ACCURACY 16 ft -080.05623° DATUM WGS84

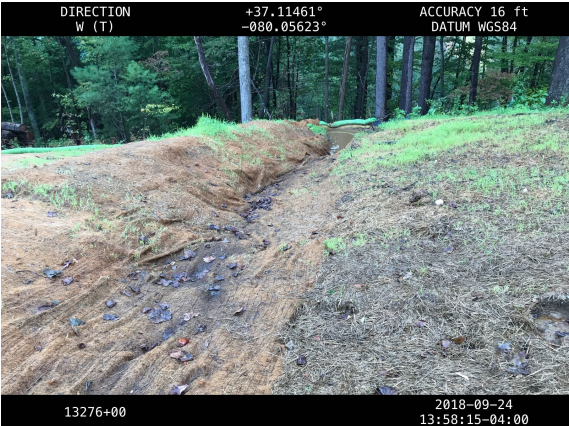
13276+00 2018-09-24 13:58:15-04:00		DIRECTION S (T) +37.11237° ACCURACY 16 ft -080.05571° DATUM WGS84

2018-09-24 14:09:31-04:00			
GPS Location	37.1157016279522, -80.0596996118129		GPS Location	37.1157784480947, -80.0596102607251	
Description	13276+00_092418 waterbar and sump. Looking W. See photo for gps data.		Description	13278+56_092418 condition of ROW. Looking S. See photo for gps data.

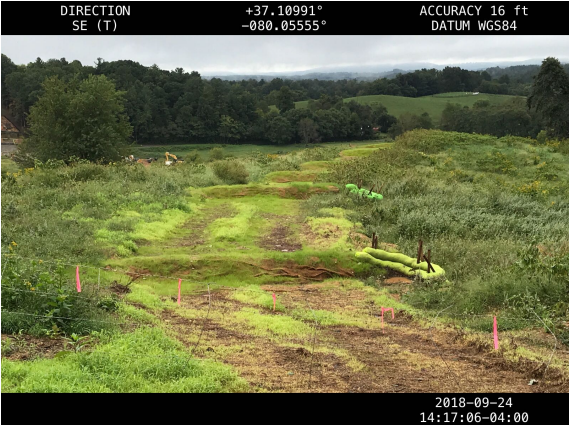
2018-09-24 14:16:55-04:00			
GPS Location	37.1157493209812, -80.0596131943912		GPS Location	37.1157811722133, -80.0596069079638	
Description	13294+48_092418 condition of ROW. Looking SE. See photo for gps data.		Description	13294+48_092418 condition of the ROW. Looking NW. See photo for gps data.
