# Visual Site Inspection Report

<b>Project Name</b>	H-600 Pipeline Spread H		<b>AFE</b>	124300138	<b>Spread</b>	H-600 Pipeline Spread H	
<b>Contractor</b>	Precision				<b>Report #</b>	8507	
<b>Inspector</b>	Pat Davis				<b>Date/Time</b>	9/28/2018 6:28 AM	
<b>Permit #</b>	TBD	<b>Inspection Type</b>	VA SWPP		<b>Station Begin</b>	+0	
<b>State</b>	VA	<b>Inspection Area</b>	Partial		<b>Station End</b>	+0	
<b>County</b>	Roanoke	<b>Ground</b>	Muddy		<b>Temperature (°F)</b>	79.00	
<b>Municipality</b>	N/A	<b>Weather</b>	Sunny		<b>Rain Gauge (in)</b>	1.10	
<b>GPS Location</b>	37.2706254758288, -80.123873390332				<b>Rain Accumulation Time (days)</b>	0.00

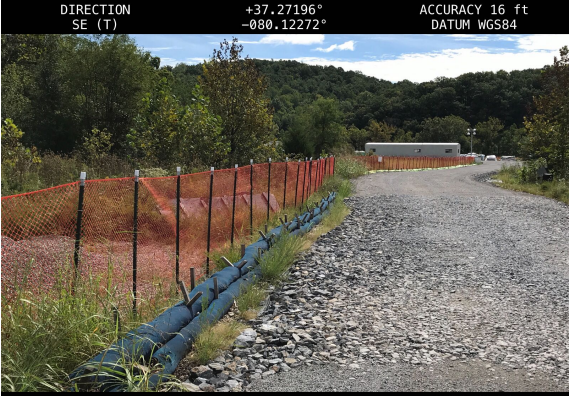
2018-09-28 11:42:49-04:00			
<b>GPS Location</b>	37.2706222907056, -80.1238750667126	<b>GPS Location</b>	37.2706222907056, -80.1238750667126		
<b>Description</b>	MVP-LY-049_092818 ECD's and safety fence a long drive. Looking SE. see photo for gps data.	<b>Description</b>	MVP-LY-049_092818 rock entrance on drive. Looking S. See photo for gps data.		
DIRECTION NW (T)      +37.27098° -080.12194°      ACCURACY 16 ft DATUM WGS84

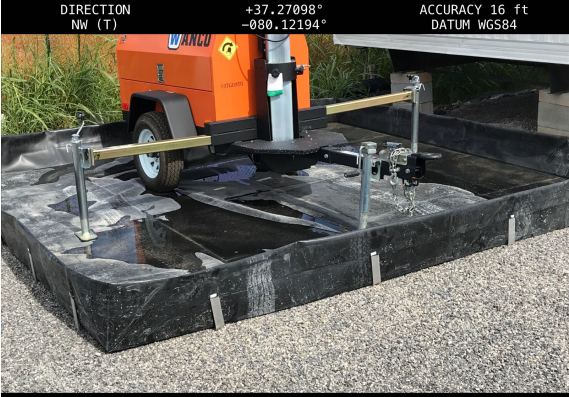
<b>Description</b>	MVP-LY-049_092818 containment under light plant. Looking NW. See photo for gps data.	<b>Description</b>	MVP-LY-049_092818 containment for stored materials. Looking NW. See photo for gps data.		
DIRECTION N (T)      +37.27152° -080.12052°      ACCURACY 16 ft DATUM WGS84

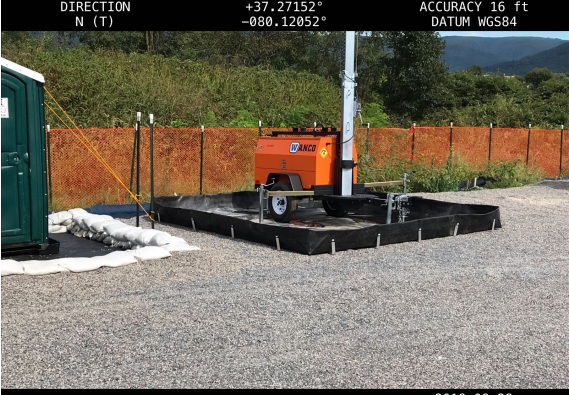
2018-09-28 11:45:56-04:00			
<b>GPS Location</b>	37.2706137411643, -80.1238714624943	<b>GPS Location</b>	37.2706137411643, -80.1238714624943		
<b>Description</b>	MVP-LY-049_092818 containment under light plant. Looking N. See photo for gps data.	<b>Description</b>	MVP-LY-049_092818 dumpster area free of loose trash. Looking NE. See photo for gps data.
