Visual Site Inspection Report

Project Name	H-600 Pipeline Spread H	AFE	124300138	Spread	H-600 Pipeline Spread H
Contractor	Precision			Report #	729
Inspector	Randy Clark			Date/Time	4/2/2018 9:04 PM
Permit #	TBD	Inspection Type	Weekly	Station Begin	12638+24
State	VA	Inspection Area	Partial	Station End	13690+91
County	Franklin	Ground	Wet	Temperature (°F)	60.00
Municipality	N/A	Weather	Cloudy	Rain Gauge (in)	0.00
GPS Location	37.2692273743798, -80.0329244603217			Rain Accumulation Time (days)	4.00

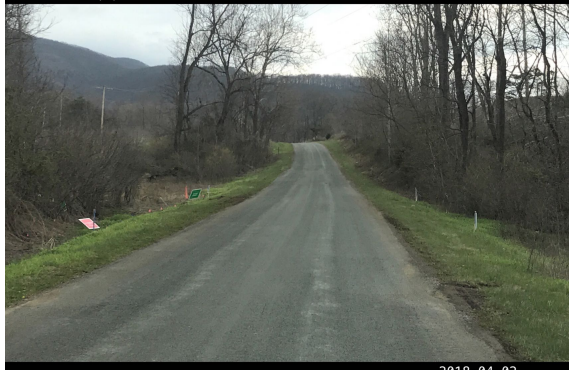
<div>Cahas MTN RD #1 13415+51 2018-04-02 16:09:52-04:00</div>			<div>DIRECTION NW (T)</div> <div>37.10387°N 080.04368°W</div> <div>ACCURACY 6 m DATUM WGS84</div>

<div>Webster Corner RD 13342+67 2018-04-02 15:58:49-04:00</div>		
GPS Location	37.269200639389, -80.0327806986458		GPS Location	37.2691198765766, -80.0327978141804	
Description	Cahas Mountain Road crossing. Please see photo overlay for actual GPS coordinates.		Description	Webster Corner Road (east side). Please see photo overlay for actual GPS coordinates.	
<div>DIRECTION S (T)</div> <div>37.08967°N 079.96091°W</div> <div>ACCURACY 8 m DATUM WGS84</div>

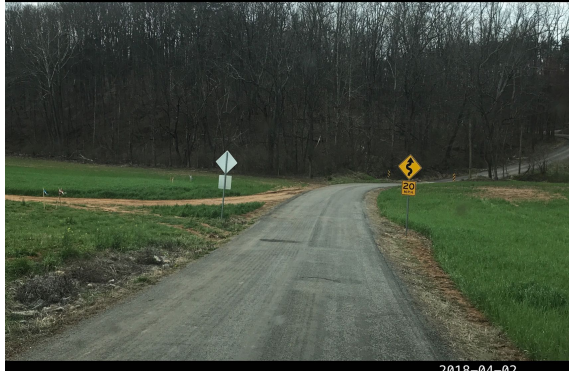
<div>Leaning Oak RD 13644+82 2018-04-02 16:45:38-04:00</div>			<div>DIRECTION NW (T)</div> <div>37.09129°N 079.99118°W</div> <div>ACCURACY 8 m DATUM WGS84</div>

GPS Location	37.2692236025233, -80.0329203531891		GPS Location	37.2692236025233, -80.0329203531891	
Description	Leaning Oak Road crossing. Please see photo overlay for actual GPS coordinates.		Description	House Rock Road (west side). Please see photo overlay for actual GPS coordinates.	
<div>DIRECTION NW (T)</div> <div>37.18758°N 080.17397°W</div> <div>ACCURACY 8 m DATUM WGS84</div>

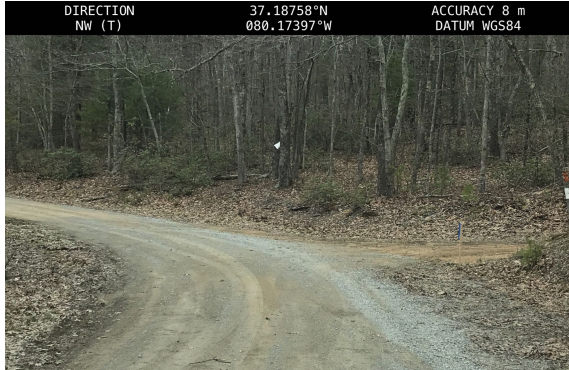
<div>MVP-R0-279.01 Honeysuckle RD. 12638+24 2018-04-02 12:16:57-04:00</div>			<div>DIRECTION NE (T)</div> <div>37.09186°N 079.98416°W</div> <div>ACCURACY 6 m DATUM WGS84</div>

<div>Bethlehem RD 13562+63 2018-04-02 16:31:28-04:00</div>		
GPS Location	37.2692236025233, -80.0329203531891		GPS Location	37.2692236025233, -80.0329203531891	
Description	Honeysuckle Road / access road (279.01). Please see photo overlay for actual GPS coordinates.		Description	Bethlehem Road crossing. Please see photo overlay for actual GPS coordinates.
