Visual Site Inspection Report

Project Name	H-600 Pipeline Spread H	AFE	124300138	Spread	H-600 Pipeline Spread H
Contractor	Precision			Report #	2045
Inspector	Randy Clark			Date/Time	5/18/2018 5:40 PM
Permit #	TBD	Inspection Type	VA SWPP	Station Begin	12371+00
State	VA	Inspection Area	Full	Station End	13415+00
County	Franklin	Ground	Wet	Temperature (°F)	71.00
Municipality	N/A	Weather	Heavy Rain	Rain Gauge (in)	3.70
GPS Location	37.2691839233823, -80.0326984815012			Rain Accumulation Time (days)	4.00

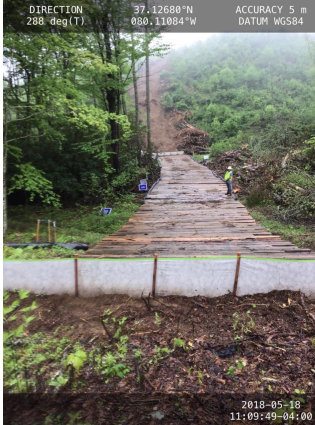
GPS Location	37.2691962231724, -80.0328268368362	GPS Location	37.2691801423554, -80.0329241250456		
Description	Stream S-G27 no issues. Milepost 247.11 See photo for GPS data.	Description	Stream S-G26 no issues. Milepost 247.13 See photo for GPS data.

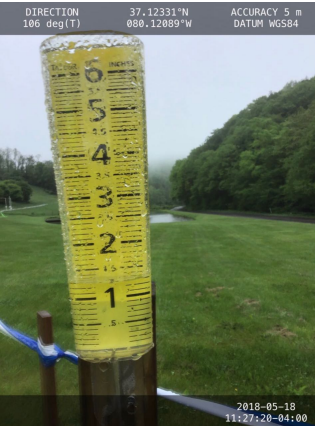
GPS Location	37.2691862789044, -80.032709846402	GPS Location	37.2692143574694, -80.0328669665914		
Description	1.4" of rainfall at access MVP-RO-290 milepost, (246.7) GPS data on photo.	Description	Stream S-II4 at milepost 250.7 Please see photo for GPS data.		
Insert image here		Insert image here			
GPS Location		GPS Location			
Description		Description
