Visual Site Inspection Report

Project Name	H-600 Pipeline Spread H	AFE	124300138	Spread	H-600 Pipeline Spread H
Contractor	Precision			Report #	2224
Inspector	Randy Clark			Date/Time	5/18/2018 6:34 PM
Permit #	TBD	Inspection Type	VA SWPP	Station Begin	12005+00
State	VA	Inspection Area	Full	Station End	12371+00
County	Montgomery	Ground	Muddy	Temperature (°F)	70.00
Municipality	N/A	Weather	Light Rain	Rain Gauge (in)	2.80
GPS Location	37.269177949739, -80.03269515645			Rain Accumulation Time (days)	4.00

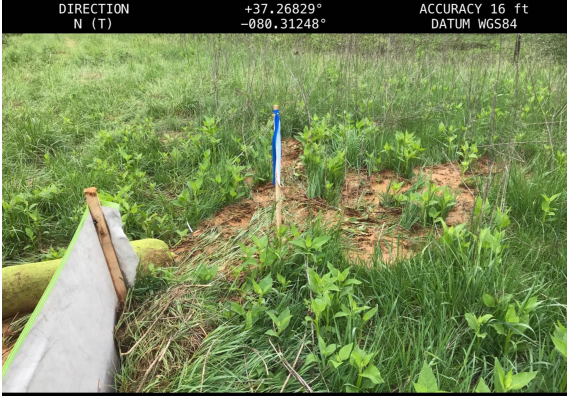
2018-05-18 12:12:05-04:00			
GPS Location	37.2690743719738, -80.0326482815694	GPS Location	37.2691835371036, -80.0325406012867		
Description	Sediment off right of way. ATWS-474. See photo for GPS data.	Description	S-G38 bridge dirty, no corner ECD installed at this time. See photo for GPS data.		
DIRECTION NW (T) +37.27014° ACCURACY 16 ft -080.31378° DATUM WGS84

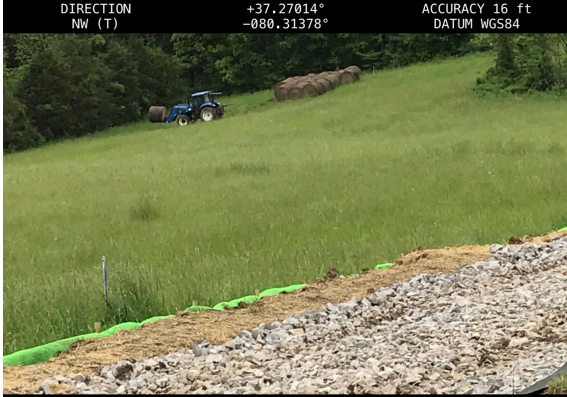
2018-05-18 12:01:17-04:00			
GPS Location	37.2691233869499, -80.0326709693383	GPS Location	37.2691671374929, -80.0327016553941		
Description	Farmer has been tracking mud out onto Callaway Road with tractor. See Photo for GPS data.	Description	Crew has installed temporary slope breaker end treatment due to storm event. 12008+80. See photo for GPS data.

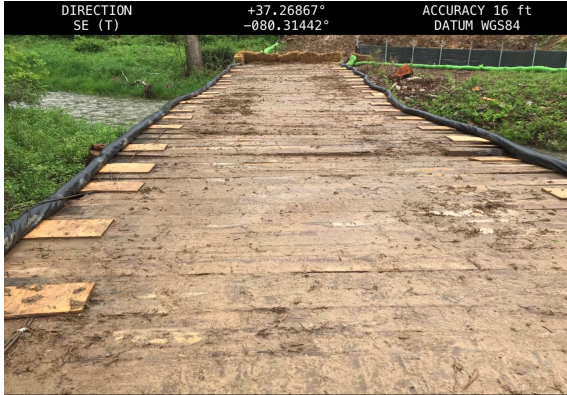
2018-05-18 11:57:04-04:00			
GPS Location	37.2691539069985, -80.0327815488726	GPS Location	37.2691539069985, -80.0327815488726		
Description	Top soil pile continues to erode. ATWS-473. See photo for GPS data.	Description	Stream S-G38. No issues noted. See photo for GPS data.
