Visual Site Inspection Report

Project Name	H-600 Pipeline Spread G	AFE	124300137	Spread	H-600 Pipeline Spread G
Contractor	Precision			Report #	10461
Inspector	Rob Robertson			Date/Time	11/5/2018 5:30 PM
Permit #	TBD	Inspection Type	VA SWPP	Station Begin	10458+91
State	VA	Inspection Area	Full	Station End	10459+03
County	Giles	Ground	Wet	Temperature (°F)	57.00
Municipality	N/A	Weather	Light Rain	Rain Gauge (in)	0.20
GPS Location	37.1345344299741, -80.3946846499691			Rain Accumulation Time (days)	1.00

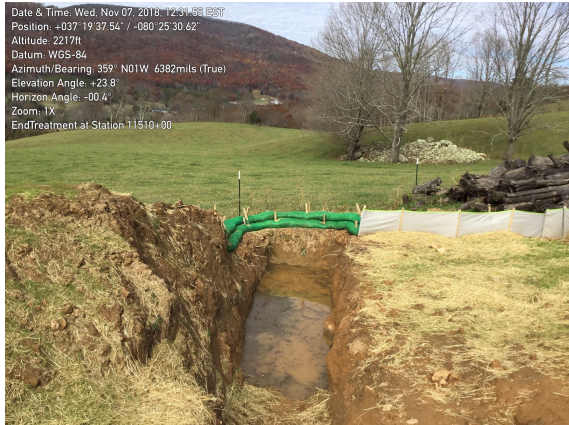
A/E	124300137	Date/Time	11/7/2018 4:39 AM	Report #	10536
Pictures					
<p>Date & Time: Wed, Nov 07, 2018, 12:31:05 EST Position: +037° 19' 37.54" / -080° 25' 30.62" Altitude: 2217ft Datum: WGS-84 Azimuth/Bearing: 359° N01W 6382mils (True) Elevation Angle: +23.8° Horizon Angle: -00.4° Zoom: 1X EndTreatment at Station 11510+00</p>

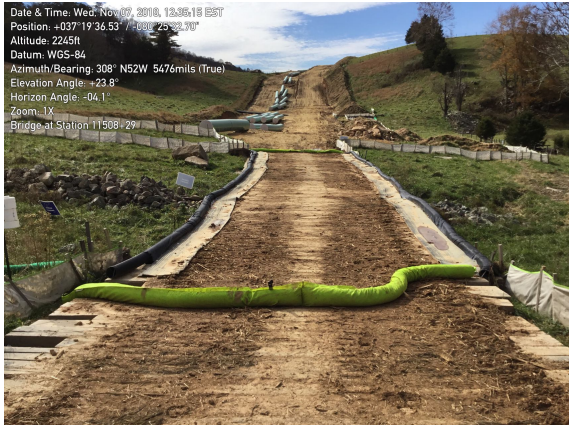
<p>Date & Time: Wed, Nov 07, 2018, 12:35:18 EST Position: +037° 19' 36.53" / -080° 25' 32.70" Altitude: 2245ft Datum: WGS-84 Azimuth/Bearing: 308° N52W 5476mils (True) Elevation Angle: +23.8° Horizon Angle: -04.1° Zoom: 1X Bridge at Station 11508+29</p>

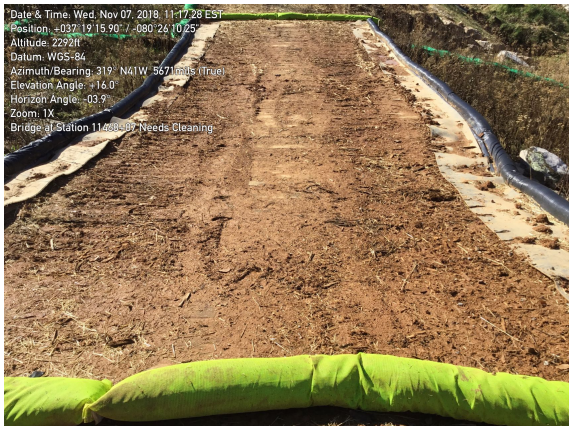
GPS Location	37.3169948766356, -80.4453625437621		GPS Location	37.3187322356154, -80.4416419007633	
Description	EndTreatment at 11510+10		Description	Bridge at Station 11508+29	
<p>Date & Time: Wed, Nov 07, 2018, 12:37:05 EST Position: +037° 19' 36.70" / -080° 25' 32.46" Altitude: 2222ft Datum: WGS-84 Azimuth/Bearing: 336° N24W 5973mils (True) Elevation Angle: +21.8° Horizon Angle: -01.4° Zoom: 1X P-1 Silt Fence at Station 11508+29</p>  		<p>Date & Time: Wed, Nov 07, 2018, 11:17:28 EST Position: +037° 19' 15.90" / -080° 26' 10.25" Altitude: 2227ft Datum: WGS-84 Azimuth/Bearing: 319° N41W 5671mils (True) Elevation Angle: +16.0° Horizon Angle: -03.9° Zoom: 1X Bridge at Station 11468+87 Needs Cleaning</p>

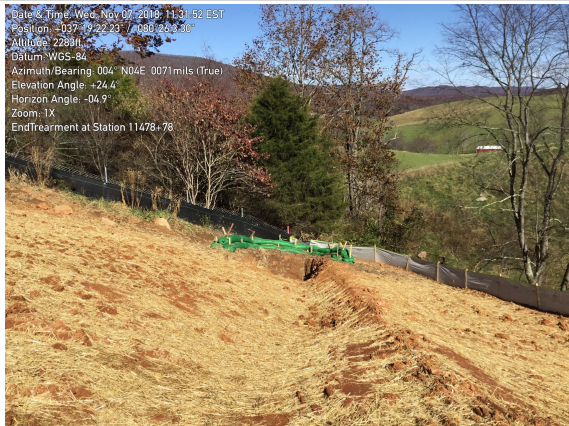
GPS Location	37.3190011689787, -80.4410112463687		GPS Location	37.3210555315365, -80.4361498263482	
Description	P-1 Silt Fence at Station 11508+29		Description	Bridge at Station 11468+87 Needs Cleaning	
<p>Date & Time: Wed, Nov 07, 2018, 11:41:52 EST Position: +037° 19' 22.20" / -080° 26' 43.00" Altitude: 2289ft Datum: WGS-84 Azimuth/Bearing: 004° N04E 0071mils (True) Elevation Angle: +24.4° Horizon Angle: -04.9° Zoom: 1X EndTreatment at Station 11478+78</p>

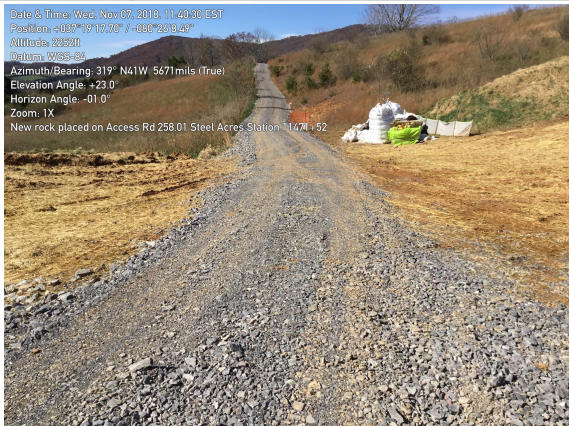
<p>Date & Time: Wed, Nov 07, 2018, 11:40:00 EST Position: +037° 19' 17.70" / -080° 26' 43.45" Altitude: 2320ft Datum: WGS-84 Azimuth/Bearing: 319° N41W 5671mils (True) Elevation Angle: +23.0° Horizon Angle: -01.0° Zoom: 1X New rock placed on Access Rd 258.01 Steel Acres Station 11474+52</p>

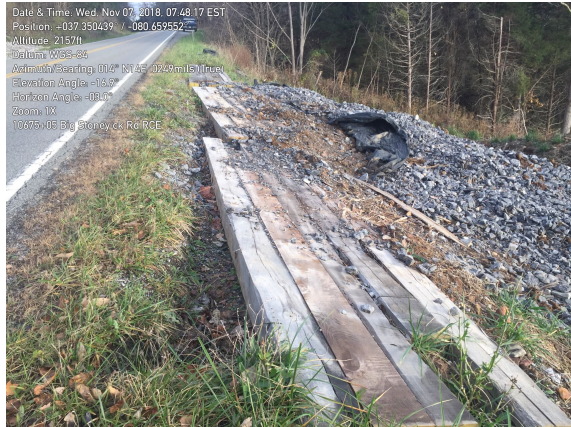
GPS Location	37.3493276490246, -80.6524636969721	GPS Location	37.3493448319261, -80.6526491046703		
Description	Buffalo Anklets 0.20" rain gauge	Description	Big Stoney Creek Rd RCE missing Stone,geo pulled up, mats twisted.10675+05

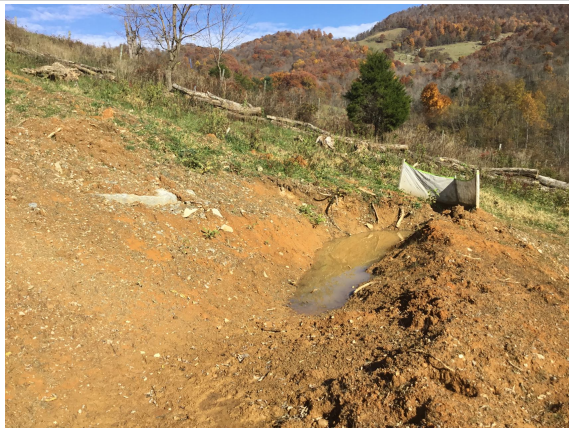
GPS Location	37.3359802225952, -80.5974080041802	GPS Location	37.3357876064604, -80.5988326762622		
Description	10877+00 off Kow Camp Rd 1 sumps hold some silt and water	Description	10875+00 off Kow Camp Rd 1 no issues

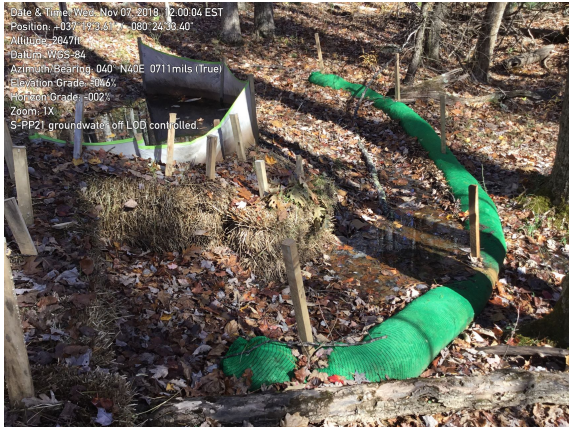
A/E	124300137	Date/Time	11/7/2018 3:36 PM	Report #	10576
Pictures					
<p>Date & Time: Wed, Nov 07, 2018, 11:52:01 EST Position: +037 18 50 61 / -080 24 30 20 Altitude: 2047ft Datum: WGS-84 Azimuth/Heading: 042 N42E 071mils (True) Elevation Grade: -003% Horizon Grade: -003% Zoom: 1X S-PP20 crossing stable</p>  		<p>Date & Time: Wed, Nov 07, 2018, 12:00:04 EST Position: +037 18 50 61 / -080 24 30 40 Altitude: 2047ft Datum: WGS-84 Azimuth/Heading: 040 N40E 071mils (True) Elevation Grade: -006% Horizon Grade: -002% Zoom: 1X S-PP21 groundwater off LOD controlled</p>

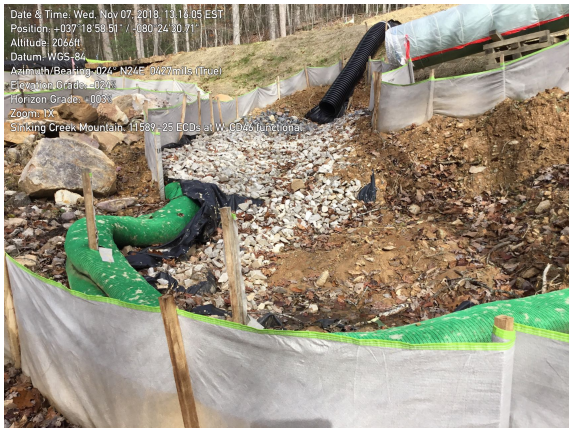
GPS Location	37.1329856152061, -80.394569384009		GPS Location	37.1329856152061, -80.394569384009	
Description	Correct coordinates on photo. S-PP20 is stable with no impact.		Description	Correct coordinates on photo. Controls at the S-PP21 crossing functional.	
<p>Date & Time: Wed, Nov 07, 2018, 12:37:49 EST Position: +037 18 50 51 / -080 24 45 58 Altitude: 2046ft Datum: WGS-84 Azimuth/Heading: 022 N22E 062mils (True) Elevation Grade: -002% Horizon Grade: -003% Zoom: 1X Sinking Creek Mountain, S-PP22 flow unobstructed at 11588-22</p>  		<p>Date & Time: Wed, Nov 07, 2018, 12:40:05 EST Position: +037 18 50 51 / -080 24 46 10 Altitude: 2046ft Datum: WGS-84 Azimuth/Heading: 022 N22E 062mils (True) Elevation Grade: -002% Horizon Grade: -003% Zoom: 1X Sinking Creek Mountain, 11589-25 ECDs at Wetland functional</p>
