# Visual Site Inspection Report

<b>Project Name</b>	H-600 Pipeline Spread G	<b>AFE</b>	124300137	<b>Spread</b>	H-600 Pipeline Spread G
<b>Contractor</b>	Precision			<b>Report #</b>	10810
<b>Inspector</b>	Rob Robertson			<b>Date/Time</b>	11/12/2018 11:44 AM
<b>Permit #</b>	TBD	<b>Inspection Type</b>	VA SWPP	<b>Station Begin</b>	11668+15
<b>State</b>	VA	<b>Inspection Area</b>	Full	<b>Station End</b>	11618+91
<b>County</b>	Montgomery	<b>Ground</b>	Wet	<b>Temperature (°F)</b>	39.00
<b>Municipality</b>	N/A	<b>Weather</b>	Light Rain	<b>Rain Gauge (in)</b>	0.00
<b>GPS Location</b>	37.286163920343, -80.4070362383585			<b>Rain Accumulation Time (days)</b>	1.00

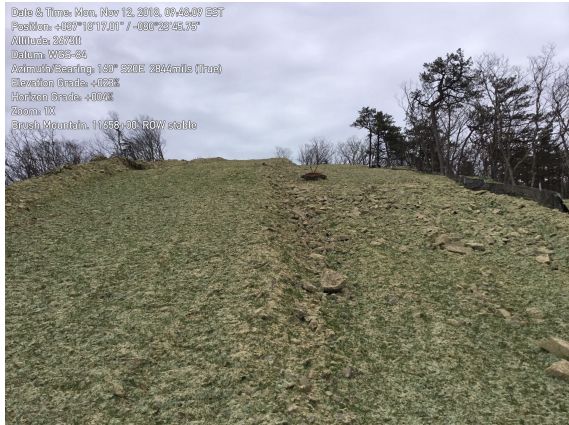
A/E	124300137	Date/Time	11/12/2018 11:44 AM	Report #	10810
Pictures					
<p>Date &amp; Time: Mon, Nov 12, 2018, 09:45:09 EST Position: +037°18'17.21" / -080°23'45.36" Altitude: 2630ft Datum: WGS-84 Azimuth/Bearing: 130° S18E 236mils (True) Elevation Grade: +022% Horizon Grade: +00% Zoom: 1X Brush Mountain: 11658+00, ROW stable</p>

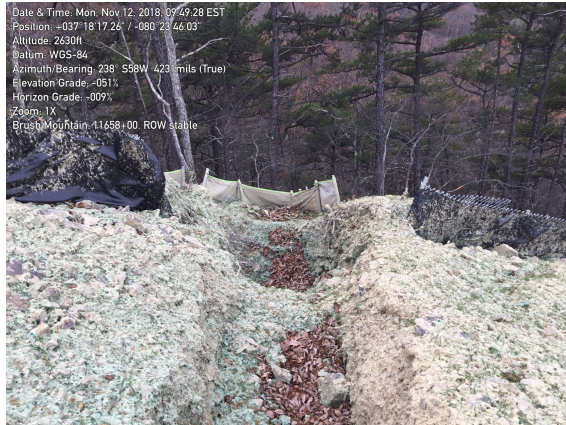
<p>Date &amp; Time: Mon, Nov 12, 2018, 09:49:28 EST Position: +037°18'17.26" / -080°23'46.03" Altitude: 2630ft Datum: WGS-84 Azimuth/Bearing: 230° S58W 423 mils (True) Elevation Grade: -051% Horizon Grade: -009% Zoom: 1X Brush Mountain: 11658+00, ROW stable</p>

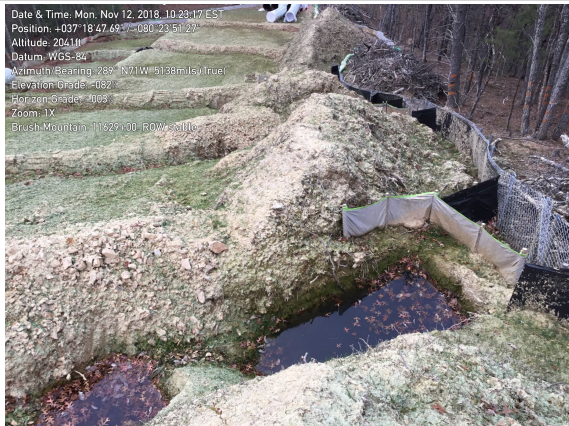
GPS Location	37.3137860326444, -80.4063137714569	GPS Location	37.3137860326444, -80.4063137714569		
Description	Correct coordinates on photo. Vegetation and fiber matrix have held soils to date.	Description	Correct coordinates on photo. Vegetation and fiber matrix have held soils to date.		
<p>Date &amp; Time: Mon, Nov 12, 2018, 10:23:17 EST Position: +037°18'47.69" / -080°23'51.27" Altitude: 2041ft Datum: WGS-84 Azimuth/Bearing: 285° N21W 513mils (True) Elevation Grade: -032% Horizon Grade: -003% Zoom: 1X Brush Mountain: 11629+00, ROW stable</p>

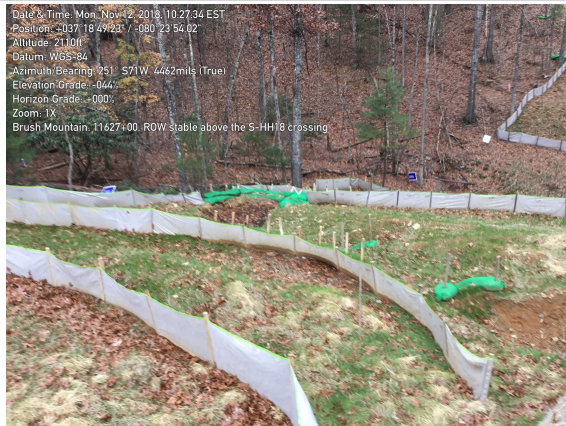
<p>Date &amp; Time: Mon, Nov 12, 2018, 10:27:34 EST Position: +037°18'49.23" / -080°23'54.02" Altitude: 2110ft Datum: WGS-84 Azimuth/Bearing: 031° S91W 4462mils (True) Elevation Grade: -044% Horizon Grade: -000% Zoom: 1X Brush Mountain: 11627+00, ROW stable above the S-HH18 crossing</p>

Description	Correct coordinates on photo. Some sumps are holding runoff indefinitely.	Description	Correct coordinates on photo. ROW stable upslope of S-HH18.

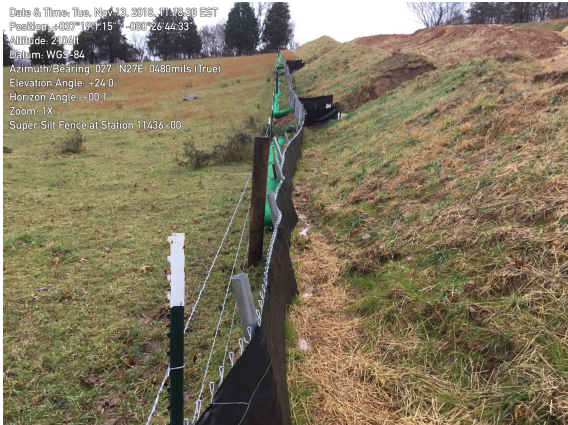
<p>Date &amp; Time: Tue, Nov 13, 2018, 11:16:50 EST Position: +037°19'15.7" / -080°26'44.33" Altitude: 2129ft Datum: WGS-84 Azimuth/Bearing: 022° N27E 0480mils (True) Elevation Angle: +24.0° Horizon Angle: +00.1° Zoom: 1X Super Silt Fence at Station 11436+00</p>

GPS Location	37.319080000778, -80.4409892857824	GPS Location	37.3170388816272, -80.4456699081514		
Description	Stream S-0013 Station 11451+28	Description	Super Silt Fence Leaning Bad at Station 11436+00		
<p>Date &amp; Time: Tue, Nov 13, 2018, 11:25:56 EST Position: +037°19'10.6" / -080°25'30.8" Altitude: 2172ft Datum: WGS-84 Azimuth/Bearing: 000° N00E 0000mils (True) Elevation Angle: +07.7° Horizon Angle: +00.2° Zoom: 1X P-1 Silt Fence Undermine at Station 11456+30</p>

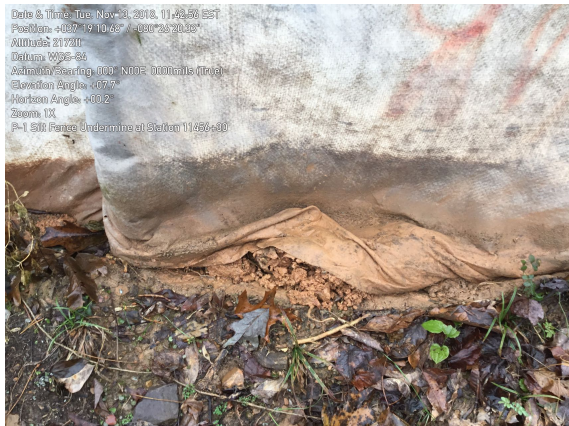
GPS Location	37.3194797756498, -80.438937395886	GPS Location	37.3268014937987, -80.4257274326686		
Description	P-1 Silt Fence Undermine at Station 11456+30 Going Away Side of Steel Acres	Description	Broken Stake on P-1 at Station 11508+29 Due To Cows		
<p>Date &amp; Time: Tue, Nov 13, 2018, 12:04:52 EST Position: +037°19'39.41" / -080°25'29.02" Altitude: 2230ft Datum: WGS-84 Azimuth/Bearing: 021° N21E 0373mils (True) Elevation Angle: +02.5° Zoom: 1X Hole in P-1 Silt Fence</p>

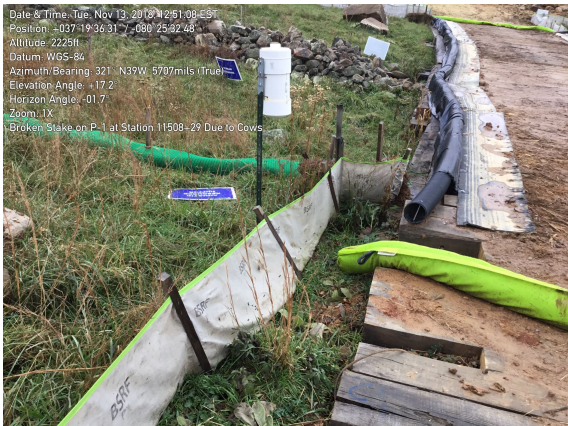
<p>Date &amp; Time: Tue, Nov 13, 2018, 12:51:09 EST Position: +037°19'36.31" / -080°25'02.46" Altitude: 2229ft Datum: WGS-84 Azimuth/Bearing: 321° N39W 5707mils (True) Elevation Angle: +17.2° Horizon Angle: -01.7° Zoom: 1X Broken Stake on P-1 at Station 11508+29 Due to Cows</p>

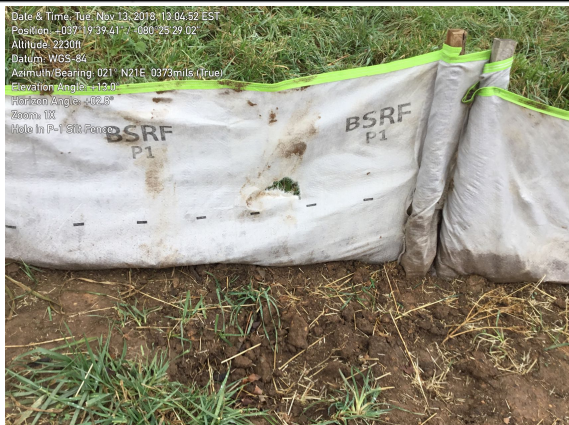
GPS Location	37.3274567071696, -80.4247436486934	GPS Location	37.3294999637057, -80.4201498628412		
Description	P-1 with Hole Station 11513+25	Description	Looking up toward Sinking Creek from Station 11527+00

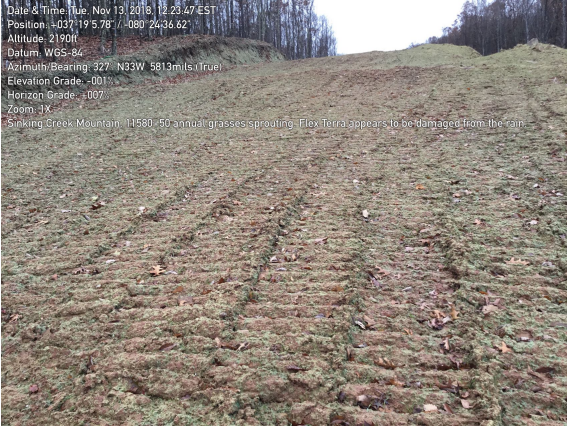
<b>A/E</b>	124300137	<b>Date/Time</b>	11/13/2018 2:00 PM	<b>Report #</b>	10863
<b>Pictures</b>					
<p>Date &amp; Time: Tue, Nov 13, 2018, 12:23:47 EST  Position: +037°19'5.78" / -080°24'36.62"  Altitude: 2190ft  Datum: WGS-84  Azimuth/Bearing: 322° N33W 5813mils (True)  Elevation Grade: -001°  Horizon Grade: -007°  Zoom: 1X  Sinking Creek Mountain: 11580-50 annual grasses sprouting. Flex Terra appears to be damaged from the rain.</p>

<b>Description</b>	Correct coordinates on photo. Fiber matrix was impacted by the rain event it appears in some areas.	<b>Description</b>	Correct coordinates on photo. The fiber matrix and young annual grasses are currently holding all soils.		
<p>Date &amp; Time: Tue, Nov 13, 2018, 12:35:44 EST  Position: +037°19'10.41" / -080°24'40.57"  Altitude: 2340ft  Datum: WGS-84  Azimuth/Bearing: 055° N55E 0278mils (True)  Elevation Grade: -027°  Horizon Grade: -003°  Zoom: 1X  Sinking Creek Mountain: 11576-00 End treatments functional.</p>

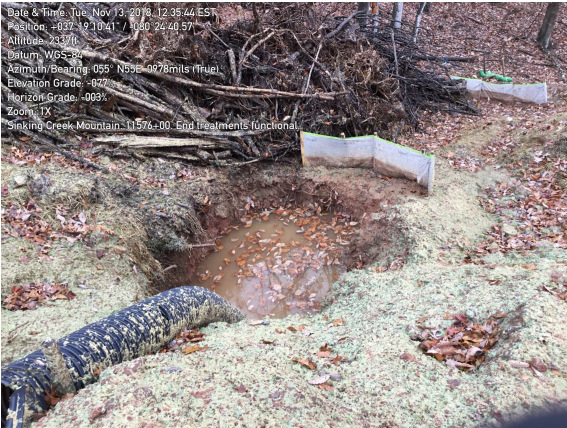
<b>Description</b>	Correct coordinates on photo. Sumps are holding runoff. End treatments are functional.	<b>Description</b>	Correct coordinates on photo. Grasses have sprouted and ROW stable currently.		
<p>Date &amp; Time: Tue, Nov 13, 2018, 12:49:27 EST  Position: +037°19'12.84" / -080°24'46.49"  Altitude: 2430ft  Datum: WGS-84  Azimuth/Bearing: 338° N42W 0272mils (True)  Elevation Grade: -011°  Horizon Grade: -005°  Zoom: 1X  Sinking Creek Mountain: 11570-02 Rock lined channels control groundwater.</p>

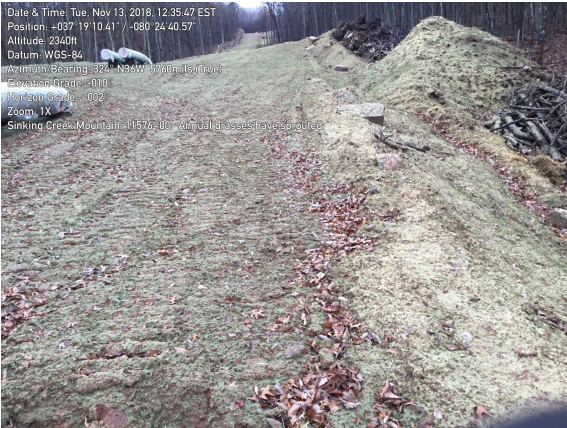
<p>Date &amp; Time: Tue, Nov 13, 2018, 12:35:47 EST  Position: +037°19'10.41" / -080°24'40.57"  Altitude: 2340ft  Datum: WGS-84  Azimuth/Bearing: 372° N36W 000mils (True)  Elevation Grade: -010°  Horizon Grade: -002°  Zoom: 1X  Sinking Creek Mountain: 11576-00 Annual grasses are sprouting.</p>

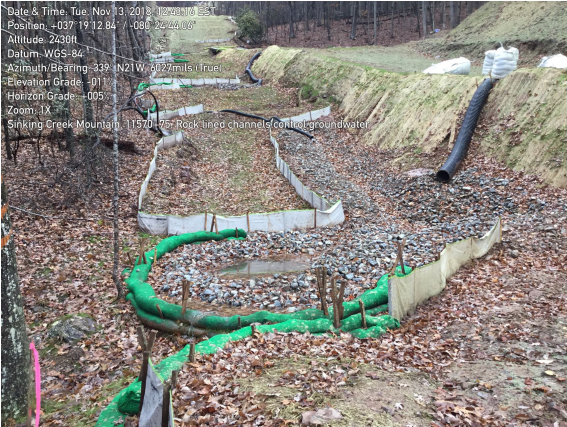
<b>Description</b>	Correct coordinates on photo. 2-tone area, rock lined channels and end treatments functional.	<b>Description</b>	Correct coordinates on photo. Runoff at the S-PP22 crossing clear and properly controlled.
