# Visual Site Inspection Report

<b>Project Name</b>	H-600 Pipeline Spread G		<b>AFE</b>	124300137	<b>Spread</b>	H-600 Pipeline Spread G	
<b>Contractor</b>	Precision				<b>Report #</b>	9462	
<b>Inspector</b>	Clinton Banks				<b>Date/Time</b>	10/16/2018 4:58 AM	
<b>Permit #</b>	TBD	<b>Inspection Type</b>	VA SWPP		<b>Station Begin</b>	+28	
<b>State</b>	VA	<b>Inspection Area</b>	Full		<b>Station End</b>	+28	
<b>County</b>	Giles	<b>Ground</b>	Wet		<b>Temperature (°F)</b>	55.00	
<b>Municipality</b>	N/A	<b>Weather</b>	Cloudy		<b>Rain Gauge (in)</b>	0.00	
<b>GPS Location</b>	37.3359918734406, -80.8084184770294			<b>Rain Accumulation Time (days)</b>	1.00

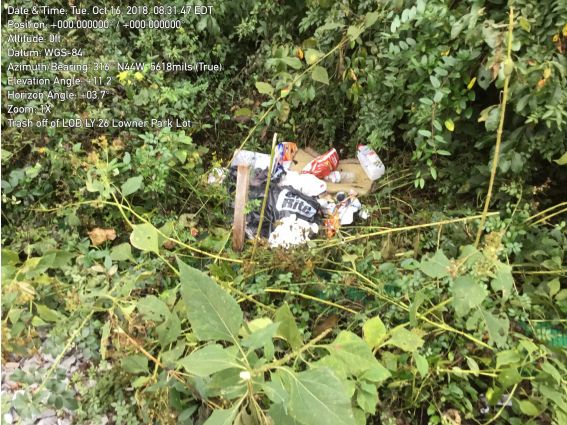
<p>Date &amp; Time: Tue, Oct 16, 2018 08:31:47 EDT Position: +000.000000° / +000.000000° Altitude: 0ft Datum: WGS-84 Azimuth/Bearing: 315° N/AW 5418mils (True) Elevation Angle: +11.7° Horizon Angle: +03.7° Zoom: 1X Trash off of LOD LY 26 Lower Park Lot</p>

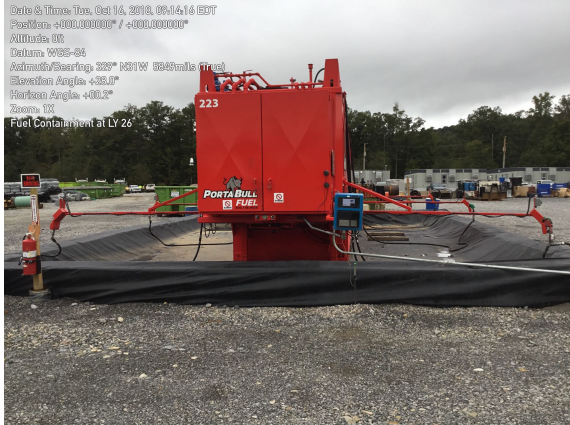
<p>Date &amp; Time: Tue, Oct 16, 2018 08:14:16 EDT Position: +000.000000° / +000.000000° Altitude: 0ft Datum: WGS-84 Azimuth/Bearing: 329° N/AW 0042mils (True) Elevation Angle: +03.9° Horizon Angle: +00.3° Zoom: 1X Fuel Containment at LY 26</p>			
<b>GPS Location</b>	37.3176746489828, -80.6593133882439	<b>GPS Location</b>	37.3192018945227, -80.657797931813		
<b>Description</b>	Trash off of LOD LY 26 Lower Parking Lot on West Side	<b>Description</b>	Fuel Containment at LY 26

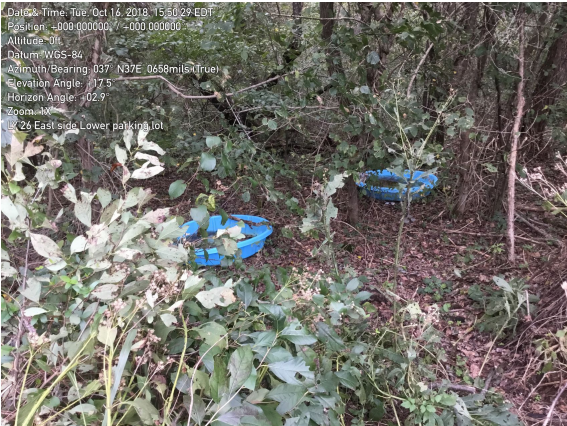
<p>Date &amp; Time: Tue, Oct 16, 2018 15:50:29 EDT Position: +000.000000° / +000.000000° Altitude: 0ft Datum: WGS-84 Azimuth/Bearing: 037° N37E 0458mils (True) Elevation Angle: +17.5° Horizon Angle: +02.9° Zoom: 1X LY 26 East side Lower parking lot</p>		<p>Insert image here</p>

<b>GPS Location</b>	37.3207677973588, -80.6415251446305	<b>GPS Location</b>			
<b>Description</b>	LY 26 East Side Lower Parking Lot	<b>Description</b>			
<p>Insert image here</p>		<p>Insert image here</p>			
<b>GPS Location</b>		<b>GPS Location</b>			
<b>Description</b>		<b>Description</b>

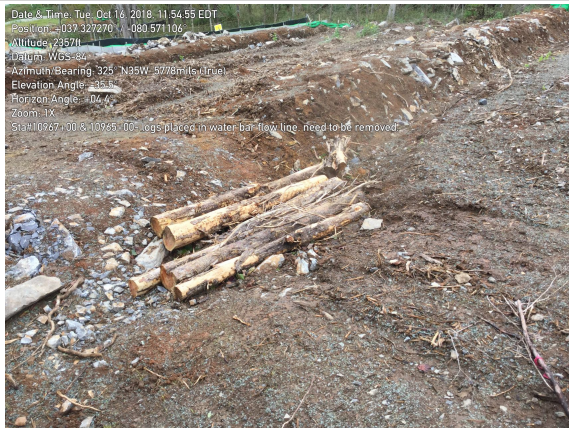
Description	Sta#10967+00 & 10965+00- logs placed in water bar flow line, need to be removed.	Description	Sta#11191+00- SSF undermined, repaired this afternoon

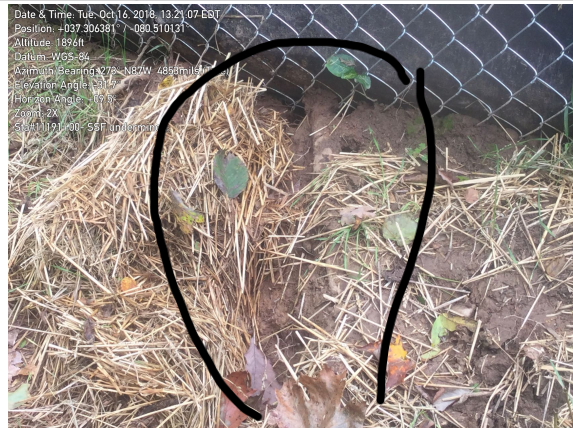
<p>Date &amp; Time: Tue, Oct 16, 2018 13:21:07 EDT Position: +037.3063019151216 / -80.51008265473 Altitude: 1896ft Datum: WGS-84 Azimuth/Bearing: 152.72E 4890mils (True) Elevation Angle: +0.1 Horizon Angle: +0.1 Zoom: 2X Sta#11191+00- SSF undermined, repaired this afternoon</p>

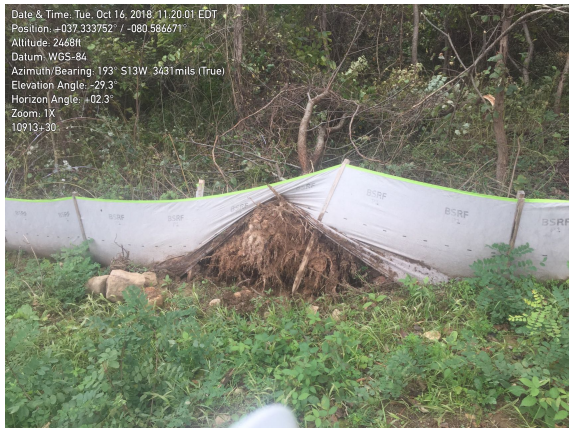
<b>GPS Location</b>	37.3422011873101, -80.6767992117262	<b>GPS Location</b>	37.342422972468, -80.6776011084026		
<b>Description</b>	10913+30 silt fence damaged by up rooted tree	<b>Description</b>	Repaired silt fence 10913+30		
<p>Date &amp; Time: Tue, Oct 16, 2018, 11:23:20 EDT Position: +037 333485 / -080 585797 Altitude: 2394ft Datum: WGS-84 Azimuth/Bearing: 169° S 11° E 3004mils (True) Elevation Angle: -22.8° Horizon Angle: -01.7° Zoom: 2X 10914+55</p>

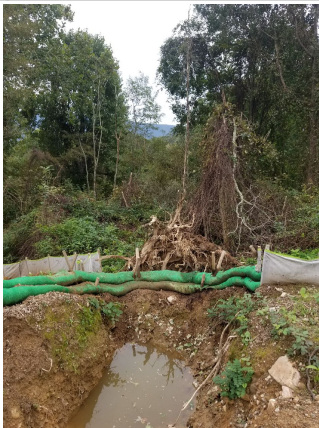
<b>GPS Location</b>	37.342422972468, -80.6776011084026	<b>GPS Location</b>	37.342422972468, -80.6776011084026		
<b>Description</b>	Uprooted outlet treatment 10914+55	<b>Description</b>	Repaired outlet treatment by crew

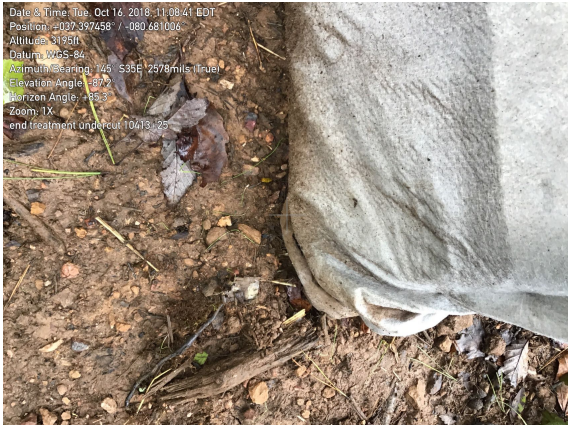
GPS Location	37.1360411960977, -80.3940854967389	GPS Location	37.1360514639291, -80.3940709960464		
Description	0.1 inches observed Pocahontas road.	Description	End treatment undercut 10413+25

E&S BMPs	Compliance Level	Corrective Action	Corrective Time Frame	Date Repaired
Silt Fence (Filter Fabric Fence)	Acceptable			
Compost Filter Sock	Acceptable			
Waterbar	Acceptable			
Waterbar Outlet Protection	Problem Area	Reinstall end treatments	24 Hours

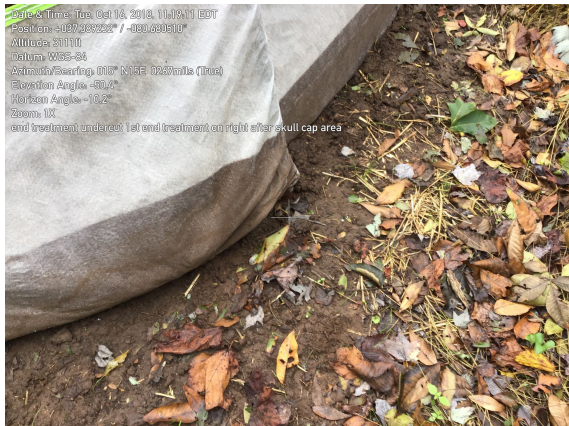
GPS Location	37.1361796651381, -80.3941053618494	GPS Location	37.1360557806093, -80.3941897676144		
Description	End treatment undercut along Mystery ridge road	Description	End treatment undercut 173+50

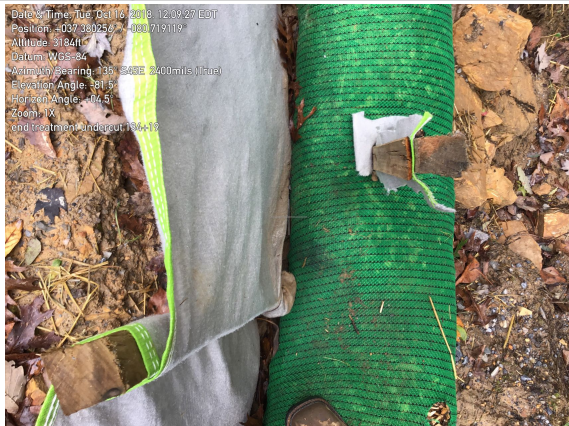
GPS Location	37.1360790823001, -80.3941733390841	GPS Location	37.1361262724149, -80.3940786235783		
Description	Undercut end treatment st134+19	Description	Sock full and in need of clean out st#106+00
