Visual Site Inspection Report

| Project Name | H-600 Pipeline Spread G | | AFE | 124300137 | Spread | H-600 Pipeline Spread G | |
| Contractor | Precision | | | | Report # | 9166 | |
| Inspector | Clinton Banks | | | | Date/Time | 10/10/2018 4:29 AM | |

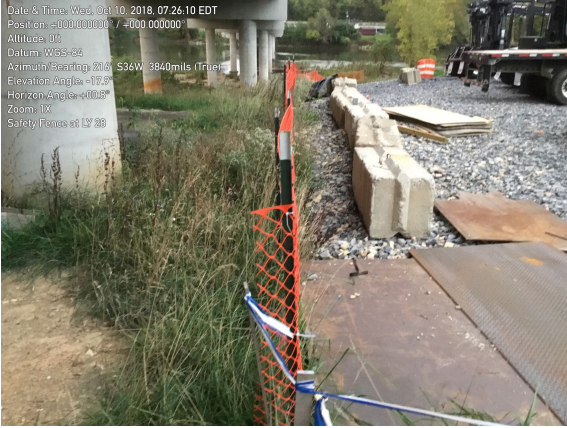
| Description | Safety Fence at LY 28 | | Description | Entrance into LY 28 | |

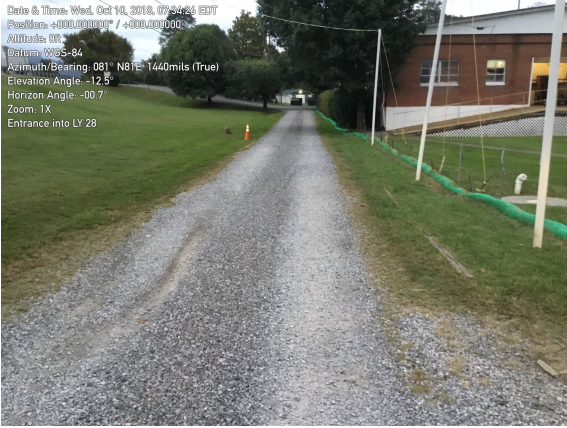
| <p><small>Date & Time: Wed, Oct 10, 2018, 07:26:10 EDT Position: +000.000000° / +000.000000° Altitude: 00' Datum: WGS-84 Azimuth Bearing: 081° 53'44" N81E 1440mils (True) Elevation Angle: -12.5° Horizon Angle: -00.8° Zoom: 1X Safety Fence at LY 28</small></p> | | | <p><small>Date & Time: Wed, Oct 10, 2018, 07:24:26 EDT Position: +000.000000° / +000.000000° Altitude: 00' Datum: WGS-84 Azimuth Bearing: 081° 53'44" N81E 1440mils (True) Elevation Angle: -12.5° Horizon Angle: -00.7° Zoom: 1X Entrance into LY 28</small></p> | | |

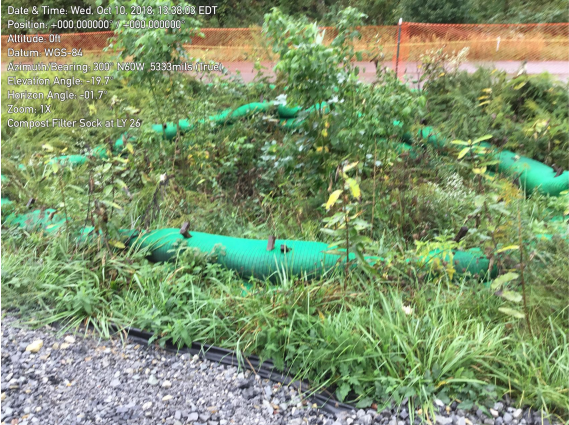
| Description | Compost Filter Sock at LY 26 | Description | Fuel Containment at LY 26 | | |

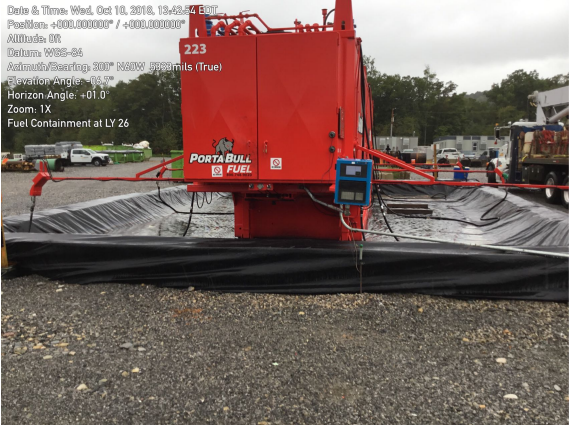
| <p>Date & Time: Wed, Oct 10, 2018, 13:58:04 EDT Position: +000.000000° / +000.000000° Altitude: 0ft Datum: WGS-84 Datum/earing: 300° NAD83 5333mils (True) Elevation Angle: -19.7° Horizon Angle: +01.7° Zoom: 1X Compost Filter Sock at LY 26</p> | | <p>Date & Time: Wed, Oct 10, 2018, 13:43:54 EDT Position: +000.000000° / +000.000000° Altitude: 0ft Datum: WGS-84 Datum/earing: 300° NAD83 5333mils (True) Elevation Angle: -19.7° Horizon Angle: +01.0° Zoom: 1X Fuel Containment at LY 26</p> | | | |

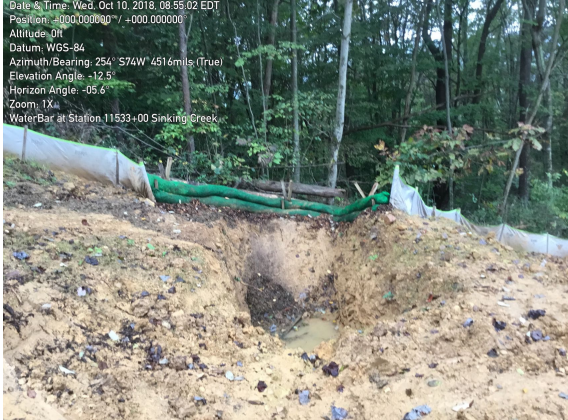
| Description | Rain Gauge at Steel Acres Station 11471+00 | Description | WaterBar at Station 11533+00 Sinking Creek | | |

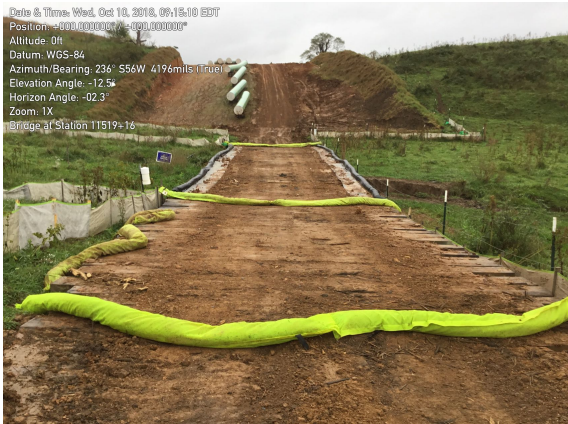
| Description | WaterBar at Station 11534+00 Sinking Creek | Description | Bridge at Station 11519+16 | | |

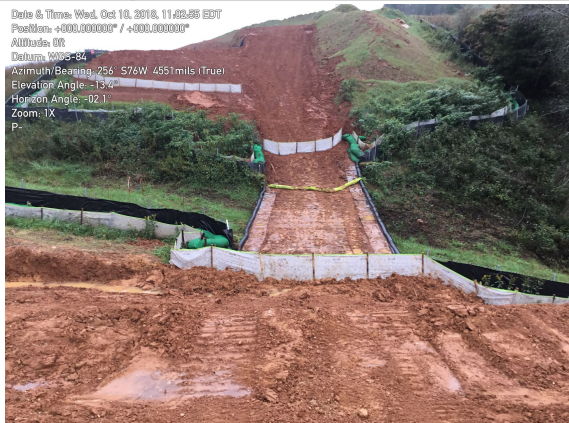
| Description | Crew installed P-1 Silt Fence to help keep Sediment off of Bridge Station 11479+22 | Description | Slop Drain Pipe at Station 11477+14 | | |

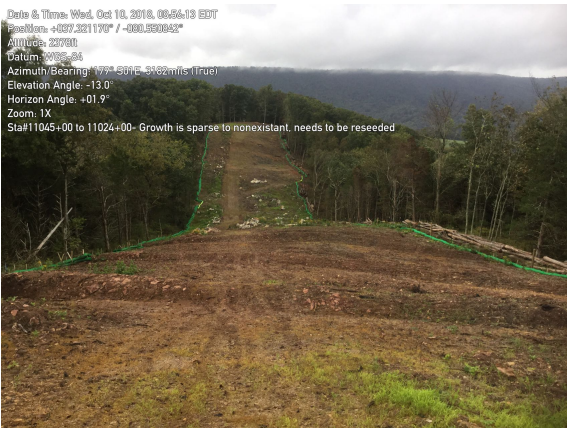
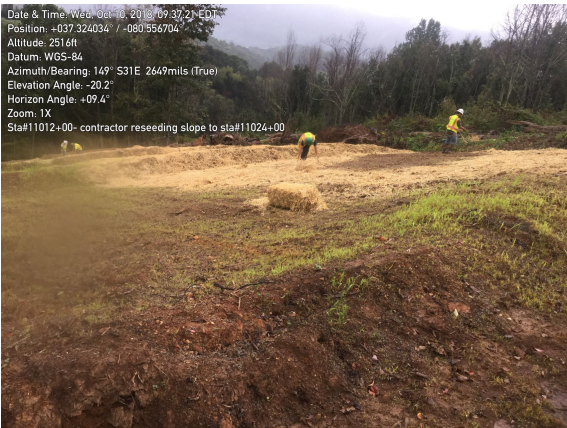
| <p>Date & Time: Wed, Oct 10, 2018, 08:06:19 EDT Position: +037.321179° / -080.550945° Altitude: 2270ft Datum: WGS-84 Azimuth/Bearing: 149° S31E 2649mils (True) Elevation Angle: -13.0° Horizon Angle: +01.9° Zoom: 1X Sta#11045+00 to 11024+00- Growth is sparse to nonexistent, needs to be reseeded</p> | | <p>Date & Time: Wed, Oct 10, 2018, 09:32:21 EDT Position: +037.324034° / -080.556704° Altitude: 2516ft Datum: WGS-84 Azimuth/Bearing: 149° S31E 2649mils (True) Elevation Angle: -20.2° Horizon Angle: +09.4° Zoom: 1X Sta#11012+00- contractor reseeding slope to sta#11024+00</p> | | GPS Location 37.3212677194153, -80.5506919697677 Description Sta#11045+00 to 11024+00- row growth sparse to nonexistent, needs to be reseeded | |

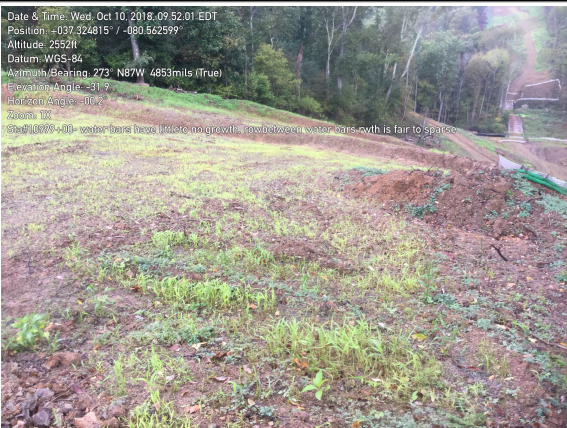
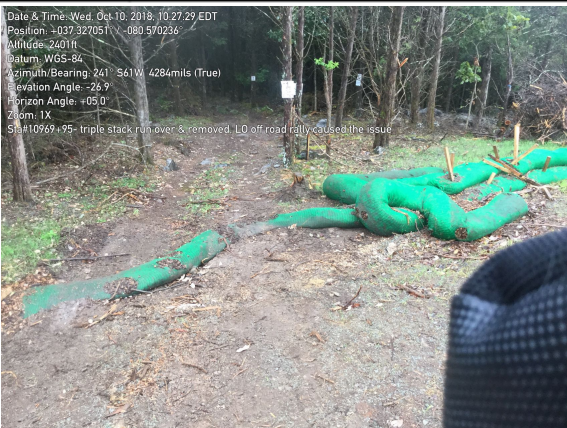
| <p>Date & Time: Wed, Oct 10, 2018, 09:52:01 EDT Position: +037.324815° / -080.562599° Altitude: 2552ft Datum: WGS-84 Azimuth/Bearing: 273° N87W 4853mils (True) Elevation Angle: -31.9° Horizon Angle: +01.0° Zoom: 1X Sta#10999+00- water bars have no growth, row between water bars is fair to sparse</p> | | <p>Date & Time: Wed, Oct 10, 2018, 10:27:29 EDT Position: +037.327051° / -080.570236° Altitude: 2401ft Datum: WGS-84 Azimuth/Bearing: 241° S61W 4284mils (True) Elevation Angle: -26.9° Horizon Angle: +05.0° Zoom: 1X Sta#10969+95- triple stack CFS run over & removed, LO off road rally caused the damage</p> | | GPS Location 37.32480693612, -80.5626909156149 Description Sta#1099 +00- water bars have no growth, row between water bars is fair to sparse. | |

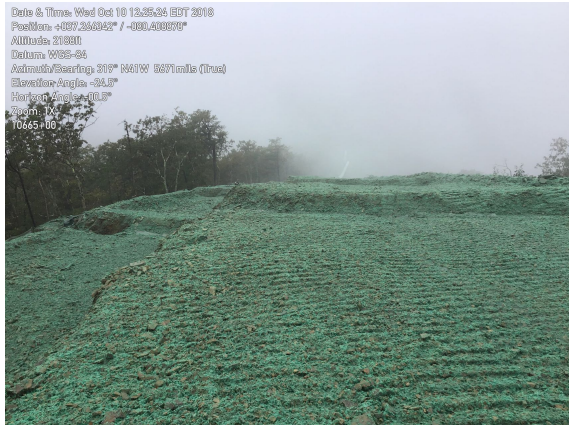
| Description | Correct coordinates on photo. Top of Brush Mountain after application of hydro mulch. | Description | Correct coordinates on photo. S-HH18 area on Brush Mountain has been stabilized. | | |

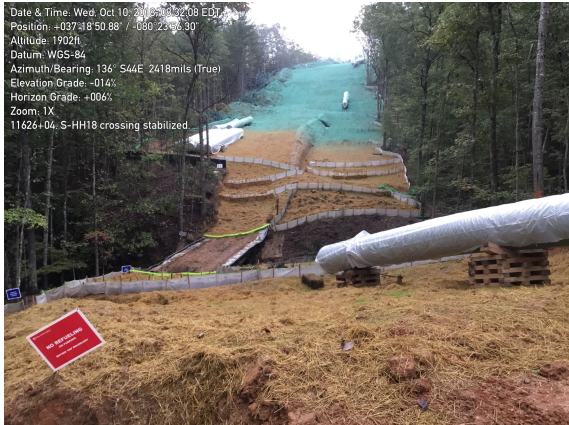
| <p>Date & Time: Wed Oct 10 13:55:54 EDT 2018 Position: +037 266042° / -080 430829° Altitude: 2180ft Datum: WGS-84 Azimuth/Bearing: 301° S61°W 667mils (True) Elevation Grade: +01.1° Horizon Grade: +00.5° Zoom: 1X 11665+00</p> | | <p>Date & Time: Wed Oct 10 2018 02:08 EDT Position: +037 18 50 88° / -080 23 16 30° Altitude: 1902ft Datum: WGS-84 Azimuth/Bearing: 136° S44E 2418mils (True) Elevation Grade: +01.6° Horizon Grade: +00.6° Zoom: 1X 11626+04 S-HH18 crossing stabilized.</p> | | | |

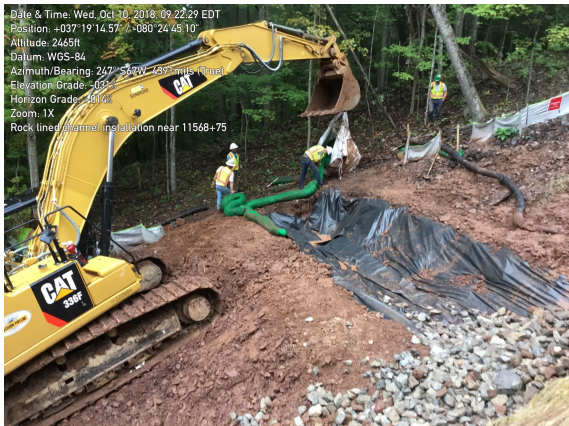
| Description | Correct coordinates on photo. Chopper worked before rain spreading hydro mulch on Brush Mountain. | Description | Correct coordinates on photo. Rock lined channel and sump to replace existing controls in effort to better control groundwater. | | |

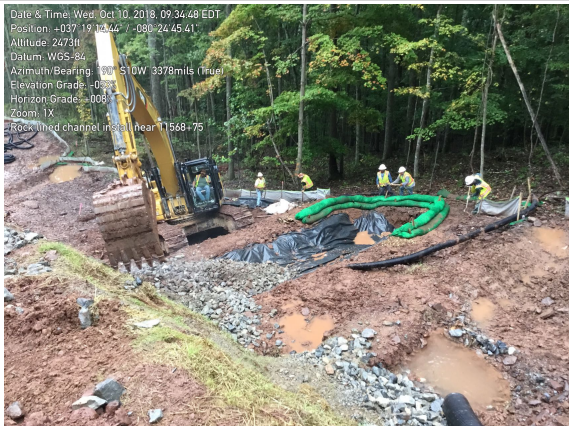
| Description | Correct coordinates on photo. Laborers stabilizing ROW upslope of the S-PP22 crossing on Sinking Creek Mountain. | Description | Correct coordinates on photo. ECD enhancements for groundwater control on Sinking Creek Mountain. | | |

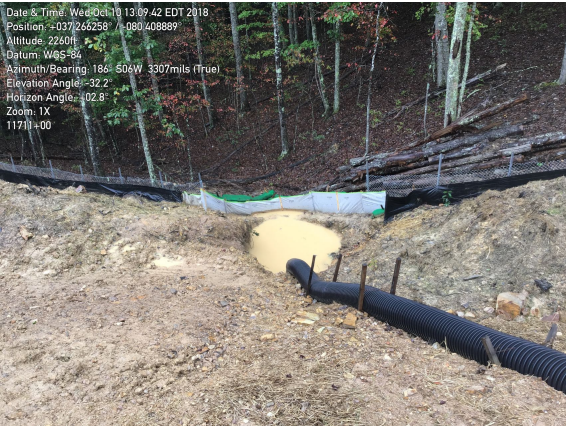
| Description | Slope drain in place with priority one silt fence and triple stack 18" CFS in place. | Description | Water bar throat maintenance needed. Water is over topping water bar. | | |

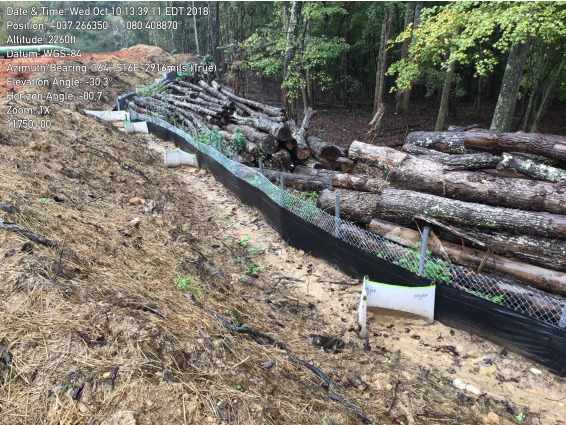
| Description | Reinforced silt fence in place. | Description | RCE in place at main line valve 26 and mount tabor road. | | |

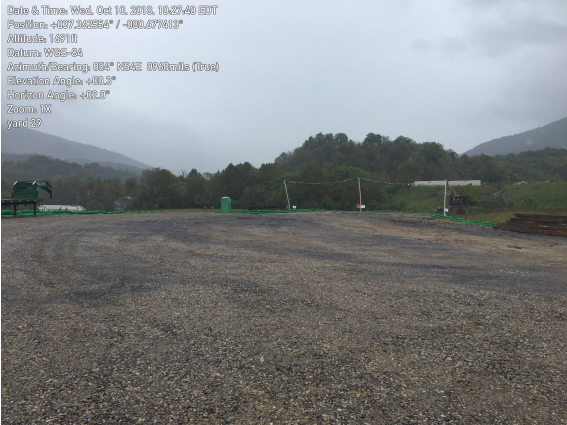
| Description | Yard 29 no issues with filter sock and rock in yard use photo gps | Description | | | |

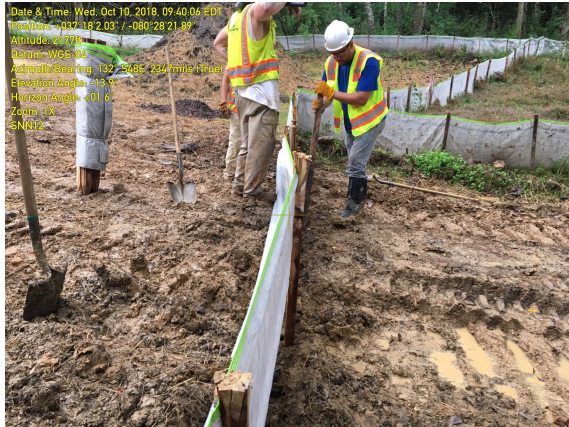
| Description | Crews install P1 across travel lane before stream crossings @ 11329+00 | Description | P1 installed across travel lane @ S-NN12 | | |

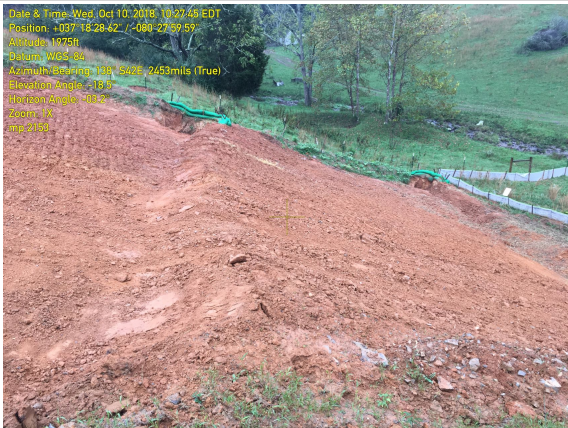
| Description | P1 installed across travel lane @ S-KL43 | Description | ROW conditions with out stabilization @ MP 215.5 | | |

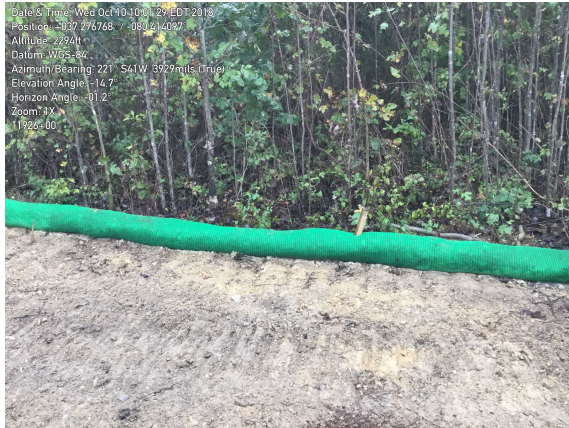
| Description | Sock replacing clean water diversion 11926+00 | | Description | Row 11924+00 | |

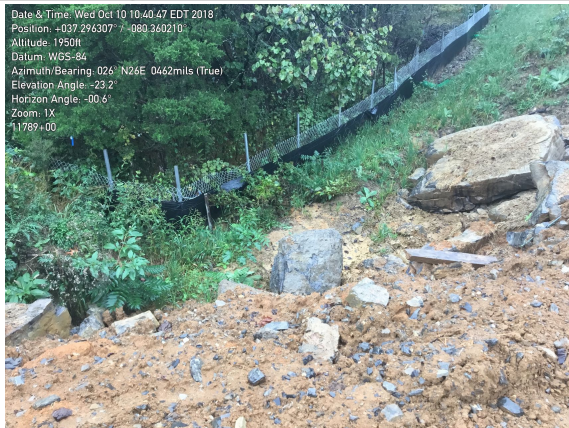
| Description | Super silt fence protecting karst feature 11789+00 | | Description | Permanent end treatment installation 11924+00 | |
