Visual Site Inspection Report

Project Name	H-600 Pipeline Spread G	AFE	124300137	Spread	H-600 Pipeline Spread G
Contractor	Precision			Report #	10196
Inspector	Rob Robertson			Date/Time	10/30/2018 6:00 PM
Permit #	TBD	Inspection Type	VA SWPP	Station Begin	10458+91
State	VA	Inspection Area	Full	Station End	10459+03
County	Montgomery	Ground	Dry	Temperature (°F)	63.00
Municipality	N/A	Weather	Sunny	Rain Gauge (in)	0.00
GPS Location	37.1331819612879, -80.394651191384			Rain Accumulation Time (days)	1.00

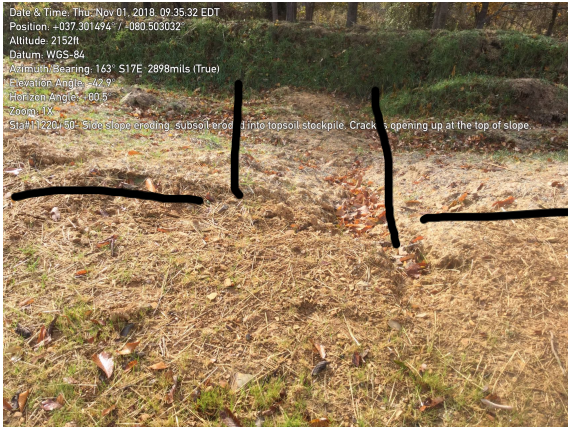
GPS Location	37.3014531517749, -80.5013756175344	GPS Location	37.3014943907385, -80.5030317977821		
Description	Sta#11227+00- contractor rutted row while performing environmental up grades.	Description	Sta#11220+50- side slope erosion, sediment against topsoil stockpile. Crack opened up at the top of the slope, could turn into slip.

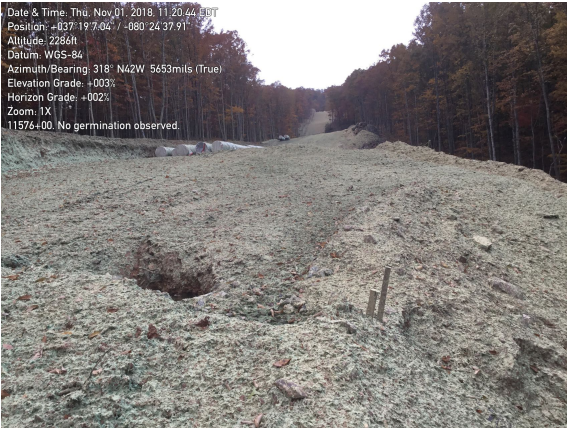
<p>Date & Time: Thu, Nov 01, 2018, 11:23:03 EDT Position: +037°19'7.95" / -080°24'37.94" Altitude: 2227ft Datum: WGS-84 Azimuth/Bearing: 135° S45E 2400mils (True) Elevation Grade: -066% Horizon Grade: +010% Zoom: 1X 11576+00. No germination observed.</p>

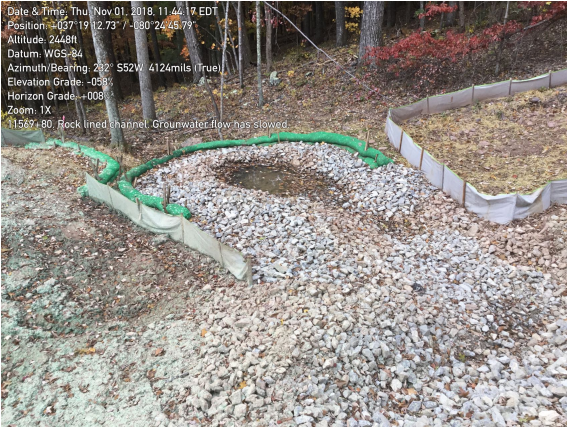
<p>Date & Time: Thu, Nov 01, 2018, 11:53:22 EDT Position: +037°19'15.46" / -080°24'46.09" Altitude: 2504ft Datum: WGS-84 Azimuth/Bearing: 202° S52W 3469mils (True) Elevation Grade: -08% Horizon Grade: +008% Zoom: 1X 11567+00. S-PP22. Groundwater flow has slowed.</p>
