Visual Site Inspection Report

Project Name	H-600 Pipeline Spread H	AFE	124300138	Spread	H-600 Pipeline Spread H
Contractor	Precision			Report #	9190
Inspector	Glenn Mike Renfro			Date/Time	10/10/2018 1:32 PM
Permit #	TBD	Inspection Type	VA SWPP	Station Begin	13415+00
State	VA	Inspection Area	Full	Station End	13670+00
County	Franklin	Ground	Damp	Temperature (°F)	72.00
Municipality	N/A	Weather	Light Rain	Rain Gauge (in)	0.15
GPS Location	36.9719008717635, -79.8701711648243		Rain Accumulation Time (days)	1.00

AFE	124300138	Date/Time	10/10/2018 1:32 PM	Report #	9190
-----	-----------	-----------	--------------------	----------	------

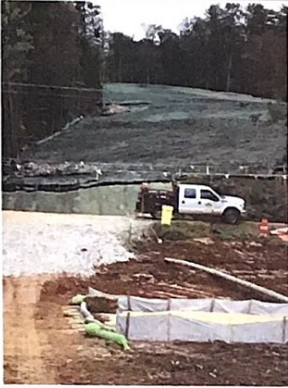
GPS Location	36.9719769241864, -79.8701417343704	GPS Location	36.9719654768925, -79.8701344999266		
Description	Hydromulching completed to Cahas Mt Rd at 13496+62.	Description	Stabilization of stream bank of stream S-IJ10 at 13498+00

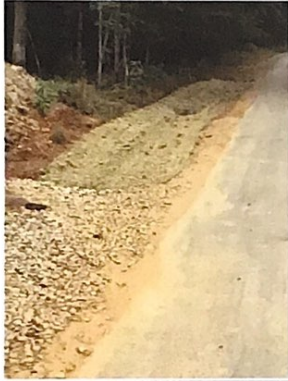
Performed SWPPP inspection of Spread H section. All perimeter ECD's were inspected and one potential issue was found near 13668+00 with the P1 silt fence being overwhelmed with soil requiring soil removal and silt fence repair. All ECE's were found to be in acceptable condition at this time. There was also possible issues observed with multiple waterbars and end treatments requiring maintenance as well. There are also potential issues with the permanent waterbar end treatments and perimeter ECD's (18" CFS) on the GAS of 13437+00 that will need to be addressed. Final clean up is complete to approximately 13570+00 and the reclamation crew is complete to the CIS of Cahas Mt#2(13496+87). All potential issues were added to the punch list and given to the contractor to address.

GPS Location	36.9719044413698, -79.8701718105881	GPS Location	36.9718850911871, -79.8701480732868		
Description	Roadside ditch stabilized with stabilization blanket at Cahas Mt#2.	Description	P1 silt fence overtaken with soil along travel lane at 13668+00 maintenance needed.

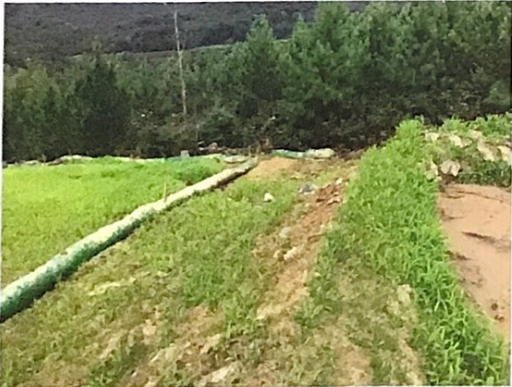
Insert image here			
GPS Location	36.9718770237735, -79.8701476836157	GPS Location			
Description	CIS of 13437+00 waterbars and CFS need maintenance.	Description
