*Spread H section  
Report #8849  
SWIN 1369  
ESIN 0946*

## Visual Site Inspection Report

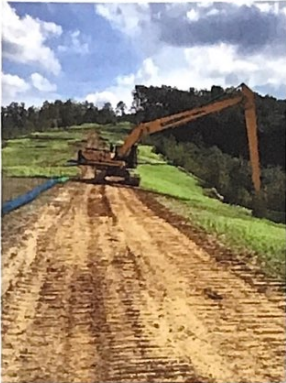
<b>GPS Location</b>	36.9718748336985, -79.8701502141847	<b>GPS Location</b>	36.9719188998186, -79.8701779683092
<b>Description</b>	stream crossing activities at 13498+00 in progress.	<b>Description</b>	CFS maintenance operations at 13444+93

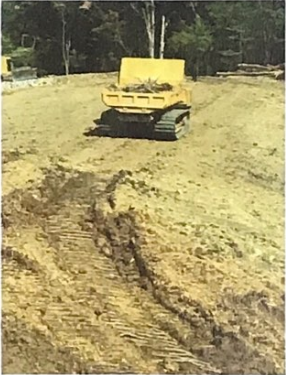
<b>GPS Location</b>	36.9719658606099, -79.8699338269232	<b>GPS Location</b>	36.971980654669, -79.8701120261847
<b>Description</b>	Reclamation crew resuming hydromulching activities at 13473+76	<b>Description</b>	Final clean up crew at 13490+00

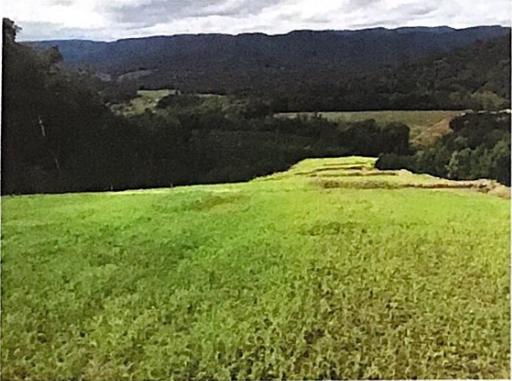
Insert image here	
<b>GPS Location</b>	36.9718926446857, -79.8700895626842	<b>GPS Location</b>	
<b>Description</b>	Grow in on CIS of 13437+00	<b>Description</b>
