Visual Site Inspection Report

Project Name	H-600 Pipeline Spread H	AFE	124300138	Spread	H-600 Pipeline Spread H
Contractor	Precision			Report #	1963
Inspector	Doug Davenport			Date/Time	5/18/2018 4:11 PM
Permit #	TBD	Inspection Type	VA SWPP	Station Begin	13336+40
State	VA	Inspection Area	Partial	Station End	13670+00
County	Franklin	Ground	Muddy	Temperature (°F)	76.00
Municipality	N/A	Weather	Heavy Rain	Rain Gauge (in)	6.25
GPS Location	37.0594010616307, -79.8825728563359			Rain Accumulation Time (days)	2.00

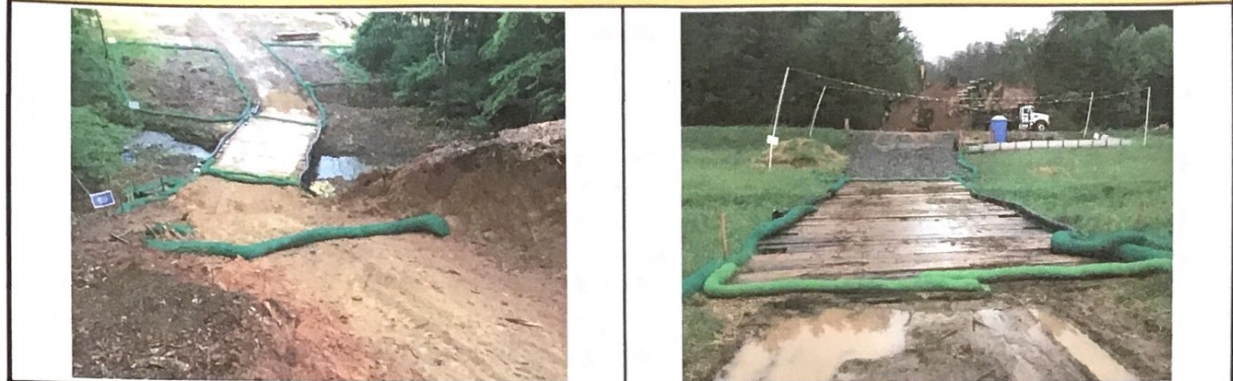
The GAS of House Rock Rd. has a very steep slope down to S-II9. The Wattles installed on the travel lane performed well, but were in need of maintenance due to the rain event. The contractor was notified of the issue and they responded immediately with an environmental crew which cleaned out the ECDS and re-staked them. A small amount of sediment had entered the creek and the contractor was able to remove the sediment with hand shovels.

GPS Location 37.0593974791638, -79.88257494338	GPS Location 37.0594010463797, -79.8825734689377
Description S-II9 GAS House Rock Rd. The travel lane ECDS were installed and functional	Description Bridge over W-IJ6 & S-IJ10 GAS of Cahas Rd. ECDS working as intended

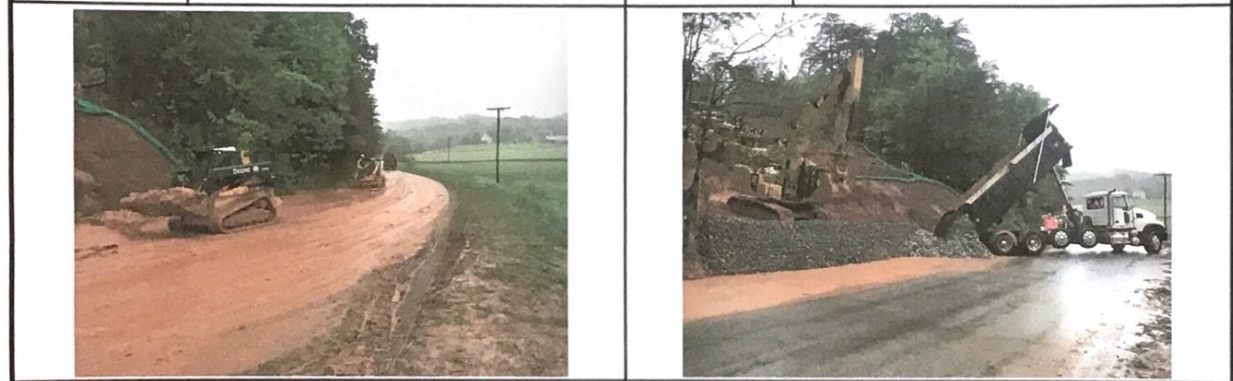
Cahas Mtn. Rd #2: Due to the excessive amount of rainfall, a water bar failed near the top of the slope which caused a cascading effect on the other water bars below on the lower portion of the slope. After multiple water bar failures, mud was deposited onto the road. The contractor closed the road after notifying VDOT and began the cleanup. The contractor worked from early morning until 9:30 pm. Cleaning the road. They installed a rock check dam at the bottom of the slope to prevent reoccurrence. VDOT was notified and the road was opened to the public again.

GPS Location 37.059409586713, -79.8825676923383	GPS Location 37.0594007925505, -79.8825760636685
Description Cahas Mtn Rd. #2 mud from ROW on road. The contractor working to clean it up.	Description Cahas Mtn. Rd #2 Contractor installing rock check dam to prevent reoccurrence. The road has been cleaned up.

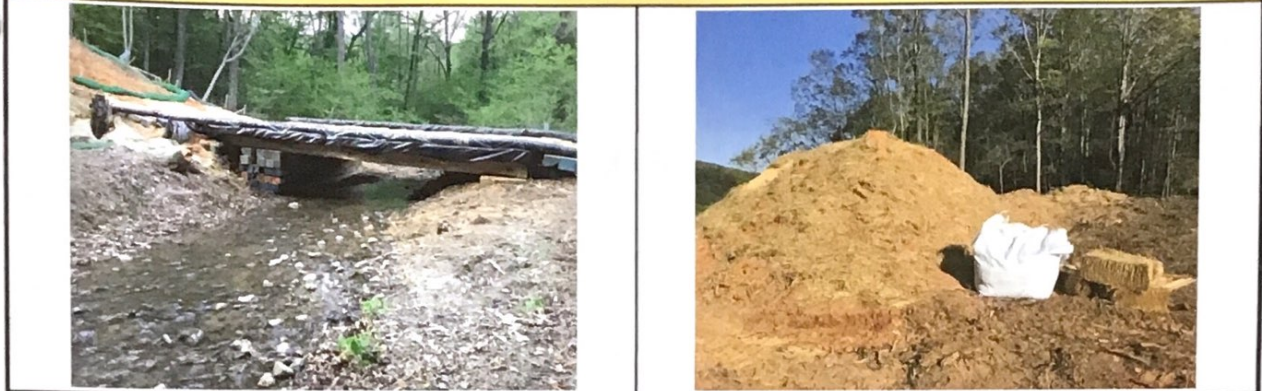
GPS Location 37.0593983781329, -79.8825871311349	GPS Location 37.0593984833957, -79.882588091587
Description Temporary bridge over S-II9 @ 13543+00	Description Soil stockpiles temporarily stabilized

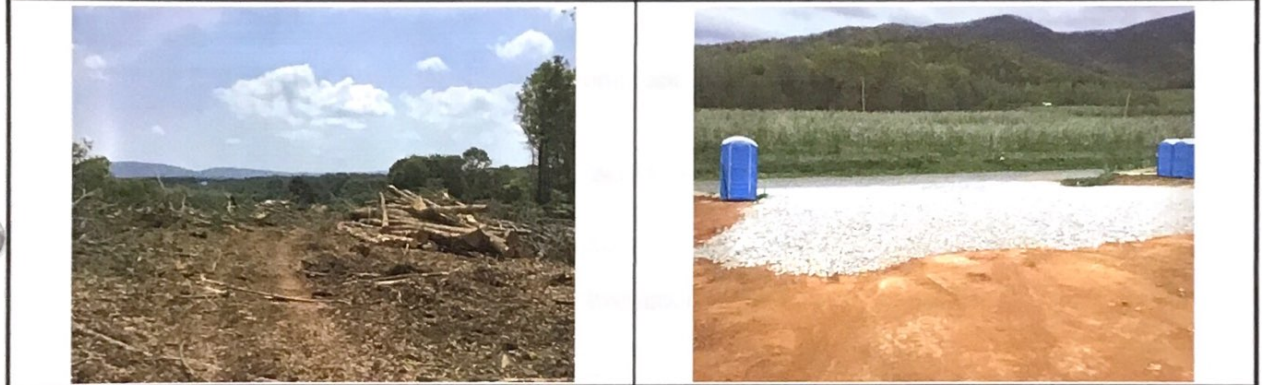
GPS Location 37.0593877450076, -79.8825957682302	GPS Location 37.0593985246522, -79.8825873015401
Description Clearing crews piled logs on the LOD	Description RCE Cahas Mtn. Rd. 1

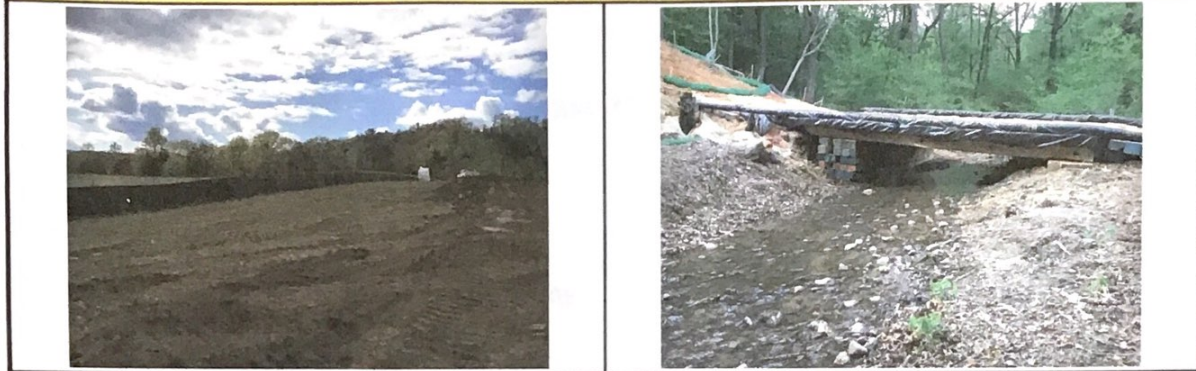
Description	SSF Installation	Description	Bridge crossing
--------------------	------------------	--------------------	-----------------

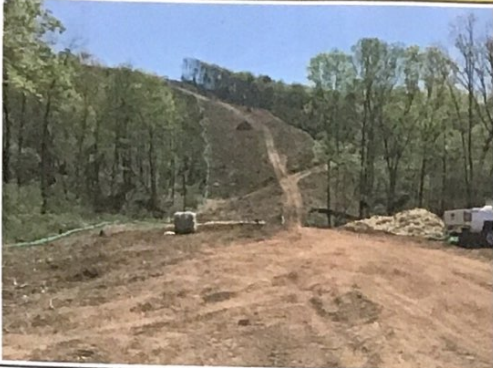
GPS Location	36.9788002875151, -79.5951087500862		GPS Location	36.9793010317134, -79.5946012158688	
Description	CFS being installed per E&S plan		Description	Stockpiles temporarily stabilized per E&S plan

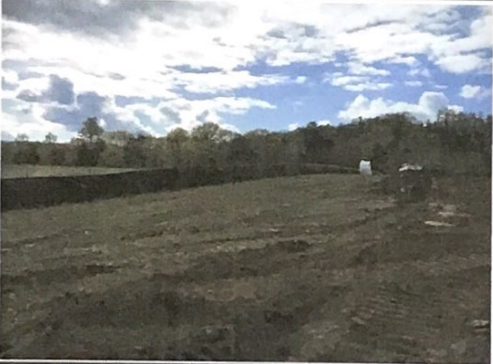
GPS Location	36.978933946264, -79.5944935922321		GPS Location	36.9791853614496, -79.594591073766	
Description	SSF installed per E&S plan		Description	Side rails need to be installed	
Insert image here			Insert image here		
GPS Location			GPS Location		
Description			Description

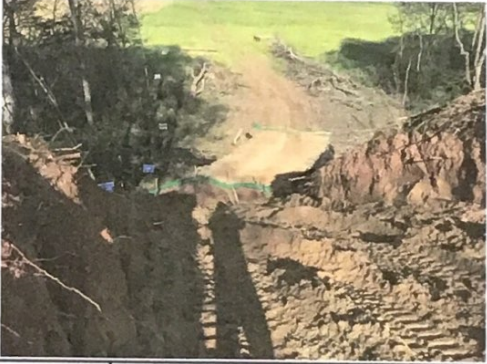
Temporary timber mat bridges are being built, some need to have the side rails installed.
