Report # 3655

Visual Site Inspection Report

| Project Name | H-600 Pipeline Spread H | AFE | 124300138 | Spread | H-600 Pipeline Spread H |

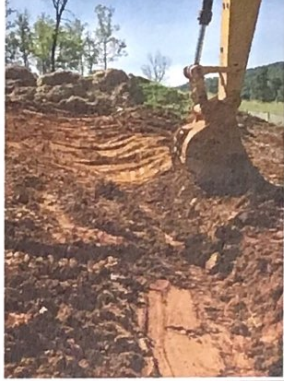
| Description | Crew cleaning Frith driveway after rain event Wednesday. Heavy rains occurred. | | Description | Crew repairing breaker on Frith Tract | |

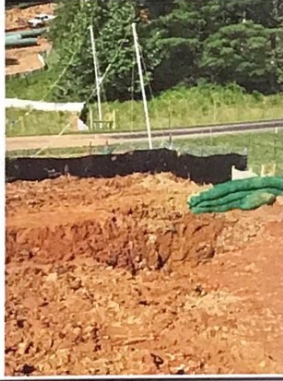
| Description | Frith Tract end treatment in compliance. New SSF in background. | | Description | | |

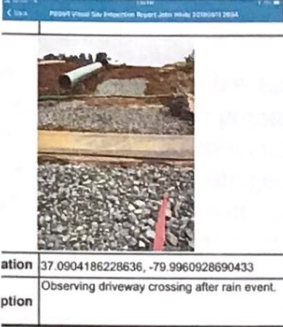
| ption | Observing driveway crossing after rain event. | | | | | | | | |

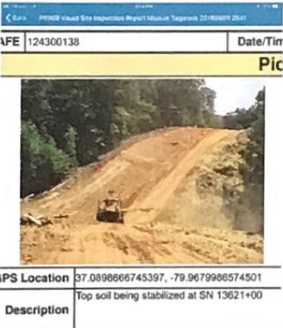
<table border="1"> <tr> <td>GPS Location</td> <td>37.0898666745397, -79.9679980574501</td> </tr> <tr> <td>Description</td> <td>Top soil being stabilized at SN 13621+00</td> </tr> </table> | GPS Location | 37.0898666745397, -79.9679980574501 | Description | Top soil being stabilized at SN 13621+00 | Insert image here | |
| GPS Location | 37.0898666745397, -79.9679980574501 | | | | | |
| Description | Top soil being stabilized at SN 13621+00 | | | | | |

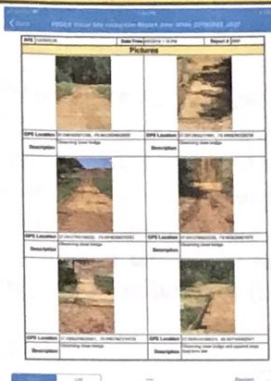
| Description | Leaned mat crossing pics | Description | ROW pics |

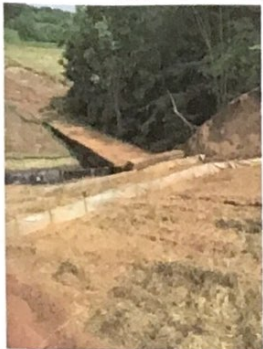
| Description | GA House Rock Road after rain event | | Description | Grading crew working on grading operations | |

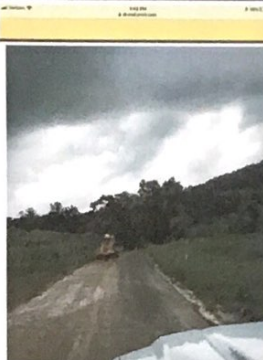
| Description | Sweeper at Cahas Road #1 working on road | | Description | | |

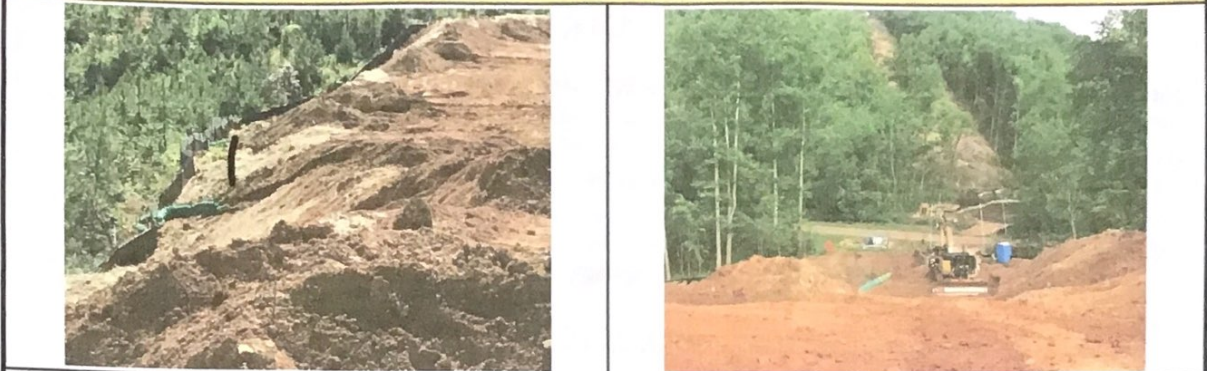
| Description | J-hooks & sumps at the low end of the waterbars. | Description | Road bore under Cahas Mtn. Rd. Crossing 1 |

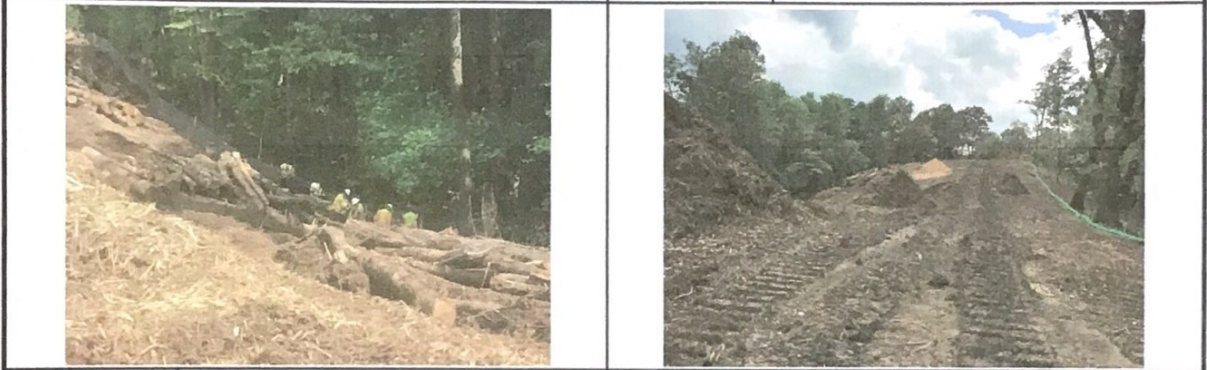
| Description | Environmental crew installing SSF as specified | Description | ECDS installed per plan immediately after grubbing crews finished working in an area. |
