Visual Site Inspection Report

Project Name	H-600 Pipeline Spread H		AFE	124300138	Spread	H-600 Pipeline Spread H	
Contractor	Precision				Report #	10289	
Inspector	Glenn Mike Renfro				Date/Time	11/1/2018 12:20 PM	
Permit #	TBD	Inspection Type	VA SWPP		Station Begin	13415+00	
State	VA	Inspection Area	Full		Station End	13670+00	
County	Franklin	Ground	Damp		Temperature (°F)	71.00	
Municipality	N/A	Weather	Cloudy		Rain Gauge (in)	0.00	
GPS Location	36.9720394956292, -79.8699883092939				Rain Accumulation Time (days)	1.00

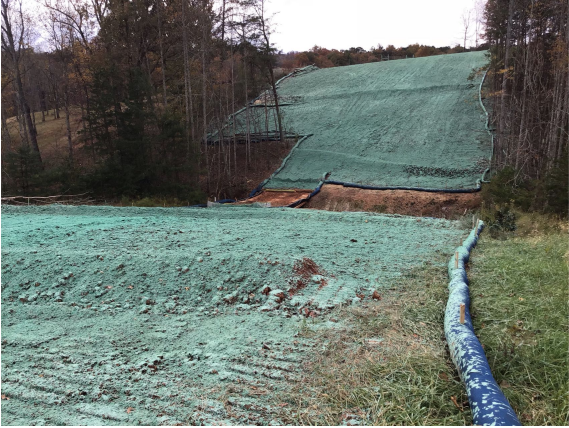
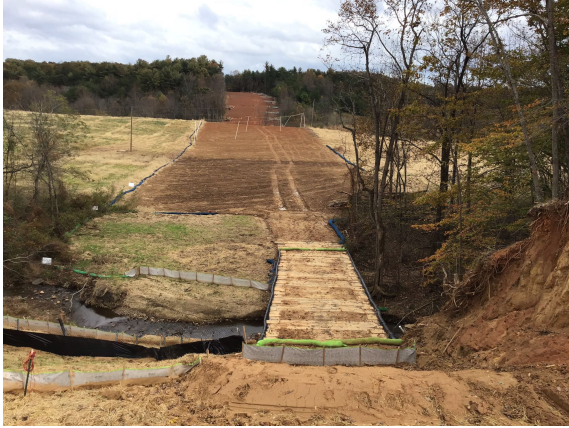
GPS Location	36.9720772980125, -79.8699088488518	GPS Location	36.9720772980125, -79.8699088488518		
Description	Final clean up completed and Hydromulched on the CIS House Rock	Description	Final clean up completed on the GAS House Rock

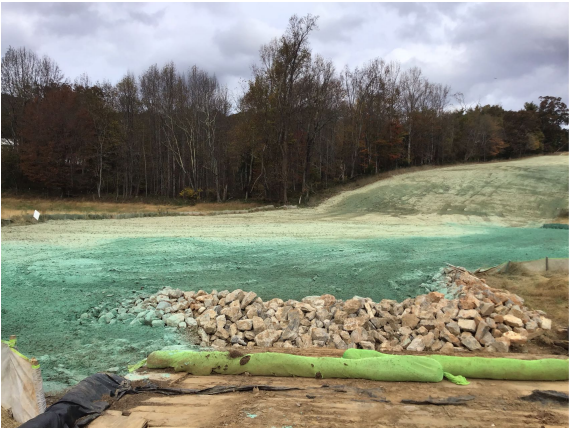
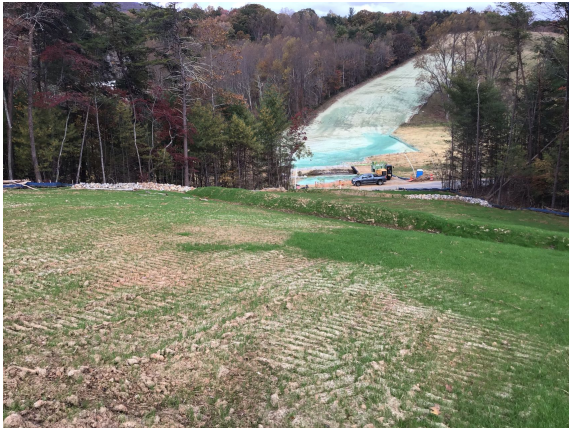
GPS Location	36.9720772980125, -79.8699088488518	GPS Location	36.9720418844716, -79.8699651752411		
Description	Final clean up completed and hydromulched on the GAS Cahas Mt #2	Description	Reclamation 100% complete on the CIS of Cahas Mt #2

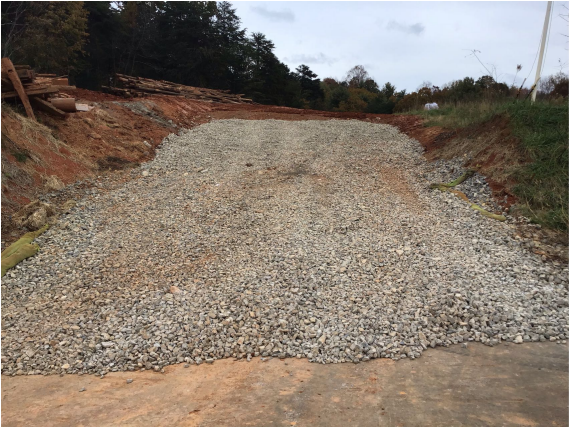
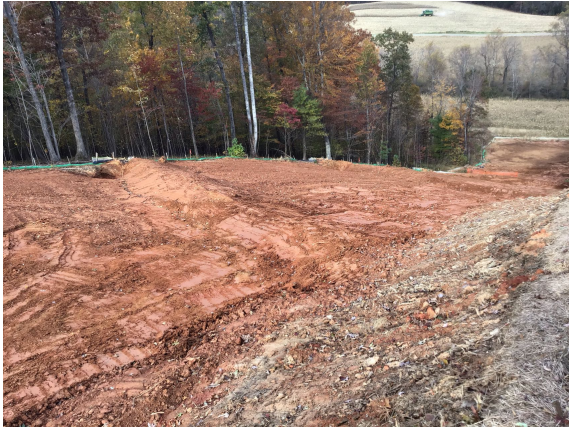
GPS Location	36.9721285114409, -79.8699888960271	GPS Location	36.9720503501938, -79.8699892313032		
Description	RCE at GAS of Monty Rd in good condition	Description	Waterbar and end treatments in good condition at approximately 13630+00

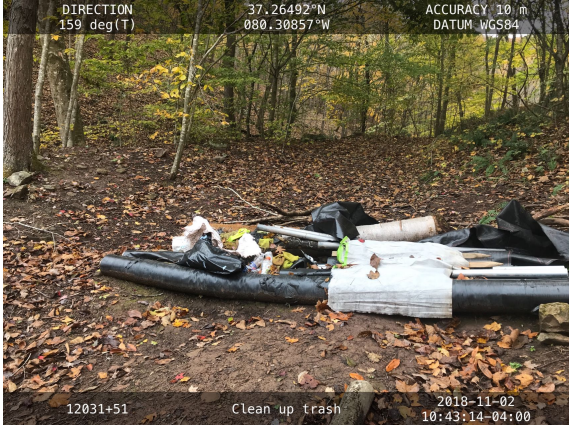
GPS Location	37.270873119158, -80.3145278245959		GPS Location	37.2707482288007, -80.3144802153858	
Description	See photo for gps data. Stone apron should be installed at the slope drain inlets.		Description	See photo for gps data. Trash and debris left on the ROW and should be cleaned up.

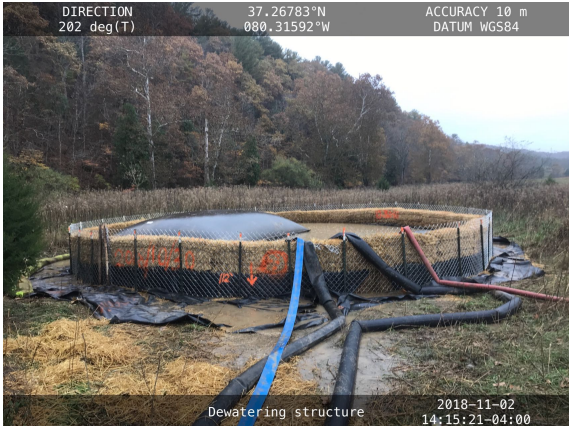
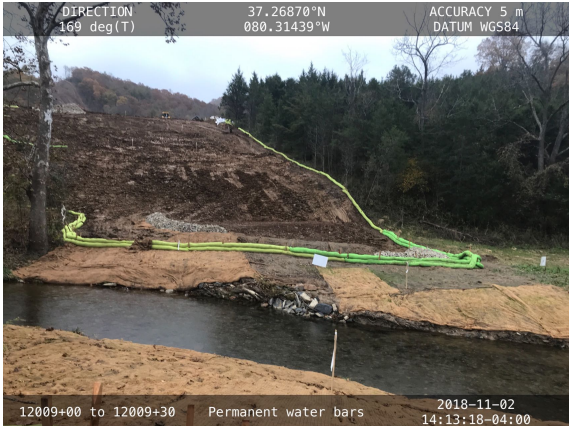
GPS Location	37.2709750431006, -80.3145687282833		GPS Location	37.2708508232956, -80.3143831529471	
Description	See photo for gps data. Dewatering structure located just off the ROW at about 12003+00.		Description	See photo for gps data. Permanent water bars installed between 12009+00 and 12009+30.

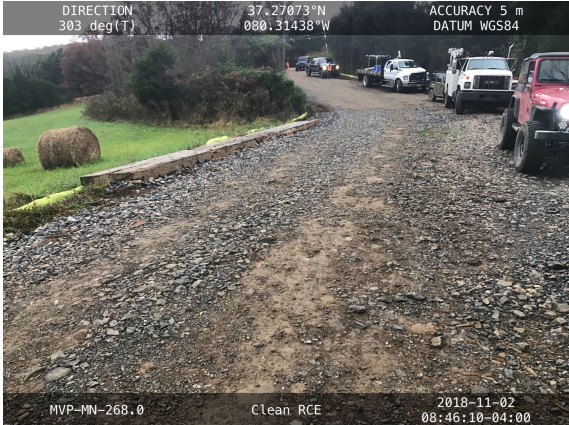
GPS Location	37.2707681777303, -80.3146754299107		GPS Location	37.2709565190945, -80.3145242203775	
Description	See photo for gps data. The rock construction entrance on MVP-MN-268.0 needs to be cleaned and fresh stone placed.		Description	See photo for gos data. Photo shows the tie in crew lowering in and adjusting the pipe supports from 12049+00 to 12051+50.

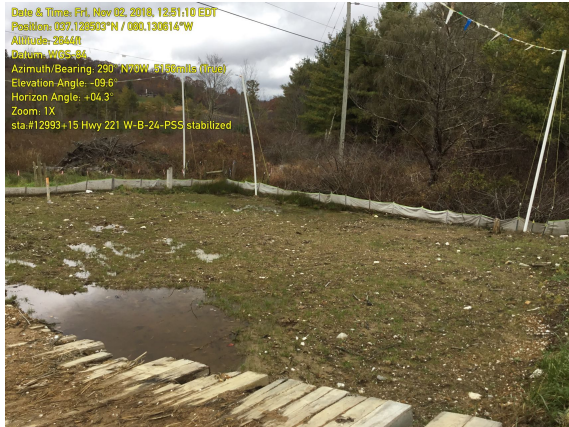
A/E	124300138	Date/Time	11/2/2018 4:34 PM	Report #	10341
Pictures					
<p>Date & Time: Fri, Nov 02, 2018, 12:51:10 EDT Position: 037.128503°N / 080.130614°W Altitude: 2644ft Datum: WGS-84 Azimuth/Bearing: 290° N90W 5150mils (True) Elevation Angle: -09.6° Horizon Angle: +04.3° Zoom: 1X Sta:#12993+15 Hwy 221 W-B-24-PSS stabilized</p>

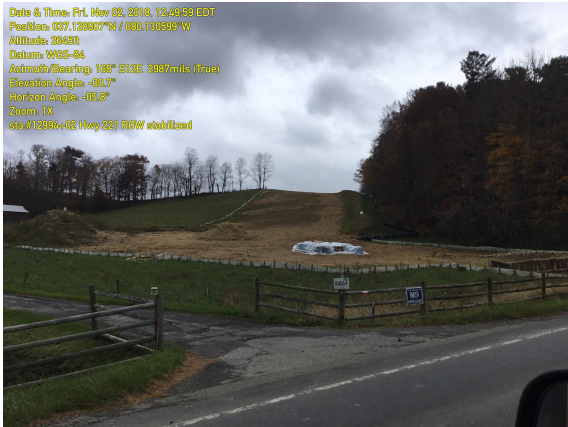
<p>Date & Time: Fri, Nov 02, 2018, 12:49:59 EDT Position: 037.128907°N / 080.130300°W Altitude: 2640ft Datum: WGS-84 Azimuth/Bearing: 180° S18E 3000mils (True) Elevation Angle: -08.7° Horizon Angle: +08.6° Zoom: 1X Sta:#12994+02 Hwy 221 ROW stabilized</p>

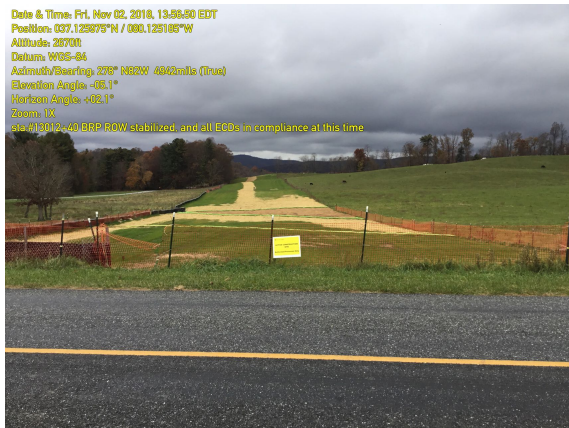
GPS Location	37.1284790011469, -80.130559464545	GPS Location	37.128486000036, -80.1305747219176		
Description	Sta:#12993+15 Hwy 221 W-B-24-PSS stabilized.	Description	Sta:#12994+02 Hwy 221 ROW stabilized		
<p>Date & Time: Fri, Nov 02, 2018, 13:55:50 EDT Position: 037.125975°N / 080.125180°W Altitude: 2670ft Datum: WGS-84 Azimuth/Bearing: 278° N52W 4042mils (True) Elevation Angle: -05.1° Horizon Angle: +05.1° Zoom: 1X Sta:#13012+40 BRP ROW stabilized, and all ECDs in compliance at this time</p>

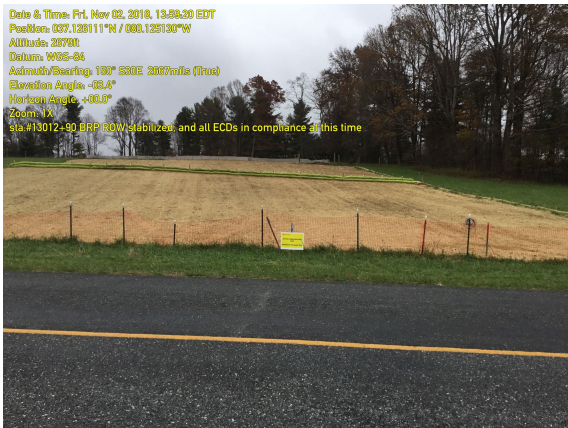
<p>Date & Time: Fri, Nov 02, 2018, 13:55:20 EDT Position: 037.126111°N / 080.125130°W Altitude: 2670ft Datum: WGS-84 Azimuth/Bearing: 180° S30E 2067mils (True) Elevation Angle: -05.4° Horizon Angle: +00.6° Zoom: 1X Sta:#13012+90 BRP ROW stabilized, and all ECDs in compliance at this time</p>

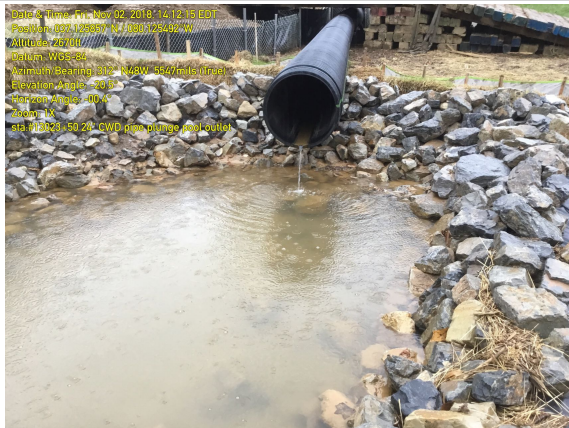
GPS Location	37.1259618737149, -80.1251668018104	GPS Location	37.1261105686772, -80.1251295861603		
Description	Sta:#13012+40 BRP ROW stabilized, and all ECDs functioning at this time.	Description	Sta:#13012+90 BRP ROW stabilized, and all ECDs functioning at this time.		
<p>Date & Time: Fri, Nov 02, 2018, 14:12:15 EDT Position: 037.125233°N / 080.121654°W Altitude: 2570ft Datum: WGS-84 Azimuth/Bearing: 261° N59W 5490mils (True) Elevation Angle: -09.4° Horizon Angle: +04.4° Zoom: 1X Sta:#13023+50 24" CWD pipe plunge pool outlet</p>

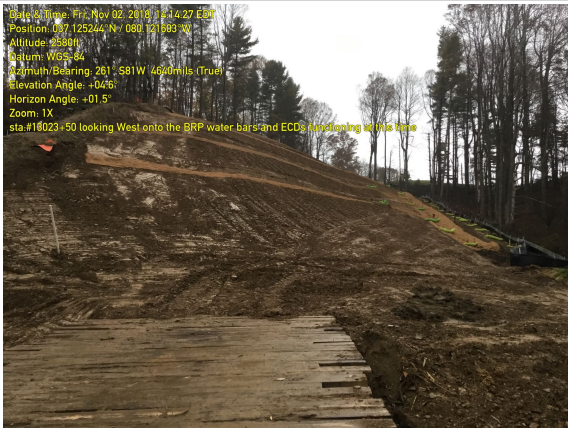
<p>Date & Time: Fri, Nov 02, 2018, 14:14:27 EDT Position: 037.125244°N / 080.121583°W Altitude: 2568ft Datum: WGS-84 Azimuth/Bearing: 261° S01W 4690mils (True) Elevation Angle: -09.4° Horizon Angle: +01.5° Zoom: 1X Sta:#13023+50 looking West onto the BRP water bars and ECDs functioning at this time</p>

Description	Sta:#13023+50 24" CWD pipe plunge pool outlet flowing clean and clear	Description	Sta:#13023+50 looking West onto the BRP

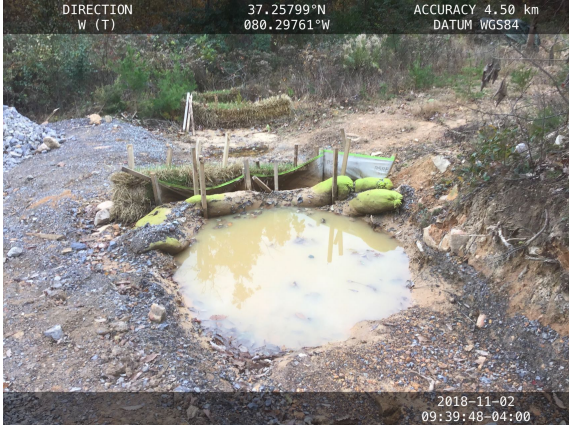
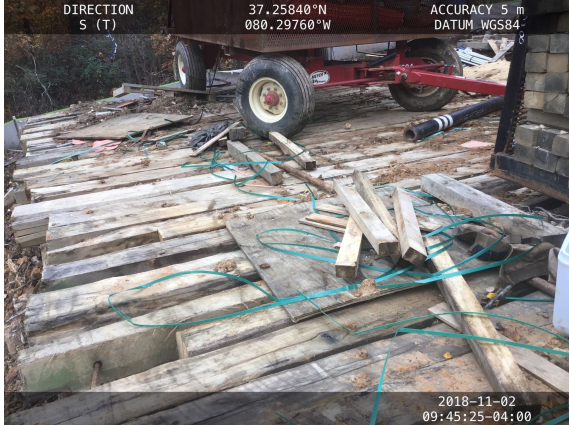
GPS Location	37.2582974145536, -80.2975688037279	GPS Location	37.2582678683449, -80.2975843940678		
Description	CFS, P1, and straw bales all need to be replaced on sump @ first turnout down from the ROW on access road MVP-MN-270.	Description	Banding, old pallets and other refuse laying around near station 12073+00, ~MP 228.5~, near large pull cart.

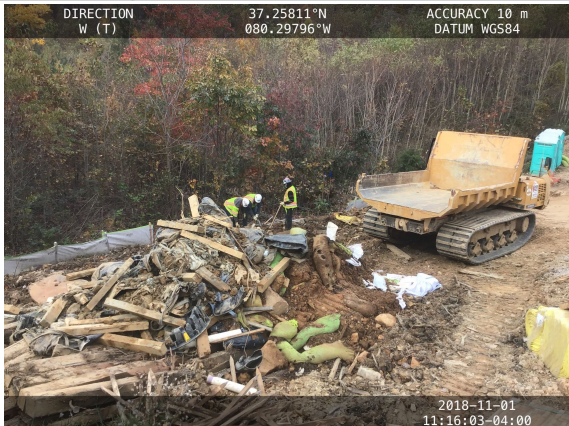
Description	Spoil pushed against side boards on going away end of the bridge @ stream S-MM15. See photo for location.	Description	A large pile of trash still remains in ATWS-1162, station 12071+90, ~MP 228.5~. See photo for location.

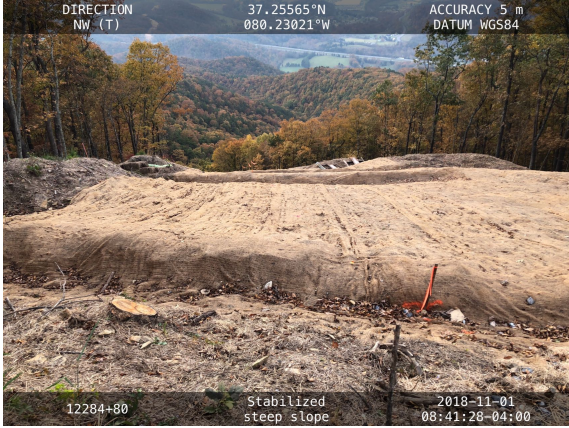
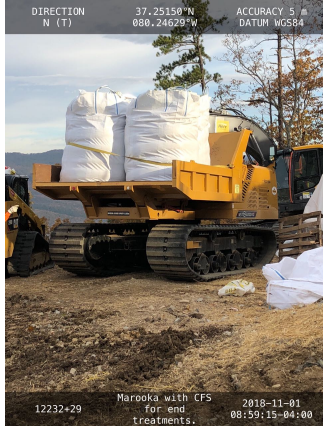
GPS Location	37.3314696369297, -79.9580253942315	GPS Location	37.3314823927924, -79.9582111509743		
Description	12284+80_110118 Stabilized steep slope. Looking NW. See picture for GPS data	Description	12232+29_110118 Marook with CFS for end treatments. Looking N. See picture for GPS data.

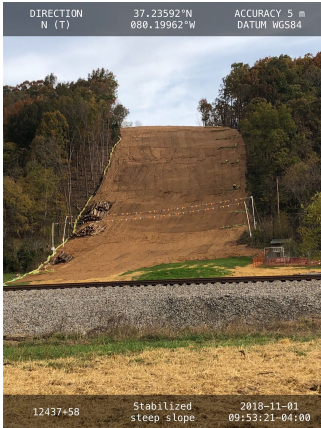
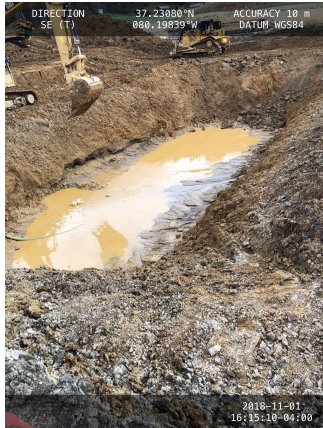
GPS Location	37.3314799820885, -79.9582157552516	GPS Location	37.3314076429581, -79.95813810274		
Description	12437+58_110118 Stabilized steep slope. Looking N. See picture for GPS data	Description	12451+00_110118 Bore pit after being pumped down. Looking SE. See picture for GPS data.

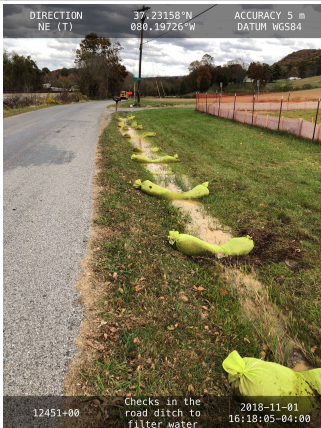
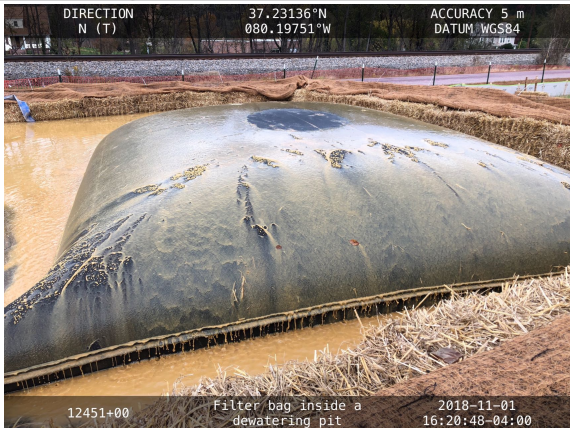
GPS Location	37.3313671164562, -79.9581180699914	GPS Location	37.3313547950586, -79.9580009748041		
Description	12451+00_110118 Checks in road ditch to filter water. Looking NE. See picture for GPS data.	Description	12451+00_110118 Filter bag inside dewatering structure. Looking N. See picture for GPS data.

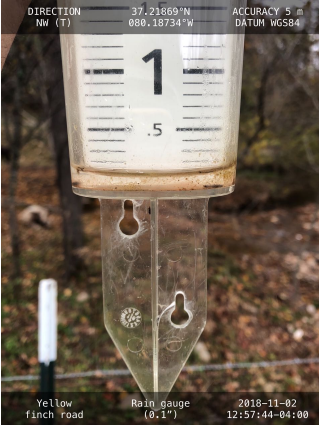
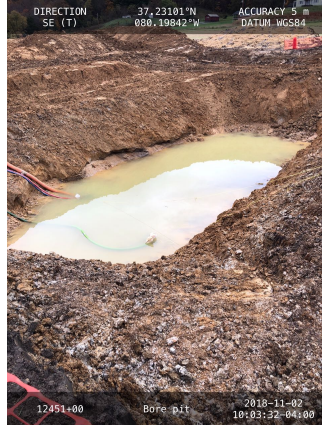
GPS Location	37.3315505318111, -79.958133787986	GPS Location	37.3313685250817, -79.9580984310856		
Description	Yellow Finch road_110218 Rain Gauge (0.1") Looking NW. See picture for GPS data.	Description	12451+00_110218 Bore pit with ground water. Looking SE. See picture for GPS data.

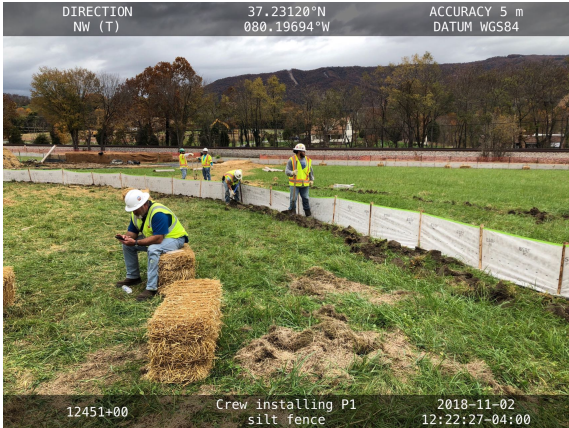
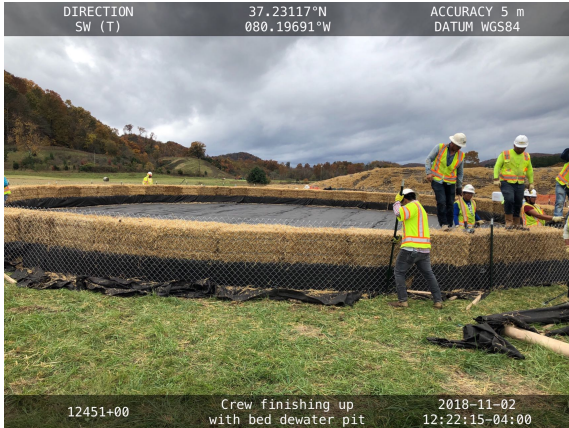
GPS Location	37.3313670896348, -79.9581005202746	GPS Location	37.331366726638, -79.9581009892358		
Description	12451+00_110218 Crew installing P1 silt fence. Looking NW. See picture for GPS data.	Description	12451+00_110218 Crew finishing up with new dewatering structure. Looking SW. See picture for GPS data.

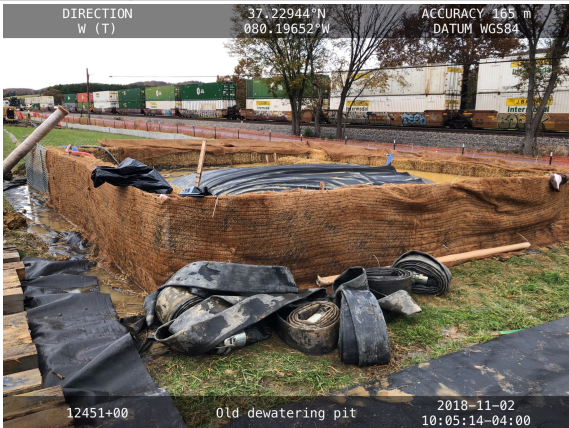
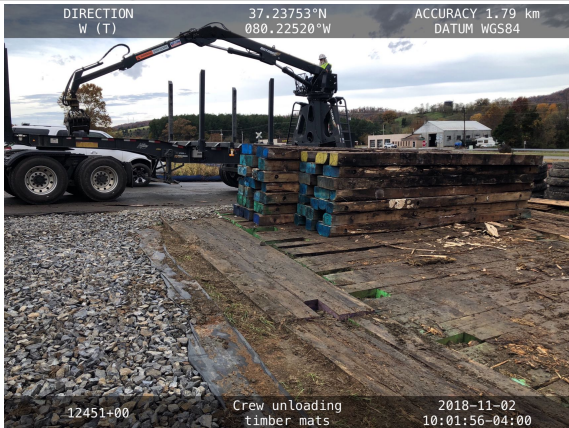
GPS Location	37.3313761689117, -79.9580977019667	GPS Location	37.3313761689117, -79.9580977019667		
Description	12451+00_110218 Old dewatering pit full of water and sediment. Looking W. See picture for GPS data.	Description	12451+00_110218 Crew unloading timber mats. Looking W. See picture for GPS data.
