# Visual Site Inspection Report

<b>Project Name</b>	H-600 Pipeline Spread H	<b>AFE</b>	124300138	<b>Spread</b>	H-600 Pipeline Spread H
<b>Contractor</b>	Precision			<b>Report #</b>	10572
<b>Inspector</b>	Glenn Mike Renfro			<b>Date/Time</b>	11/7/2018 1:59 PM
<b>Permit #</b>	TBD	<b>Inspection Type</b>	VA SWPP	<b>Station Begin</b>	13415+00
<b>State</b>	VA	<b>Inspection Area</b>	Full	<b>Station End</b>	14670+00
<b>County</b>	Franklin	<b>Ground</b>	Wet	<b>Temperature (°F)</b>	69.00
<b>Municipality</b>	N/A	<b>Weather</b>	Sunny	<b>Rain Gauge (in)</b>	3.80
<b>GPS Location</b>	37.0896852482456, -79.9656047020852			<b>Rain Accumulation Time (days)</b>	4.00

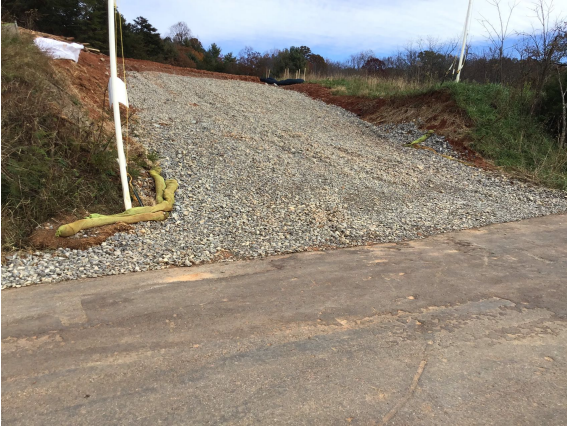
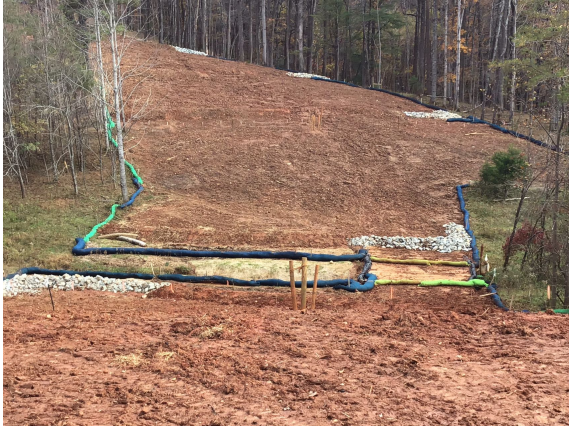
<b>GPS Location</b>	37.0894331205982, -79.9652852677553	<b>GPS Location</b>	37.0893264189708, -79.9654009380191		
<b>Description</b>	RCE at GAS of Monty Rd.	<b>Description</b>	Clean up operations completed near stream crossing S-116 at 13579+93

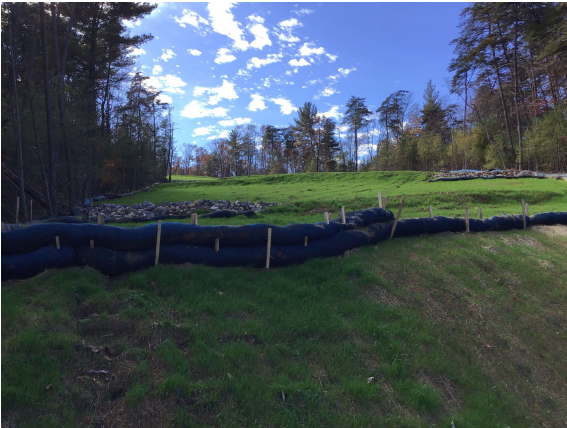
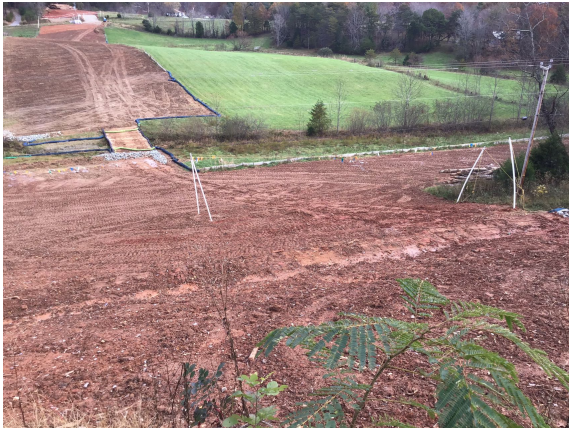
<b>GPS Location</b>	37.0894581824886, -79.965310664922	<b>GPS Location</b>	37.0895882696259, -79.9649985228479		
<b>Description</b>	Reclamation completed, seed growing in CIS Cahas Mt #2	<b>Description</b>	Clean up operations completed on GAS Bethlehem Rd

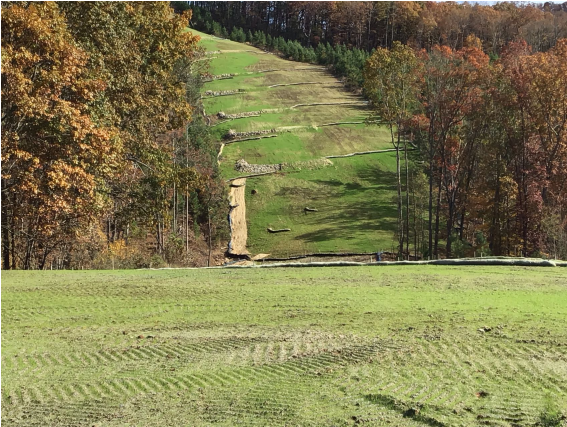
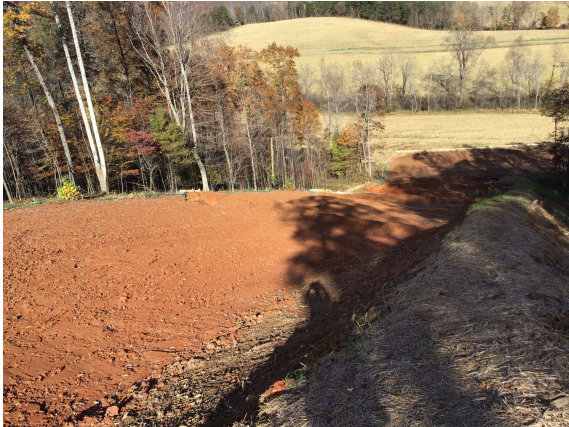
<b>GPS Location</b>	37.0894794725227, -79.9653772172331	<b>GPS Location</b>	37.0894769160422, -79.9653574359417		
<b>Description</b>	Reclamation completed, seed growing in GAS of 13416+00	<b>Description</b>	Waterbars and end treatments in good condition at approximately 13630+00

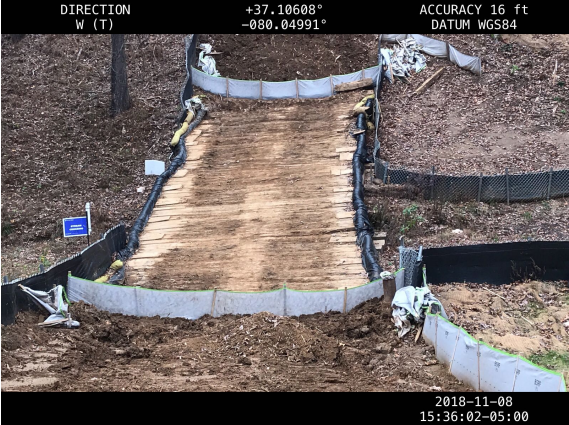
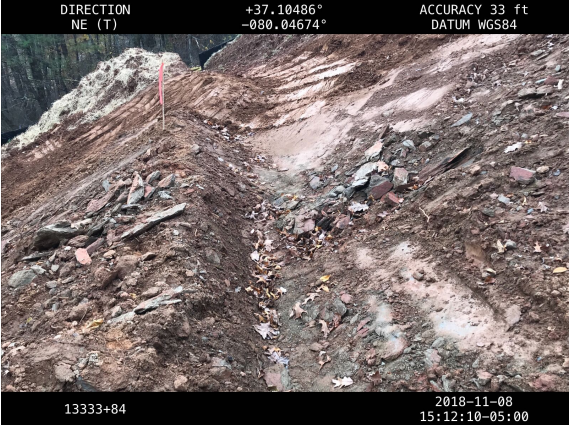
<b>GPS Location</b>	37.278830374884, -80.0288117850179		<b>GPS Location</b>	37.2789241640344, -80.0286178819704	
<b>Description</b>	13325+30_110818 trashed old P1 silt fence needs removed. Looking W. See photo for gps data.		<b>Description</b>	13333+84_110818 waterbar channel high in the travel lane. Looking NE. See photo for gps data.

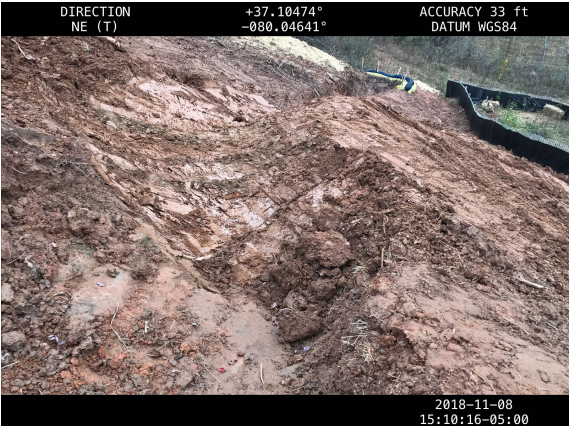
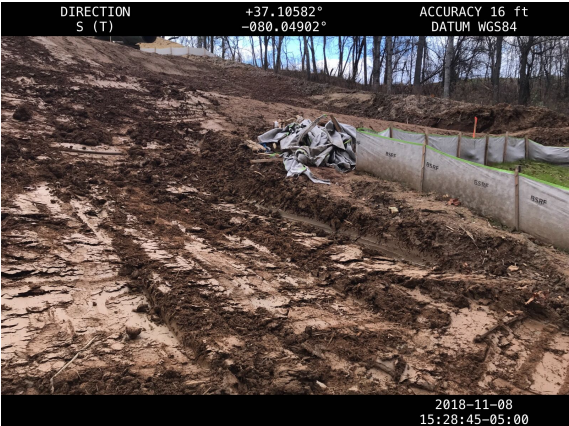
<b>GPS Location</b>	37.2789885616277, -80.0286290702224		<b>GPS Location</b>	37.2789885616277, -80.0286290702224	
<b>Description</b>	13333+67_110818 waterbar channel high in travel lane. Looking NE. See photo for gps data.		<b>Description</b>	13325+30_110818 trashed old P1 silt fence needs removed. Looking S. See photo for gps data.

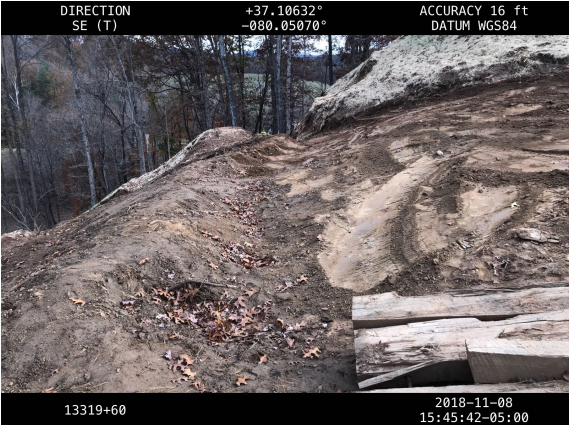
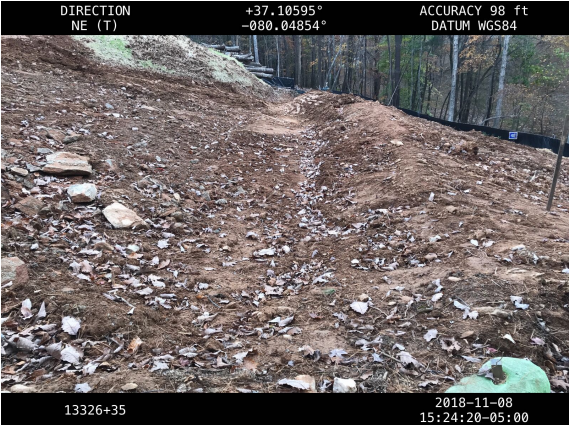
<b>Description</b>	13319+60_110818 waterbar channel high in the travel lane. Looking SE. See photo for gps data.		<b>Description</b>	13336+35_110818 waterbar channel high in the travel lane. Looking NE. See photo for gps data.

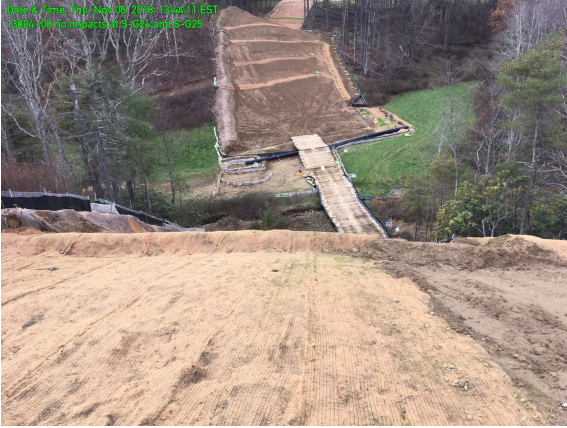
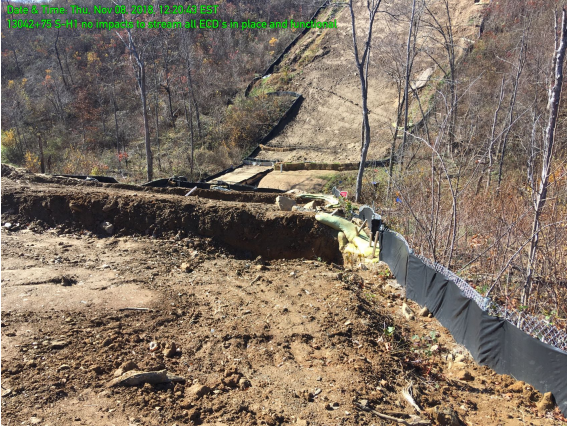
<b>AFE</b>	124300138	<b>Date/Time</b>	11/8/2018 3:36 PM	<b>Report #</b>	10640
<b>Pictures</b>					
<small>Date &amp; Time: Thu, Nov 08, 2018, 13:35:11 EST 13077+00 tie-in crew working in the area</small>

<small>Date &amp; Time: Thu, Nov 08, 2018, 13:35:11 EST 13077+00 tie-in crew working in the area</small>

<b>GPS Location</b>	37.1258198423657, -80.1188848168404	<b>GPS Location</b>	37.1258011926311, -80.1188851521165		
<b>Description</b>	The waddle on the mat bridge that was noted on the punch list to be replaced was completed.	<b>Description</b>	No impacts were observed in this area today.		
<small>Date &amp; Time: Thu, Nov 08, 2018, 13:56:01 EST 13115+00 no impacts observed in this area today</small>

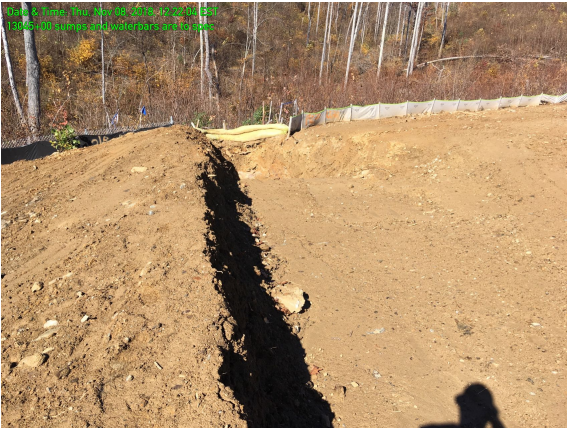
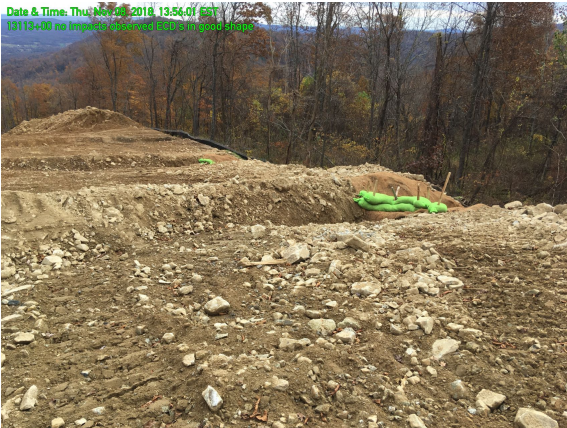
<small>Date &amp; Time: Thu, Nov 08, 2018, 13:56:01 EST 13115+00 no impacts observed in this area today</small>

<b>Description</b>	Waterbars and sumps were within specifications.	<b>Description</b>	Waterbars and sumps in this area were adequate.		
<small>Date &amp; Time: Thu, Nov 08, 2018, 14:17:23 EST 13077+00 tie-in crew working in the area</small>

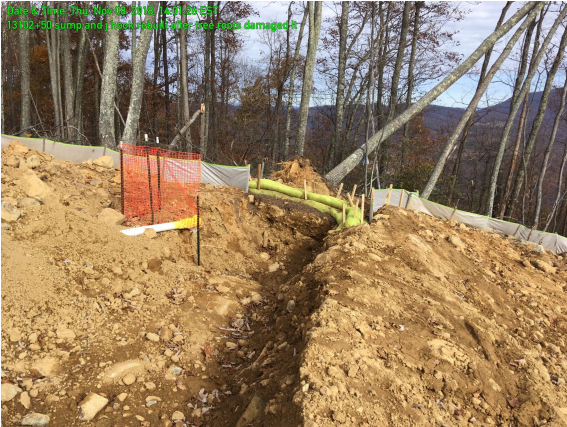
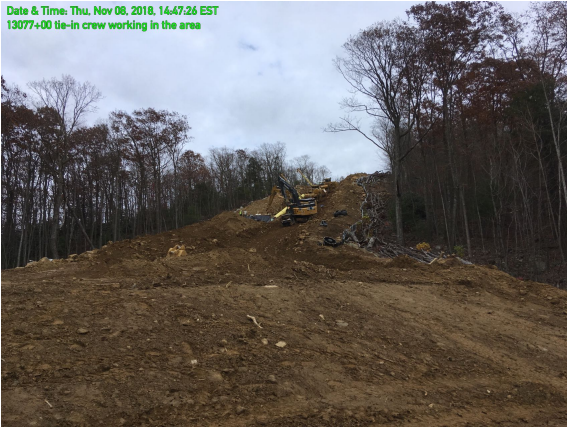
<small>Date &amp; Time: Thu, Nov 08, 2018, 14:47:26 EST 13077+00 tie-in crew working in the area</small>

<b>GPS Location</b>	37.1258223988462, -80.118862688616	<b>GPS Location</b>	37.1258205129179, -80.1188643649967		
<b>Description</b>	This j hook had to be replaced due to the tree blowing over.	<b>Description</b>	Tie-in crew working on the steep slope area between FR-290 and FR-291. From 13077+00 to 13088+00

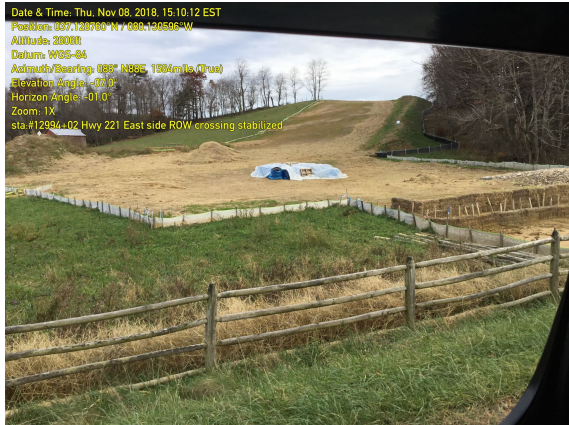
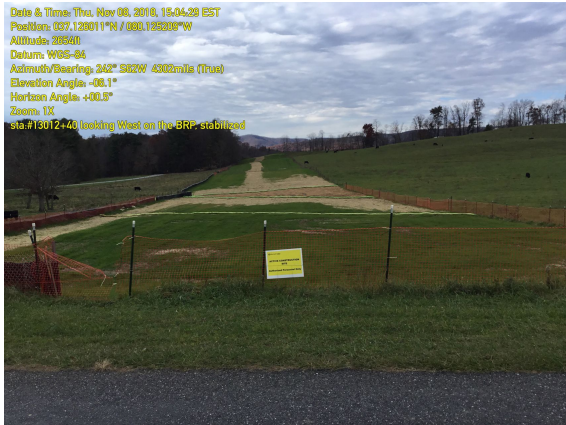
A/E	124300138	Date/Time	11/8/2018 5:05 PM	Report #	10645
Pictures					
<p>Date &amp; Time: Thu, Nov 08, 2018, 15:10:12 EST Position: 037.128700°N / 080.125505°W Altitude: 2600ft Datum: WGS-84 Azimuth/Bearing: 091° 58'55" 1584mils (True) Elevation Angle: -01.1° Horizon Angle: -01.0° Zoom: 1X Sta: #12994+02 Hwy 221 East side ROW crossing stabilized</p>

<p>Date &amp; Time: Thu, Nov 08, 2018, 15:04:39 EST Position: 037.128011°N / 080.125300°W Altitude: 2656ft Datum: WGS-84 Azimuth/Bearing: 242° 58'25" 4302mils (True) Elevation Angle: -05.1° Horizon Angle: +00.5° Zoom: 1X Sta: #13012+40 looking West on the BRP- stabilized</p>

GPS Location	37.2799096978771, -80.0289341621002	GPS Location	37.2800682345752, -80.0294599682838		
Description	Sta:#12994+02 ROW is stabilized. See photo for accurate coordinates.	Description	Sta:#13012+40 the BRP ROW is stabilized. See photo for accurate coordinates.

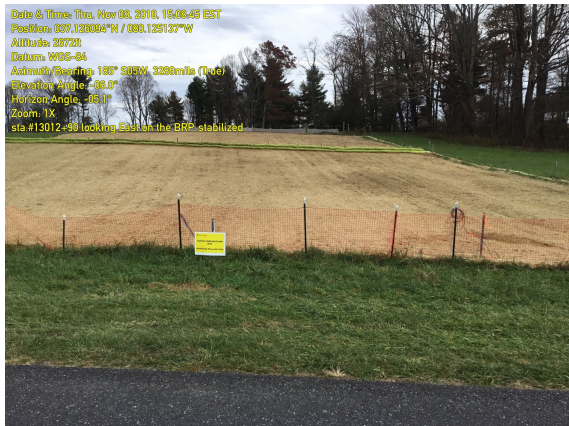
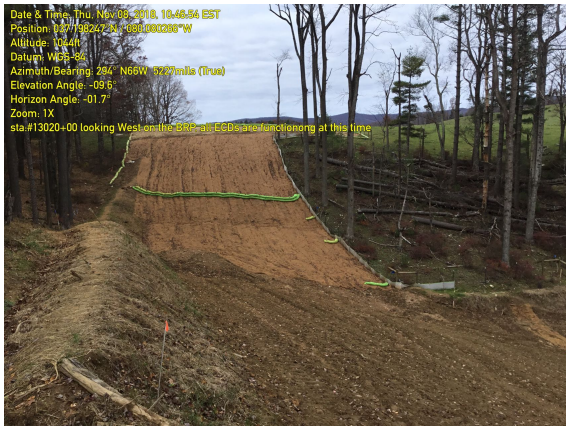
<p>Date &amp; Time: Thu, Nov 08, 2018, 15:08:45 EST Position: 037.128094°N / 080.125137°W Altitude: 2672ft Datum: WGS-84 Azimuth/Bearing: 180° 58'55" 3289mils (True) Elevation Angle: -08.0° Horizon Angle: -05.0° Zoom: 1X Sta: #13012+90 looking East on the BRP- stabilized</p>

<p>Date &amp; Time: Thu, Nov 08, 2018, 15:08:34 EST Position: 037.128094°N / 080.125137°W Altitude: 2672ft Datum: WGS-84 Azimuth/Bearing: 264° 58'55" 4693mils (True) Elevation Angle: -09.5° Horizon Angle: -01.7° Zoom: 1X Sta: #13020+00 looking West on the BRP- at EEB site/land clearing at this time</p>

GPS Location	37.2800524346878, -80.0294398517162	GPS Location	37.2799574677248, -80.0291996263713		
Description	Sta:#13012+90 the BRP ROW is stabilized. See photo for accurate coordinates.	Description	Sta:#13020+00 the BRP ROW is stabilized. See photo for accurate coordinates.		
<p>Date &amp; Time: Thu, Nov 08, 2018, 11:05:51 EST Position: 037.125215°N / 80.131560°W Altitude: 2612ft Datum: WGS-84 Azimuth/Bearing: 264° 58'55" 4693mils (True) Elevation Angle: -01.7° Horizon Angle: -01.7° Zoom: 1X Sta: #13023+50 looking West survey marking 20' ROW easement</p>

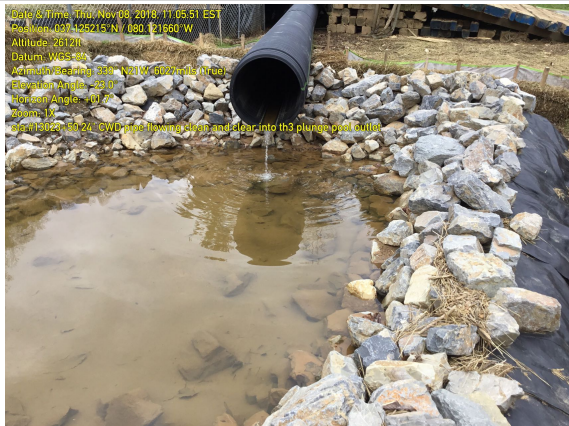
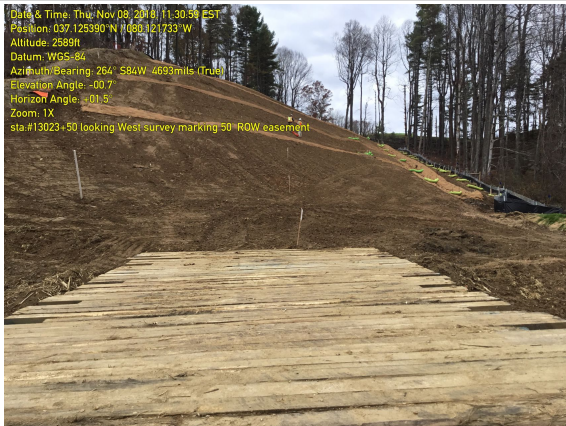
<p>Date &amp; Time: Thu, Nov 08, 2018, 11:30:55 EST Position: 037.125390°N / 080.121733°W Altitude: 2589ft Datum: WGS-84 Azimuth/Bearing: 264° 58'55" 4693mils (True) Elevation Angle: -01.7° Horizon Angle: -01.7° Zoom: 1X Sta: #13023+50 looking West survey marking 20' ROW easement</p>

GPS Location	37.2799357585956, -80.0292031467706	GPS Location	37.280029384454, -80.0292005483806		
Description	Sta:#13023+50 plunge pool outlet clean and clear. See photo for accurate coordinates.	Description	Sta:#13023+00 the ROW is stabilized. See photo for accurate coordinates.

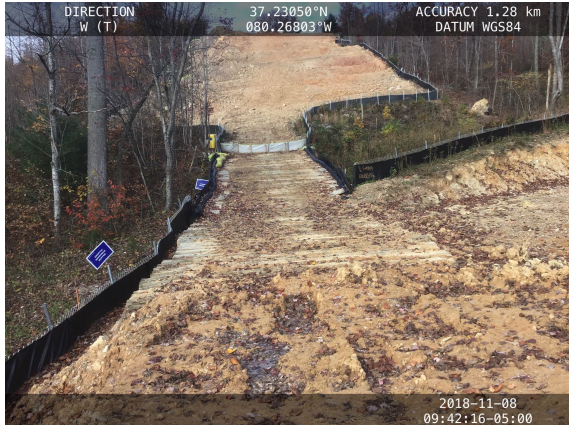
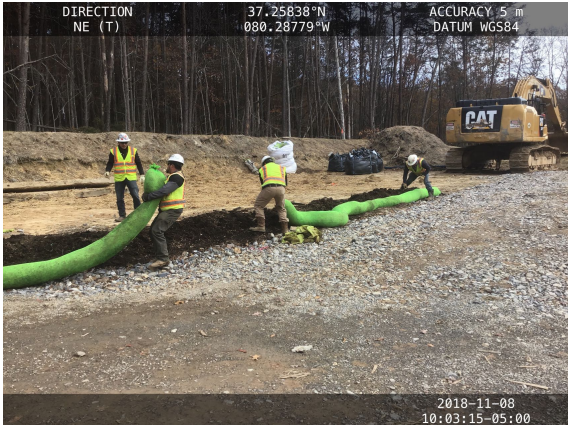
<b>GPS Location</b>	37.2585352510561, -80.2928342019024		<b>GPS Location</b>	37.2583811497663, -80.2877918165925	
<b>Description</b>	Bridge and ECDs functioning properly @ stream S-MM14, station 12086+56, ~MP 228.75~.		<b>Description</b>	Laborers from the env crew replaced flattened CFS @ RCE on the going away side of Half Acre Rock Road.

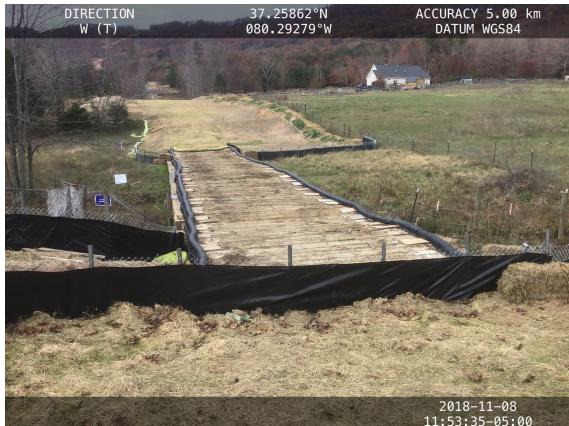
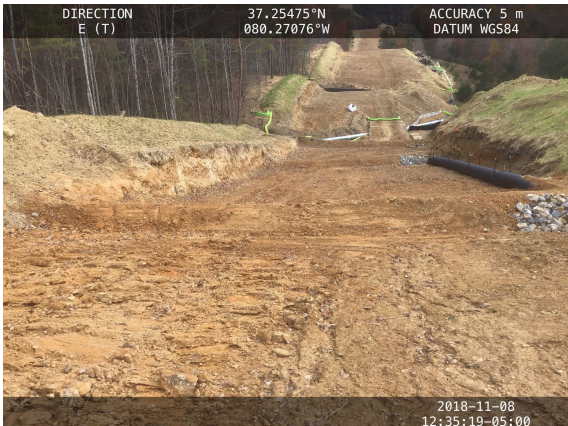
<b>GPS Location</b>	37.256337390316, -80.2777996660027		<b>GPS Location</b>	37.2547792783354, -80.2708093263956	
<b>Description</b>	The bridge and ECDs in satisfactory condition at stream S-C29, station 12132+73, ~MP 29.6~.		<b>Description</b>	A waterbar was fixed where it previously was less than the 18" height requirement @ station 12154+75 per PL item #1518.

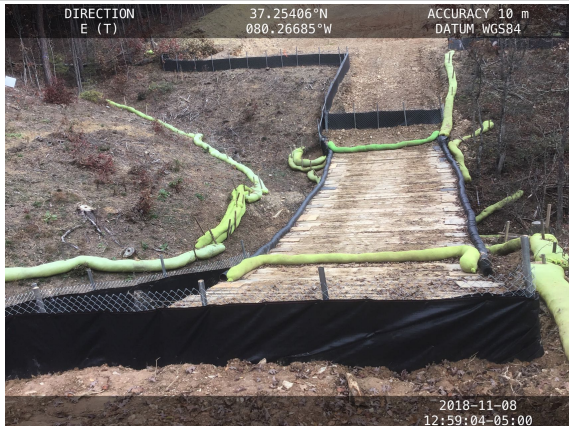
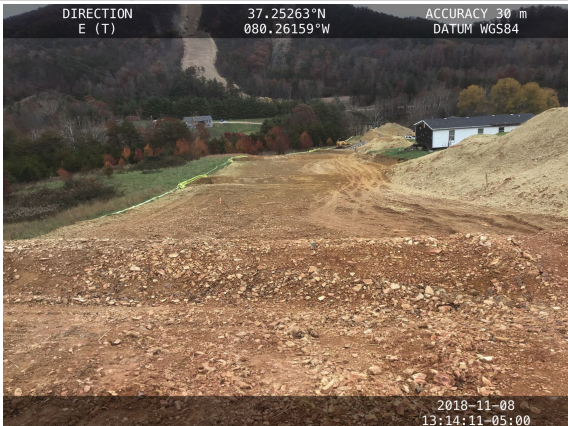
<b>Description</b>	No apparent issues with the bridge or ECDs at stream S-C24, station 12166+47, ~MP 230.25~.		<b>Description</b>	ROW will need to be stabilized between access road MVP-MN-272 and Bradshaw Road.

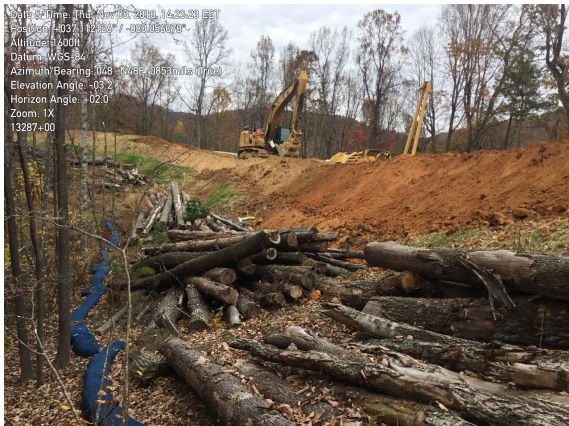
<p>Date &amp; Time: Thu, Nov 08, 2018, 14:02:51 EST Position: +037.115289° / -080.056303° Altitude: 1634ft Datum: WGS-84 Azimuth/Bearing: 281° N79W 4996mils (True) Elevation Angle: -15.4° Horizon Angle: +03.8° Zoom: 2X 13270+12</p>  		<p>Date &amp; Time: Thu, Nov 08, 2018, 14:28:10 EST Position: +037.118371° / -080.056303° Altitude: 1620ft Datum: WGS-84 Azimuth/Bearing: 043° N43E 4956mils (True) Elevation Angle: -03.2° Horizon Angle: +02.0° Zoom: 1X 13287+00</p>

GPS Location	37.3256270634358, -80.0286790263653		GPS Location	37.3256178433423, -80.0287371129543	
Description	Please see photo for coordinates. St. No. 13270+12, looking down to Flanders Road crossing, pipe lowered in.		Description	Please see photo for coordinates. Sta. No. 13287+00, subsoil pulled off of topsoil.	
<p>Date &amp; Time: Thu, Nov 08, 2018, 14:58:17 EST Position: +037.108359° / -080.055177° Altitude: 1471ft Datum: WGS-84 Azimuth/Bearing: 239° S59W 4249mils (True) Elevation Angle: -31.2° Horizon Angle: +00.0° Zoom: 1X 13300+00</p>

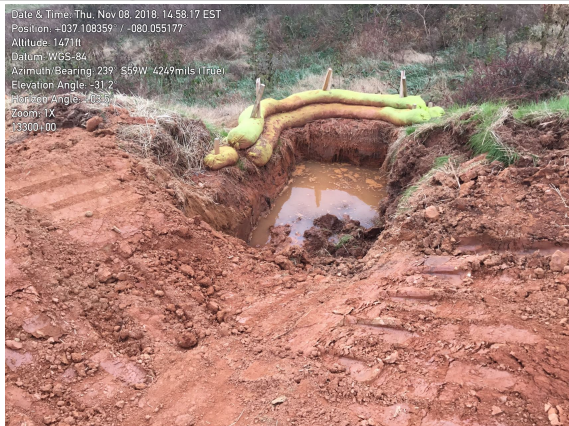
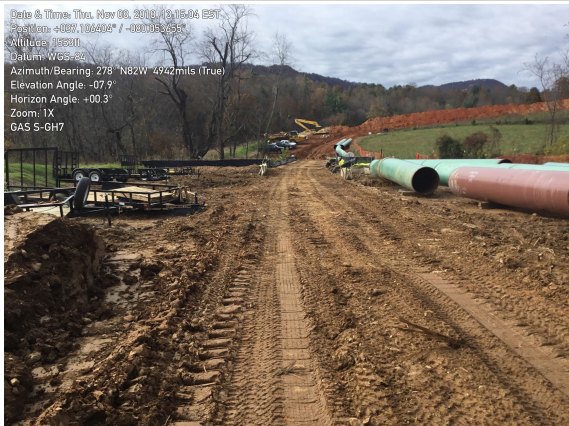
<p>Date &amp; Time: Thu, Nov 08, 2018, 13:15:06 EST Position: +037.106404° / -080.052453° Altitude: 1350ft Datum: WGS-84 Azimuth/Bearing: 278° N82W 4942mils (True) Elevation Angle: -07.9° Horizon Angle: +00.3° Zoom: 1X GAS S-GH7</p>

GPS Location	37.3256178433423, -80.0287371129543		GPS Location	37.3256178433423, -80.0287371129543	
Description	Please see photo for coordinates. ~Sta. No. 13300+00, sump needs cleaned.		Description	Please see photo for coordinates. ~Sta. No. 13310+00, GAS of S-GH7, no environmental issues noted.

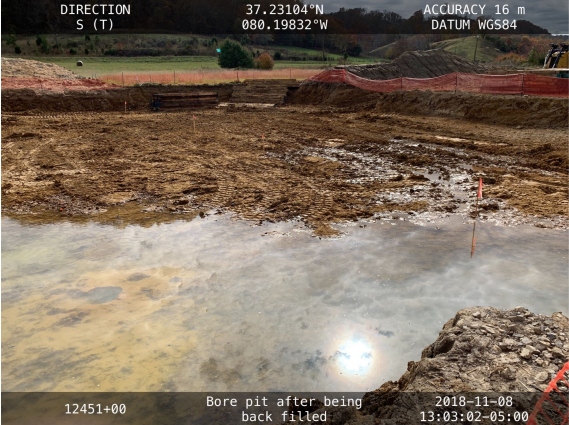
<b>GPS Location</b>	37.3313957949451, -79.9581378795561		<b>GPS Location</b>	37.3314475980517, -79.9581534036654	
<b>Description</b>	12451+00_110818 Bore pit after being back filled. Looking S. See picture for GPS data.		<b>Description</b>	12451+00_110818 New dewatering pit after water filtered out. Looking W. See picture for GPS data.

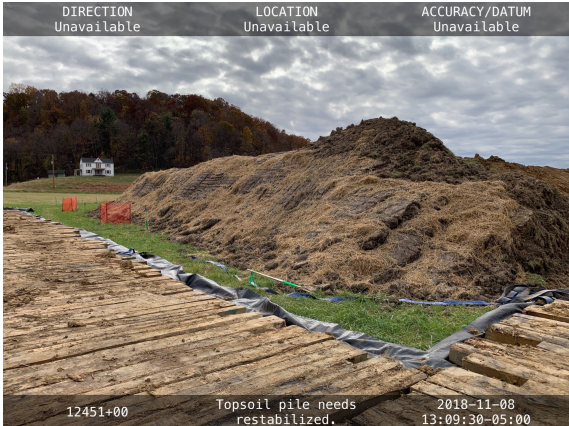
<b>GPS Location</b>	37.3314485601205, -79.9581966572424		<b>GPS Location</b>	37.3314802083441, -79.9582367222022	
<b>Description</b>	12451+00_110818 Many Layers of filtration. Looking N. See picture for GPS data.		<b>Description</b>	12451+00_110818 Top soil pile needs restabilized.

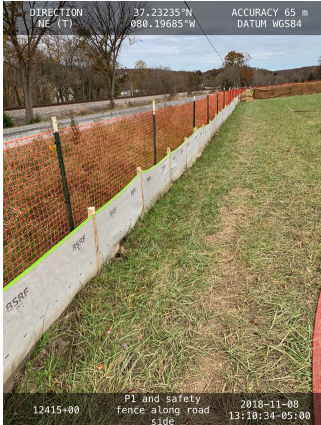
<b>GPS Location</b>	37.3314674776948, -79.9581799074886		<b>GPS Location</b>	37.3315156080902, -79.958340129685	
<b>Description</b>	12451+00_110818 Old dewatering pit full of sediment. Looking NW. See picture for GPS data.		<b>Description</b>	12451+00_110818 P1 skit fence and safety fence along road side. Looking NE. See picture for GPS data.

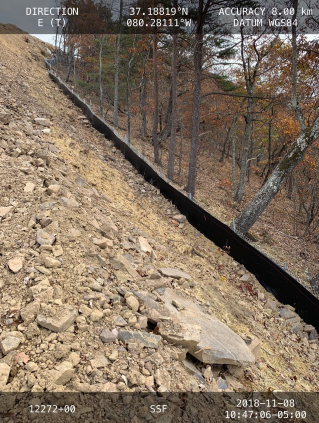
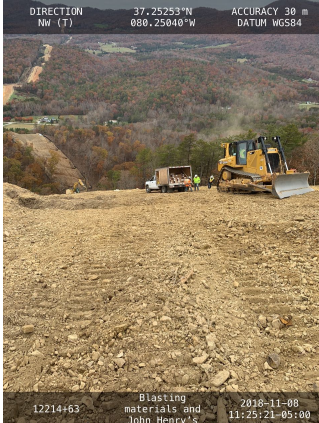
<b>GPS Location</b>	37.3315300652699, -79.9581061864593	<b>GPS Location</b>	37.3315255895851, -79.9581135026331		
<b>Description</b>	12272+00_110818 SSF perimeter controls. Looking E. See picture for GPS data.	<b>Description</b>	12214+63_110818 Blasting crew drilling and loading charges. Looking NW. See picture for GPS data.

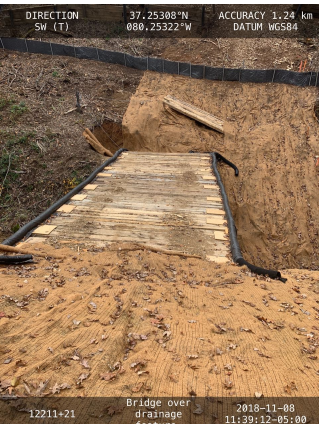
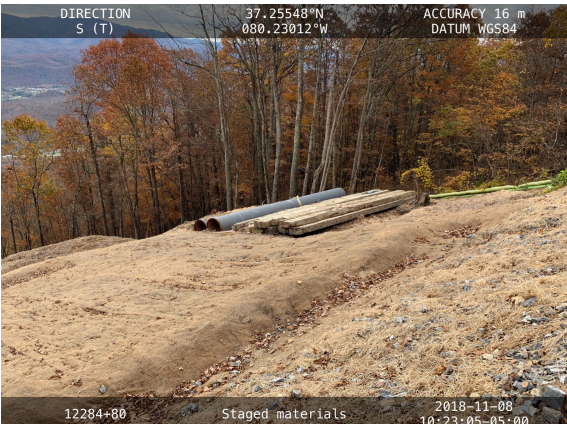
<b>GPS Location</b>	37.3315389680132, -79.9581122690509	<b>GPS Location</b>	37.3315868076157, -79.9581249319762		
<b>Description</b>	12211+21_110818 Bridge over drainage feature. Looking SW. See picture for GPS data.	<b>Description</b>	12284+80_110818 Staged materials. Looking S. See picture for GPS data.

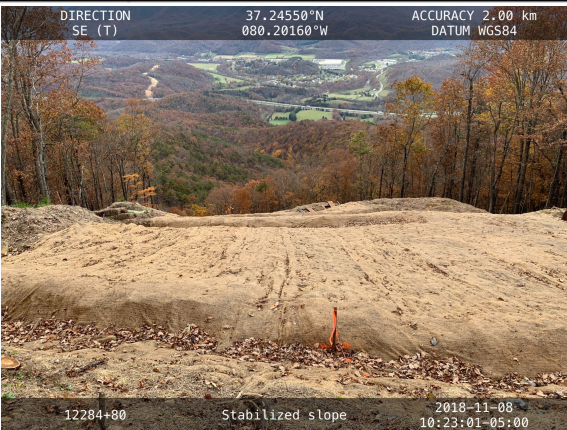
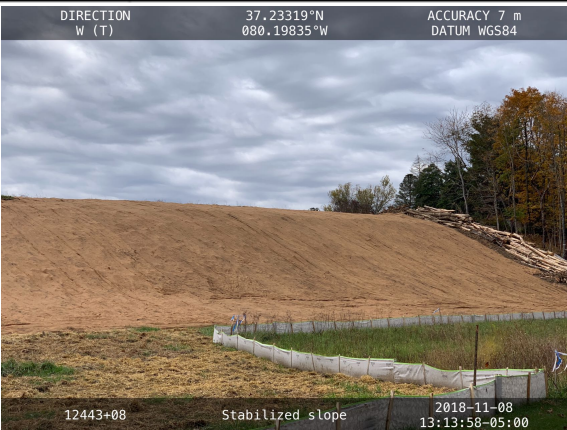
<b>GPS Location</b>	37.331503192133, -79.9584519758866	<b>GPS Location</b>	37.3315151667569, -79.9582831026964		
<b>Description</b>	12284+80_110818 stabilized steep slope. Looking SE. See picture for GPS data.	<b>Description</b>	12443+08_110818 Stabilized slope at Lafayette Rd. Looking W. See picture for GPS data.
