*Spread I Laydown yard
Report # 8808
SWIN 1369
ESIN 0946*

Visual Site Inspection Report

Project Name H-600 Pipeline Spread I	AFE 124300139	Spread H-600 Pipeline Spread I
Contractor Precision	Report # 8808	
Inspector Glenn Mike Renfro	Date/Time 10/3/2018 3:34 PM	
Permit # TBD	Inspection Type VA SWPP	Station Begin 0000+00
State VA	Inspection Area Full	Station End 0000+00
County Franklin	Ground Dry	Temperature (°F) 82.00
Municipality N/A	Weather Sunny	Rain Gauge (in) 0.00
GPS Location 36.9720695866616, -79.8699722998588		Rain Accumulation Time (days) 0.00

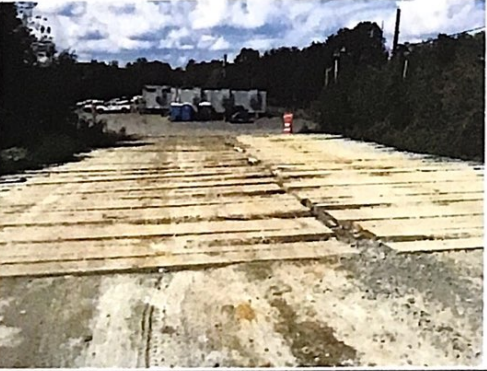
GPS Location	36.9719582431583, -79.8702220185783	GPS Location	36.9719564891688, -79.8702200886698
Description	CFS needs to be restacked in the for southwest corner of paved yard.	Description	Perimeter ECD's on north end of gravel laydown yard in good condition.
