*Spread I Laydown yard
Report # 8490
SWIN 1369
ESIN 0946*

Visual Site Inspection Report

Project Name	H-600 Pipeline Spread I	AFE	124300139	Spread	H-600 Pipeline Spread I
Contractor	Precision			Report #	8490
Inspector	Glenn Mike Renfro			Date/Time	9/27/2018 3:19 PM
Permit #	TBD	Inspection Type	VA SWPP	Station Begin	0000+00
State	VA	Inspection Area	Full	Station End	0000+00
County	Franklin	Ground	Wet	Temperature (°F)	62.00
Municipality	N/A	Weather	Light Rain	Rain Gauge (in)	5.25
GPS Location	36.9717677227582, -79.8700839971254			Rain Accumulation Time (days)	5.00

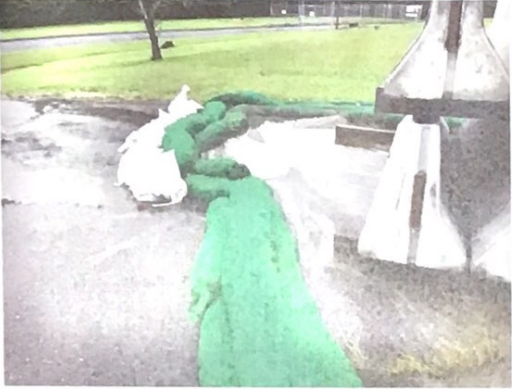
Performed SWPPP inspection of main laydown yard in Rocky Mount, Va. The site received over 5" of rainfall since the last inspection. All perimeter ECD's were inspected and one potential issue was observed with the triple stacked sock in the far north end of the paved laydown yard. The RCE was clean and the road was clear of any debris. All secondary containment structures were found to be in good condition. The inlet drain protections in the paved areas were all found to be in acceptable condition. All issues that were found were put on a punch list and given to the contractor to address.

GPS Location	36.9717756940819, -79.8707749595915		GPS Location	36.971559691742, -79.8703300667823	
Description	Perimeter ECD's in need of repair.		Description	Secondary containment structure for barrel storage in compliance

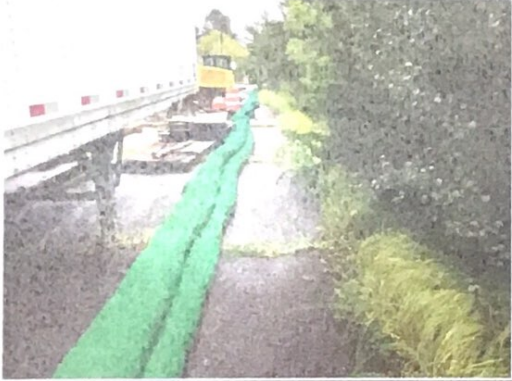
GPS Location	36.971559691742, -79.8703300667823		GPS Location	36.971559691742, -79.8703300667823	
Description	Perimeter ECD's in good condition		Description	Perimeter ECD's on west side of gravel yard in good condition.

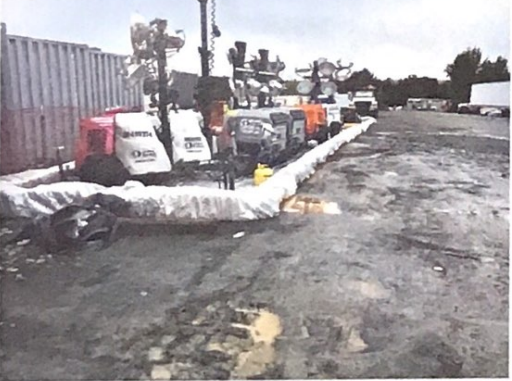
GPS Location	36.971559691742, -79.8703300667823		GPS Location	36.9698149088725, -79.8679284551103	
Description	Secondary containment structure for light plants in good condition		Description	RCE is clean and road free of any debris.
