*Spread I
Report # 8134
DIN0847*

Visual Site Inspection Report

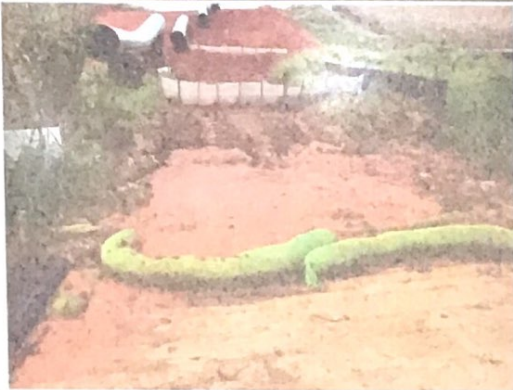
GPS Location	37.0258870208981, -79.5908158645775
Description	Maintenance required at stream S-CD1 sta 13949+70

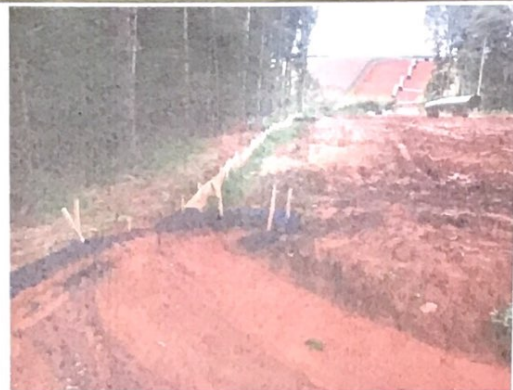
GPS Location	37.0258848835128, -79.5908149425682
Description	Maintenance required at breaker end sta 13953+00

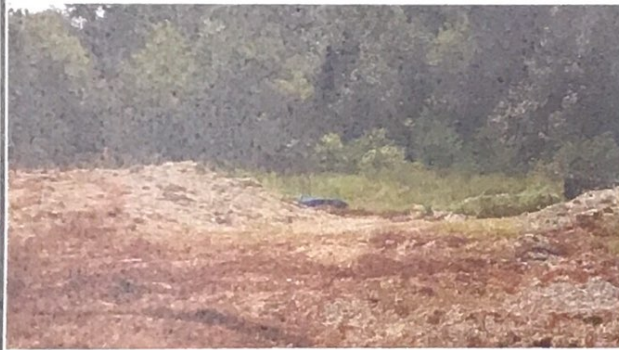
GPS Location	37.0258848835128, -79.5908149425682
Description	Fill slope stabilized sta 14548+00

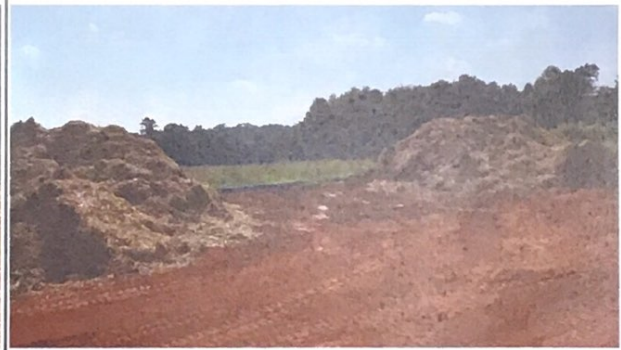
GPS Location	37.0258848835128, -79.5908149425682
Description	Gap excavated for L/O crossing sta 14343+50

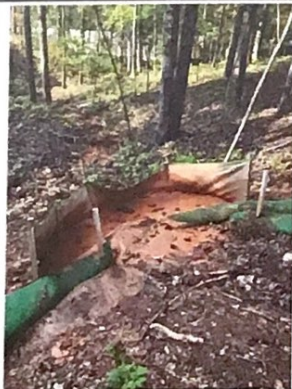
GPS Location	32.9715118408203, -91.3639984130859
Description	Maintenance required sta 14045+59

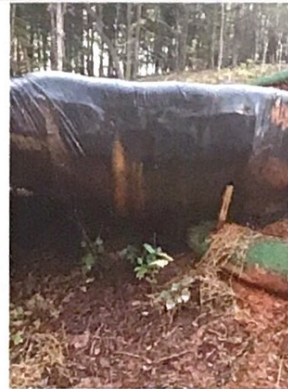
GPS Location	32.9715118408203, -91.3639984130859
Description	Geotechnical under mat bridge at stream S-YZ5 is full. Maintenance required sta 14045+71
