*Spread I
Report # 7484
DIN 0847*

A/E	124300139	Date/Time	9/6/2018 6:00 PM	Report #	7434
------------	-----------	------------------	------------------	-----------------	------

A/E	124300139	Date/Time	9/6/2018 6:00 PM	Report #	7434
Pictures

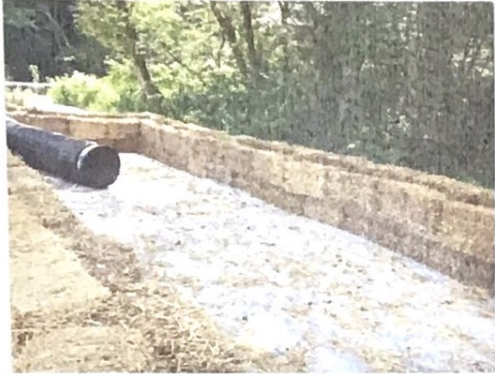
GPS Location	37.0065463534807, -79.7402803592413		GPS Location	37.0065463534807, -79.7402803592413	
Description	Above ground sediment trap for stormwater runoff sta 13887+50		Description	Maintenance has been performed sta 13708+00

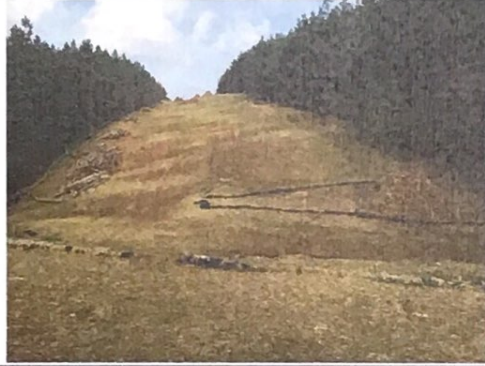
GPS Location	37.0065463534807, -79.7402803592413		GPS Location	37.0065463534807, -79.7402803592413	
Description	Maintenance has been performed sta 13860+00		Description	Row is stabilized and vegetation growing sta. 14970+00
