Visual Site Inspection Report

Report #'s 2611 + 2643

Project Name	H-600 Pipeline Spread I	AFE	124300139	Spread	H-600 Pipeline Spread I
Contractor	Precision	Report #	2611		
Inspector	Casey McGaha	Date/Time	6/4/2018 8:17 AM		
Permit #	TBD	Inspection Type	VA SWPP	Station Begin	13670+00
State	VA	Inspection Area	Full	Station End	14009+00
County	Franklin	Ground	Dry	Temperature (°F)	82.00
Municipality	N/A	Weather	Sunny	Rain Gauge (in)	0.00
GPS Location	37.0710886130455, -79.9372524955123			Rain Accumulation Time (days)	0.00

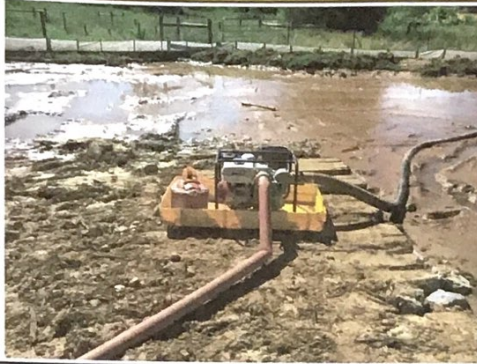
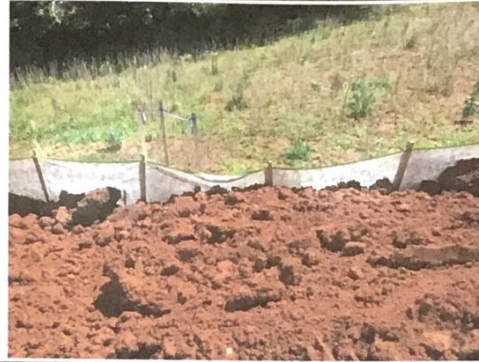
Description Pump in containment at sta. 13695+21.	Description Maintenance required at sta. 13769+91
--	--

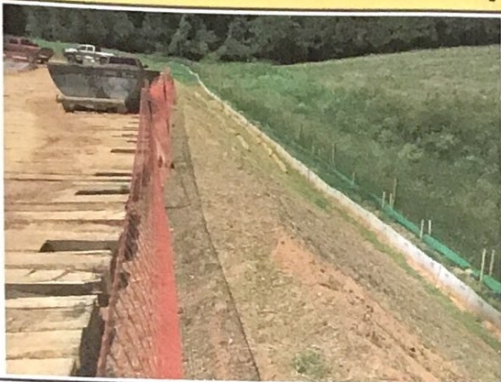
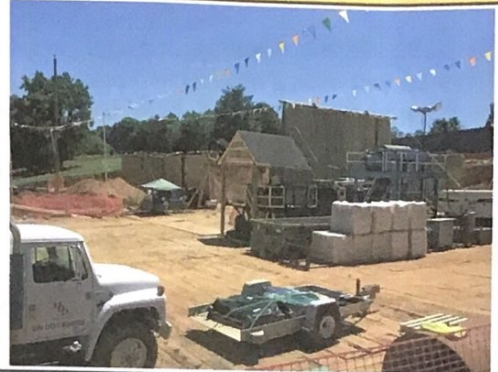
GPS Location 36.8772973150618, -79.5914378043994	GPS Location 36.9318687636749, -79.5304874517764
Description BMPs in proper working conditions at Pigg River HDD site	Description Additional sound barriers were constructed at Pigg River HDD

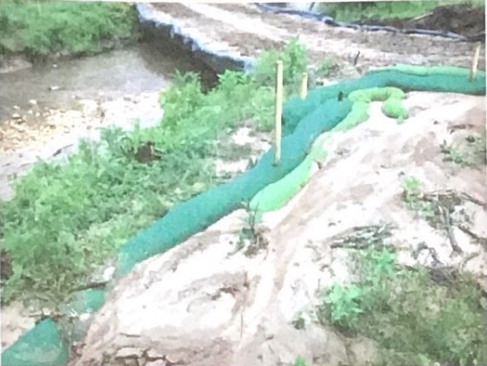
Description	Maintenance required at sta. 13705+25	Description	
--------------------	---------------------------------------	--------------------	--

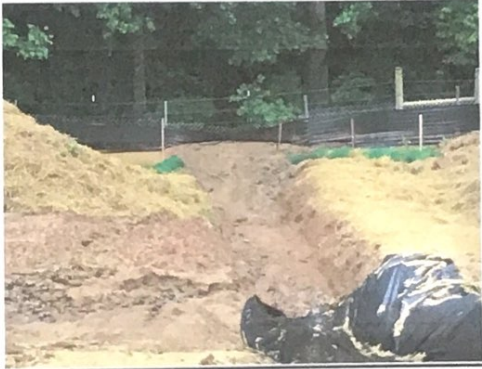
Description		Description	Maintenance required at sta. 13710+00.
--------------------	--	--------------------	--

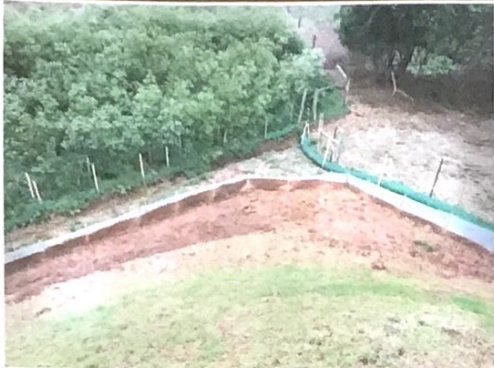
Observed HDD site. Rain event occurred Saturday and Sunday resulting in minor erosion along fill slope on east side of site. No issue to BMPs occurred due to the erosion.

GPS Location	36.9318150775851, -79.5304881223287	GPS Location	
Description	BMPs along east end of site are still in working condition.	Description

GPS Location	36.9322079373868, -79.5306771342452	GPS Location	
Description	Erosion along fill slope occurred during rain event.	Description

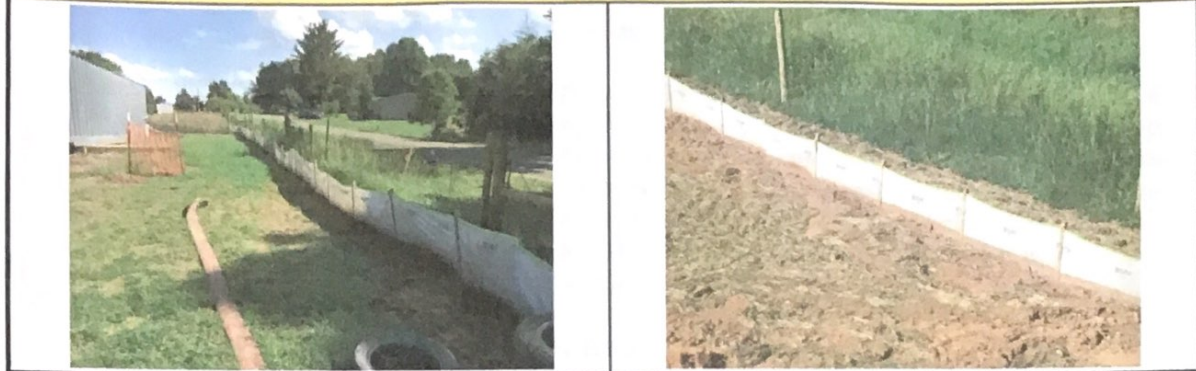
Description Silt fence along LOD.	Description Silt fence along LOD.
--	--

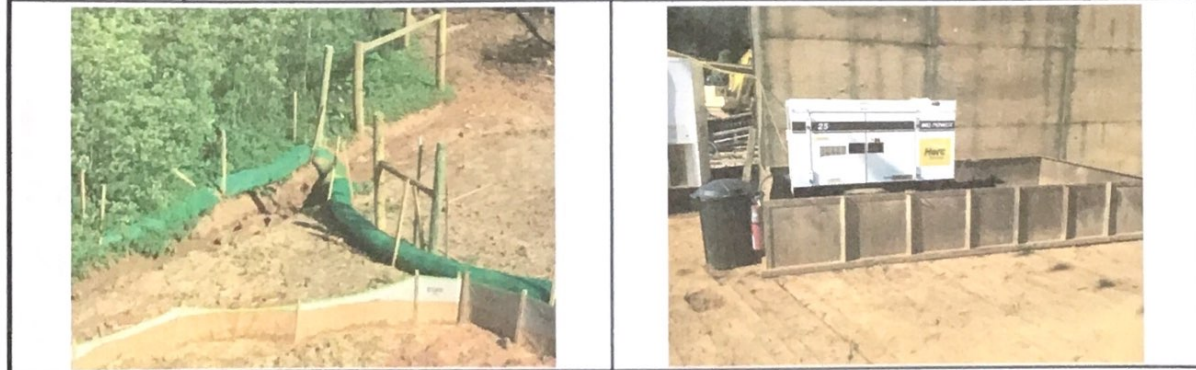
BMPs on southeast side of site needs maintenance due to heavy rainfall. Spoke with env crew about issue. Will send workers out to repair issue tomorrow.

Description Maintenance required at southeast corner of drill site.	Description Generator in containment
--	---

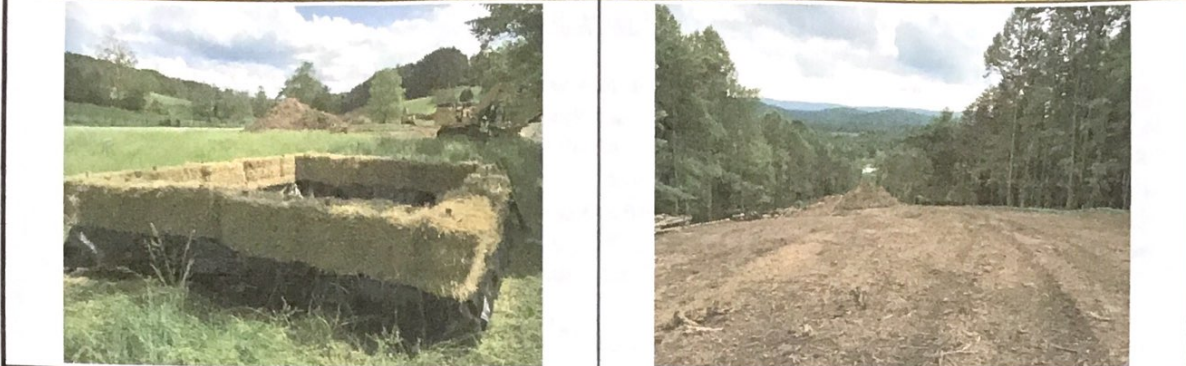
GPS Location 36.9786673626962, -79.5950292672603	GPS Location 36.9792127702729, -79.5947701112177
Description Dewatering structure near Grassy Hill Rd.	Description Grubbed ROW with ECDS installed

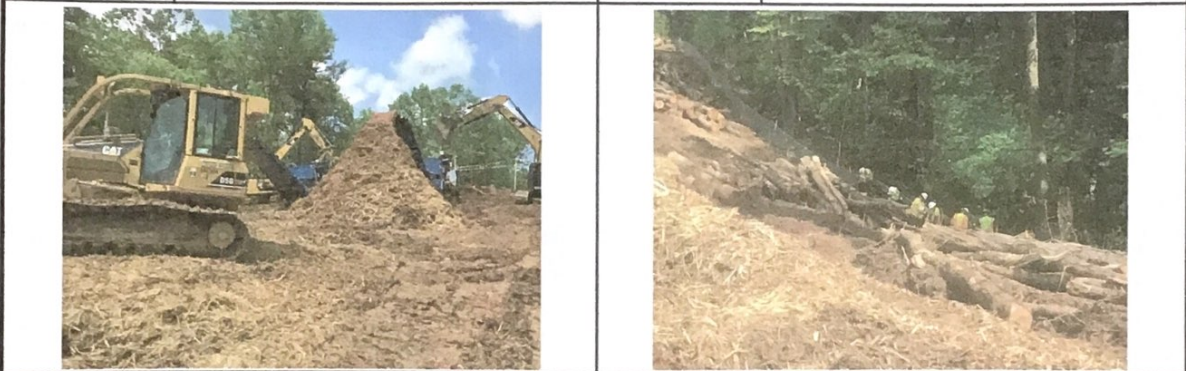
GPS Location 36.9792444957764, -79.5947791636731	GPS Location 36.9791608024733, -79.5946746413406
Description Grubbing & grinding operations	Description Environment crews installing SSF
