Report # 5026

Visual Site Inspection Report

| Project Name | H-600 Pipeline Spread I | AFE | 124300139 | Spread | H-600 Pipeline Spread I |
| Inspector | Casey McGaha | Date/Time | 7/24/2018 8:03 PM | | |

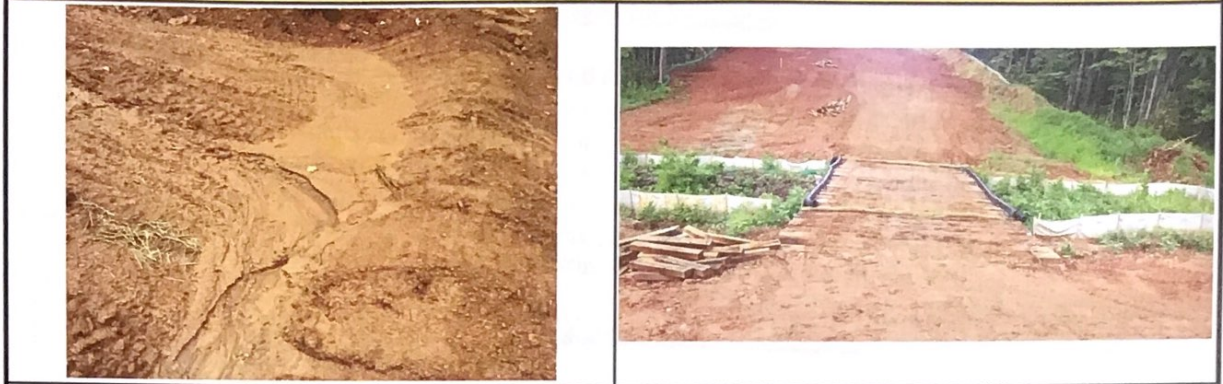
| Description | Breaker maintenance req'd sta | Description | Replace bridge wattles sta 14126+75 |

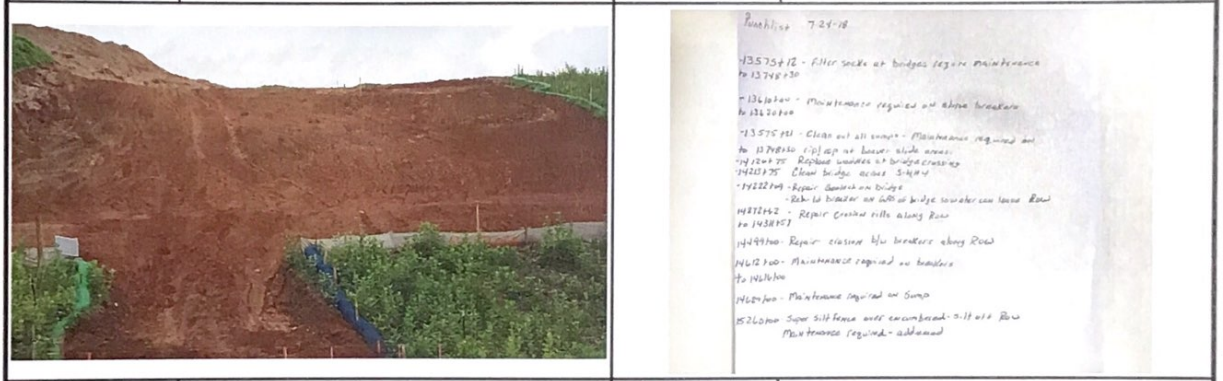
Handwritten note:
 7-24-18
 +3575+12 - Filler socks at bridge require maintenance
 to 13748+50
 +13610+00 - Maintenance required on abutment breakers
 to 13120+00
 +13575+00 - Clean out all culverts - Maintenance required on
 to 13700+00 - Rip rap on lower side needs
 +14126+75 - Replace wattles at bridge crossing
 +14121+75 - Clean bridge across bridge
 +14122+75 - Repair abutment on bridge
 - Re-tilt breaker on abutment bridge so water can leave Road
 to 1438+00
 +1449+00 - Repair erosion thru breaker along Road
 +1412+00 - Maintenance required on breakers
 to 1450+00
 +1424+00 - Maintenance required on Sump
 +1426+00 - Super Silt fence under embankment - 9-12 ft off Road
 Maintenance required - addressed

| Description | Erosion rills forming between breakers. Maintenance required sta. 14275+00 | Description | Punchlist 7-24-18 |

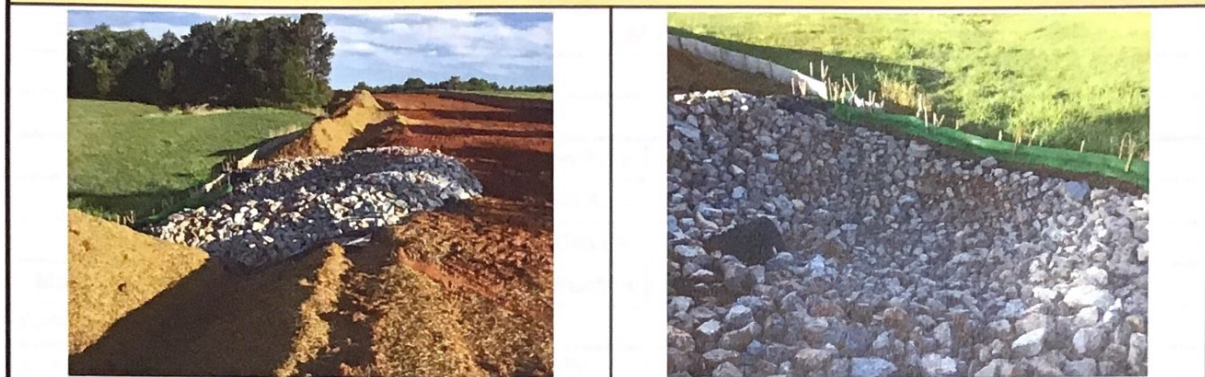
| Description | Plunge pool installed sta. 14642+00 | Description | Plunge pool installed sta. 14642+00 |

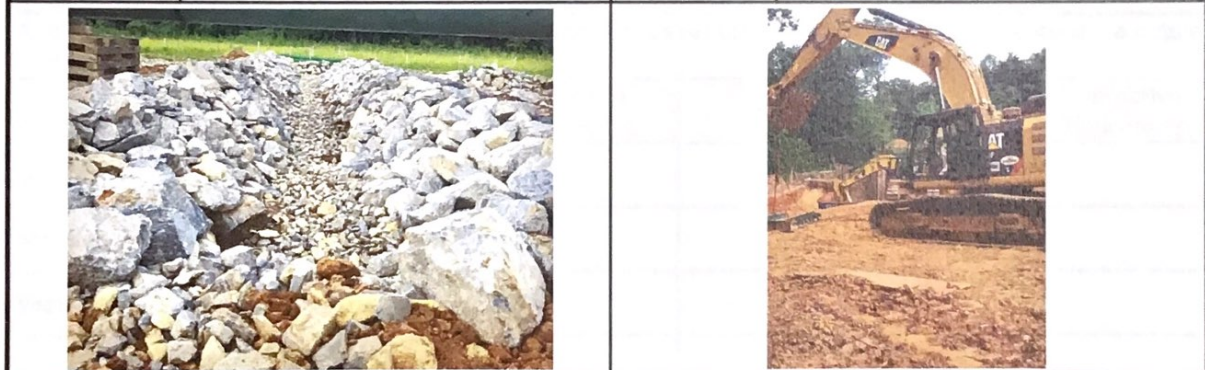
| Description | Added additional geotechnical and rip rap to clean water diversion sta 13675+00 | Description | Crew installing sheet piling along ROW as additional BMP sta. 14042+23 |

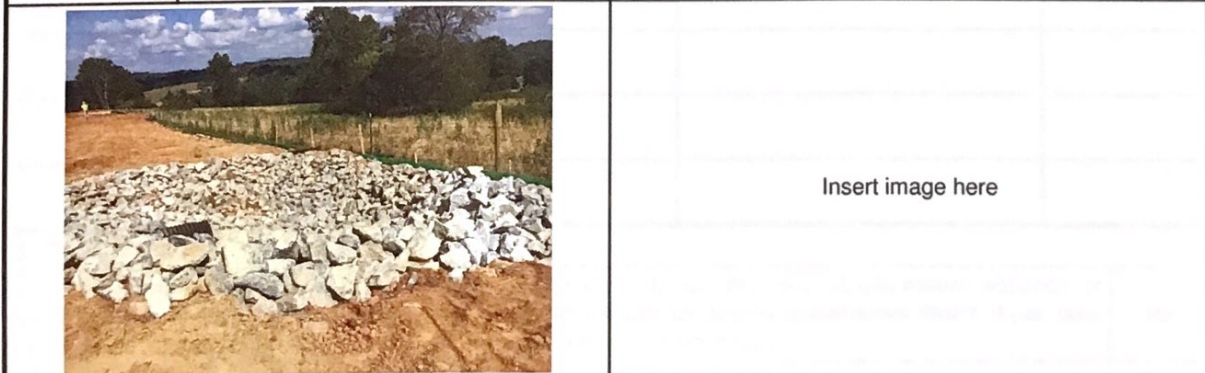
| Description | Plunge pool installed sta. 14407+00 | Description | |

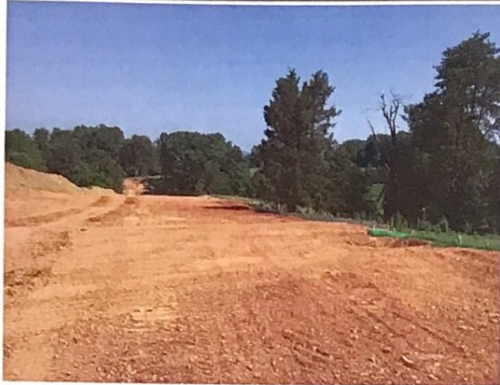
| Description | Precision installing breakers to spec sta 14302+00 | Description | Crew performing maintenance on bridge across S-F9A sta. 14294+50 |

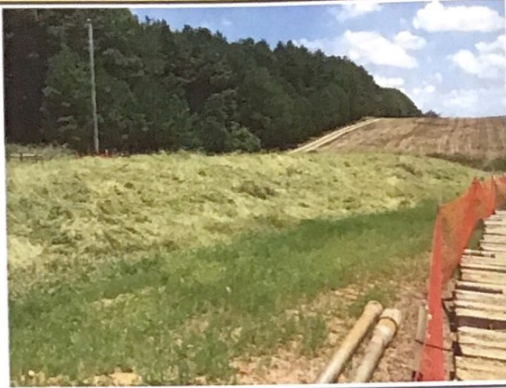
| Description | Spoil pile is well vegetated. | Description | |
