Visual Site Inspection Report

Project Name		H-600 Pipeline Spread I	AFE	124300139	Spread	H-600 Pipeline Spread I	
Contractor		Precision			Report #	4155	
Inspector		Casey McGaha			Date/Time	7/6/2018 5:01 PM	
Permit #	TBD	Inspection Type	VA SWPP		Station Begin	13670+00	
State	VA	Inspection Area	Full		Station End	14364+00	
County	Franklin	Ground	Dry		Temperature (°F)	82.00	
Municipality	N/A	Weather	Cloudy		Rain Gauge (in)	0.00	
GPS Location			36.9718242660503, -79.8700254013511		Rain Accumulation Time (days)	0.00

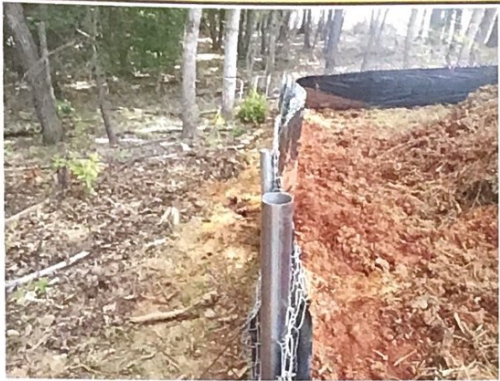
<p style="text-align: center;">Insert image here</p>		
GPS Location	36.9719000098539, -79.8701267868855		GPS Location		
Description	Sediment removed from off ROW. Super silt fence repaired at sta. 14027+00		Description		
<p style="text-align: center;">Insert image here</p>			<p style="text-align: center;">Insert image here</p>		
GPS Location			GPS Location		
Description			Description		
<p style="text-align: center;">Insert image here</p>			<p style="text-align: center;">Insert image here</p>		
GPS Location			GPS Location		
Description			Description

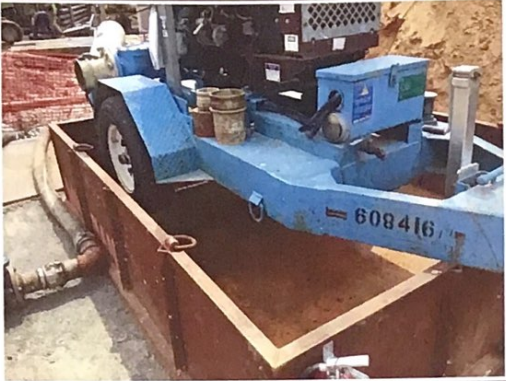
Description	Secondary containment is free of water and functional at Pigg River HDD	Description	
--------------------	---	--------------------	--

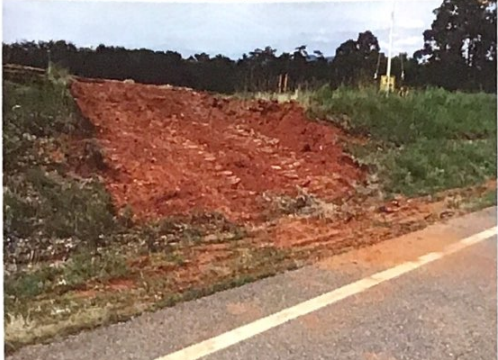
GPS Location 36.9718286112988, -79.8701858195867	GPS Location 36.9717522372921, -79.8700460243609
Description Stabilization required at RCE at Museville Rd sta 15113+00	Description Punchlist created during week. Crews are working on issues

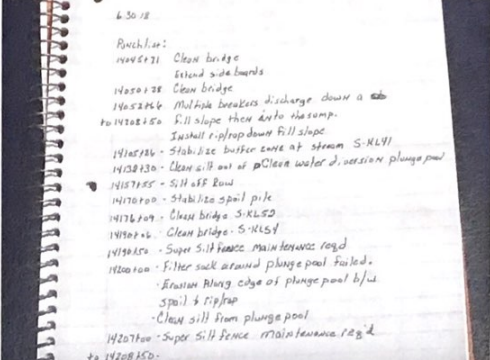
<p>6.30.18 Punchlist: 1445171 - Clean bridge 1445172 - Erosion side-banks 1445173 - Clean bridge 1445174 - Multiple beavers discharge down a emb 1445175 - Fill slope then into the comp. 1445176 - Install riprap down fill slope 1445177 - Stabilize buffer zone at stream S-KLVI 1445178 - Clean silt out of plunge pool 1445179 - Silt off road 1445180 - Stabilize spill pile 1445181 - Clean bridge S-KLSD 1445182 - Clean bridge S-KLSD 1445183 - Super Silt Fence main terrace road 1445184 - Filter sock around plunge pool failed. - Erosion along edge of plunge pool b/w - Spill & riprap - Clean silt from plunge pool 1445185 - Super Silt Fence main terrace road to 1445186</p>
---	--

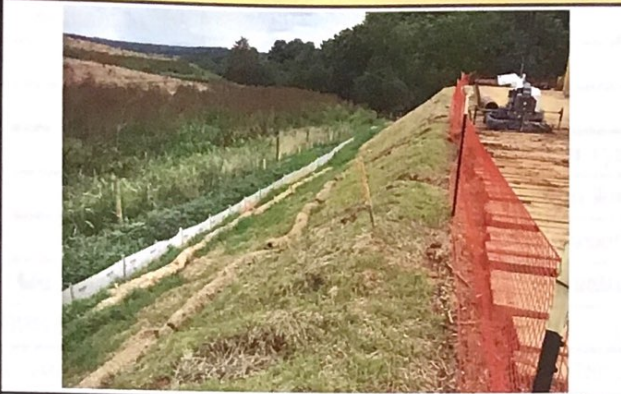
GPS Location	36.9319888344379, -79.5306572691347	GPS Location	36.9322056742729, -79.5307158586378
Description	Fill slope and BMPs are still in good condition at Pigg River HDD	Description	Good housekeeping at Pigg River HDD.

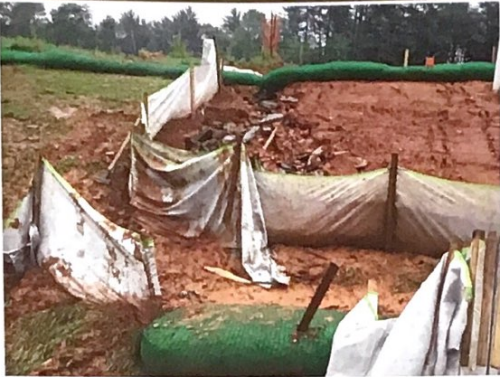
GPS Location	37.0558065176355, -79.8300855886934	GPS Location	37.055683638935, -79.8297695909439
Description	BMP failure at sta. 14019+00.	Description	Breakers are not being restored after crews complete work in sections.

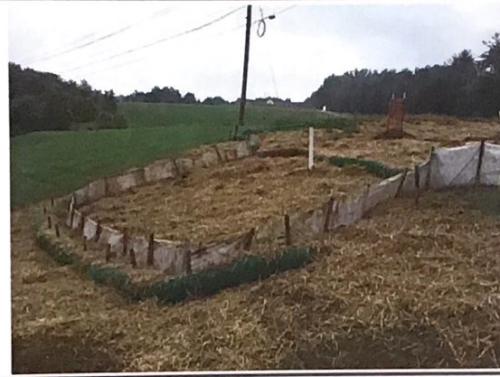
GPS Location	37.0556625584486, -79.8298936431108	GPS Location	37.0557120954963, -79.8299940583108
Description	Maintenance performed and ROW stabilized at sta 14019+00	Description	Maintenance required at sta 14075+55

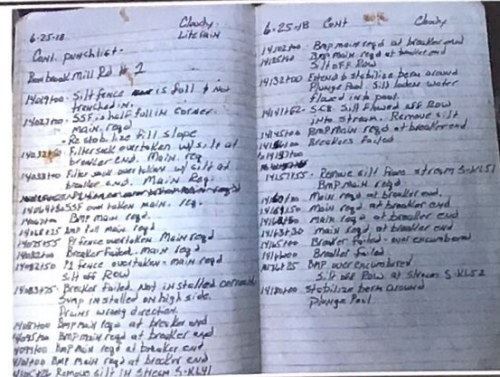
GPS Location	37.0557160349908, -79.8299762048571	GPS Location	
Description	Punchlist 6-25-18	Description
