Visual Site Inspection Report

Project Name	Transco Interconnect Station		AFE	124300113	Spread	Transco Interconnect Station	
Contractor	Kanahwa				Report #	10218	
Inspector	Dave Burkhart				Date/Time	10/31/2018 7:52 AM	
Permit #	TBD	Inspection Type	VA SWPP		Station Begin	0+00	
State	VA	Inspection Area	Full		Station End	0+00	
County	Pittsylvania	Ground	Damp		Temperature (°F)	43.00	
Municipality	Chatham	Weather	Sunny		Rain Gauge (in)	0.00	
GPS Location	36.8347861606872, -79.3421332308447				Rain Accumulation Time (days)	0.00

Project Name	H-602 Pipeline Spread I	AFE	124300139	Spread	H-602 Pipeline Spread I	
Contractor	Precision			Report #	10219	
Inspector	Dave Burkhart			Date/Time	10/31/2018 7:53 AM	
Permit #	TBD	Inspection Type	VA SWPP	Station Begin	0+00	
State	VA	Inspection Area	Full	Station End	19+00	
County	Pittsylvania	Ground	Damp	Temperature (°F)	43.00	
Municipality	Chatham	Weather	Sunny	Rain Gauge (in)	0.00	
GPS Location	36.8349152477801, -79.3422282301628			Rain Accumulation Time (days)	0.00

Project Name	H-600 Pipeline Spread I	AFE	124300139	Spread	H-600 Pipeline Spread I
Contractor	Precision			Report #	10228
Inspector	Casey McGaha			Date/Time	10/31/2018 6:00 PM
Permit #	TBD

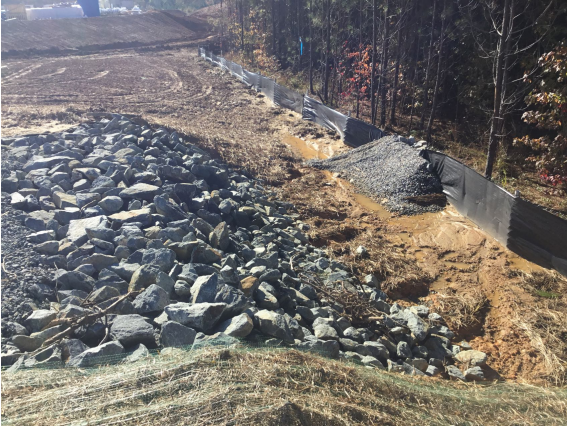
GPS Location	36.8347671395511, -79.3423803617054	GPS Location	36.8347671395511, -79.3423803617054		
Description	Sediment Trap #1, SSF and RFO	Description	Plunge pool and spreader bar for sediment basin outlet

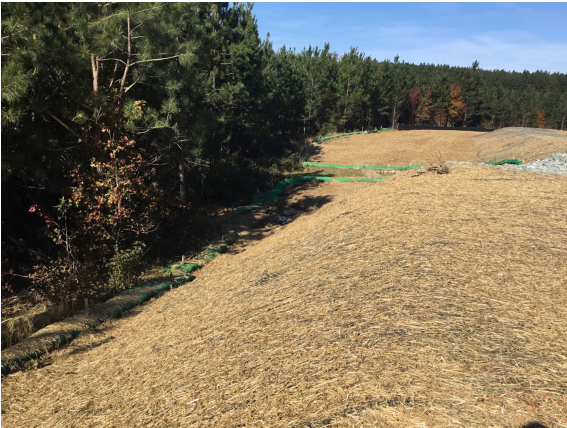
GPS Location	36.8347671395511, -79.3423803617054	GPS Location	36.8347671395511, -79.3423803617054		
Description	Temp vegetation around sediment basin	Description	Concrete washout

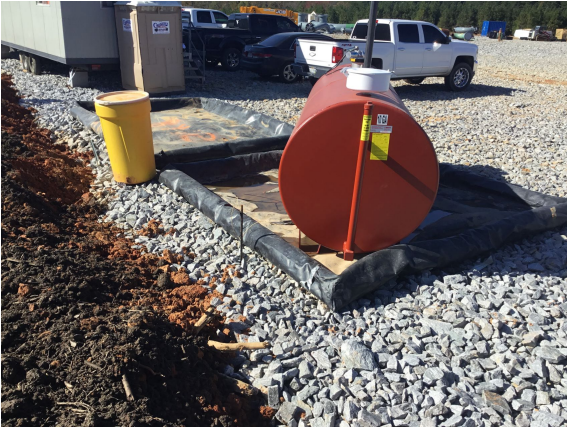
GPS Location	36.8347671395511, -79.3423803617054	GPS Location	36.8347905717594, -79.3421664171948		
Description	1000 gal diesel fuel tank	Description	SSF along west LOD
