Visual Site Inspection Report

Project Name	H-602 Pipeline Spread I	AFE	124300139	Spread	H-602 Pipeline Spread I
Contractor	Precision			Report #	10508
Inspector	Dave Burkhart			Date/Time	11/6/2018 2:05 PM
Permit #	TBD	Inspection Type	VA SWPP	Station Begin	0+00
State	VA	Inspection Area	Full	Station End	19+00
County	Pittsylvania	Ground	Wet	Temperature (°F)	66.00
Municipality	Chatham	Weather	Light Rain	Rain Gauge (in)	0.50
GPS Location	36.8347764961916, -79.3420931746413			Rain Accumulation Time (days)	1.00

Project Name	Transco Interconnect Station	AFE	124300113	Spread	Transco Interconnect Station
Contractor	Kanahwa			Report #	10509
Inspector	Dave Burkhart			Date/Time	11/6/2018 2:09 PM
Permit #	TBD	Inspection Type	VA SWPP	Station Begin	0+00
State	VA	Inspection Area	Full	Station End	0+00
County	Pittsylvania	Ground	Wet	Temperature (°F)	66.00
Municipality	Chatham	Weather	Light Rain	Rain Gauge (in)	0.50
GPS Location	36.8347862516899, -79.3421603780224			Rain Accumulation Time (days)	1.00

Project Name	H-600 Pipeline Spread I	AFE	124300139	Spread	H-600 Pipeline Spread I
Contractor	Precision			Report #	10564
Inspector	Casey McGaha			Date/Time	11/6/2018 5:00 PM
Permit #	TBD	Inspection Type

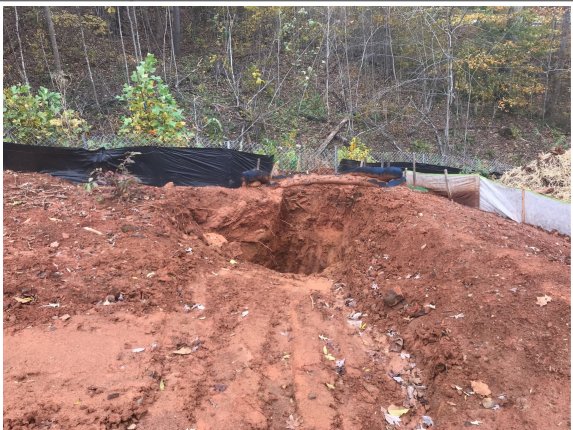
GPS Location		37.0657280087816, -79.9321782589703		GPS Location		37.0657280087816, -79.9321782589703	
Description		ECDs and signage installed at stream S-CC16 sta 15447+67		Description		Fill slope stabilized sta 14844+00

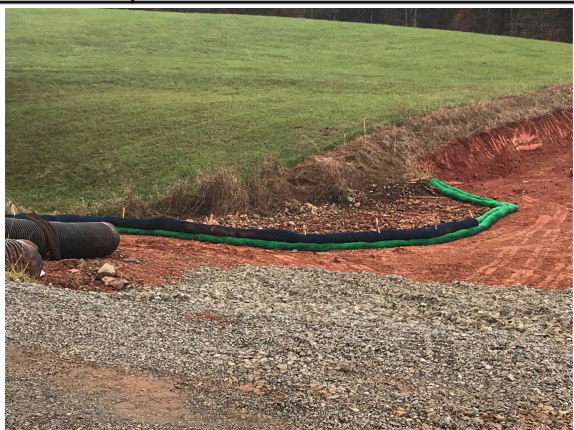
GPS Location		37.0658552041622, -79.932254115194		GPS Location		37.0657280087816, -79.9321782589703	
Description		Stabilized stormwater drainage sta 14062+50		Description		Maintenance performed along breaker and sump sta 14008+30
