Visual Site Inspection Report

Project Name	H-600 Pipeline Spread I	AFE	124300139	Spread	H-600 Pipeline Spread I
Contractor	Precision			Report #	13244
Inspector	Glenn Mike Renfro			Date/Time	1/22/2019 2:38 PM
Permit #	TBD	Inspection Type	VA SWPP	Station Begin	0000+00
State	VA	Inspection Area	Full	Station End	0000+00
County	Franklin	Ground	Frozen	Temperature (°F)	30.00
Municipality	N/A	Weather	Sunny	Rain Gauge (in)	1.00
GPS Location	36.9717985282631, -79.8699122520304			Rain Accumulation Time (days)	6.00

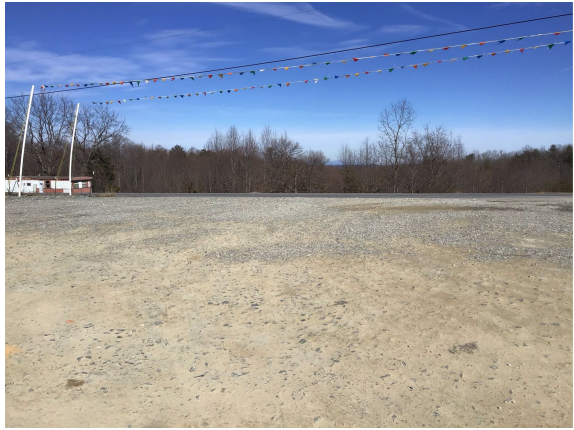
GPS Location	36.9718632242055, -79.8698371835797		GPS Location	36.9720241986559, -79.8700090964137	
Description	RCE at gravel yard in good condition.		Description	Permit postings at main entrance of paved yard

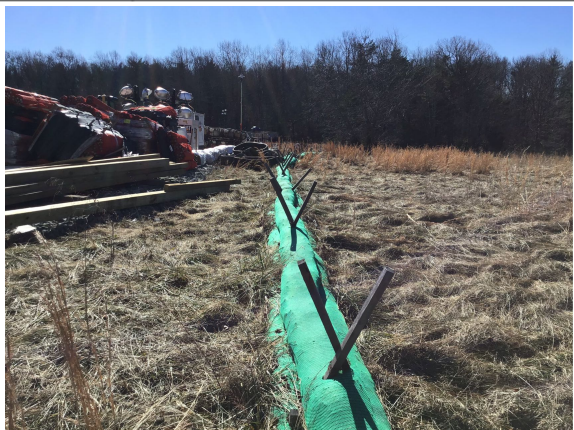
GPS Location	36.9720241986559, -79.8700090964137		GPS Location	36.9720241986559, -79.8700090964137	
Description	Perimeter ECD's on north end of gravel yard in good condition.		Description	Secondary containment structure for fuel cell in compliance.

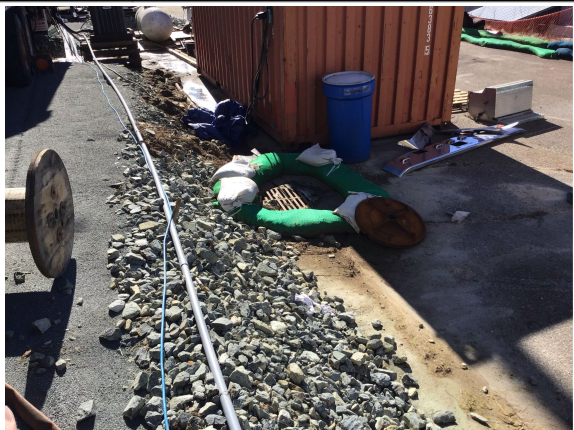
Insert image here			
GPS Location	36.9720241986559, -79.8700090964137		GPS Location		
Description	Parking lot drain inlet near equipment storage building in good condition.		Description
