Visual Site Inspection Report

Project Name	H-600 Pipeline Spread I	AFE	124300139	Spread	H-600 Pipeline Spread I
Contractor	Precision			Report #	10816
Inspector	Glenn Mike Renfro			Date/Time	11/12/2018 1:21 PM
Permit #	TBD	Inspection Type	VA SWPP	Station Begin	0000+00
State	VA	Inspection Area	Full	Station End	0000+00
County	Franklin	Ground	Damp	Temperature (°F)	45.00
Municipality	N/A	Weather	Light Rain	Rain Gauge (in)	0.50
GPS Location	36.9717743440199, -79.8700234990127			Rain Accumulation Time (days)	4.00

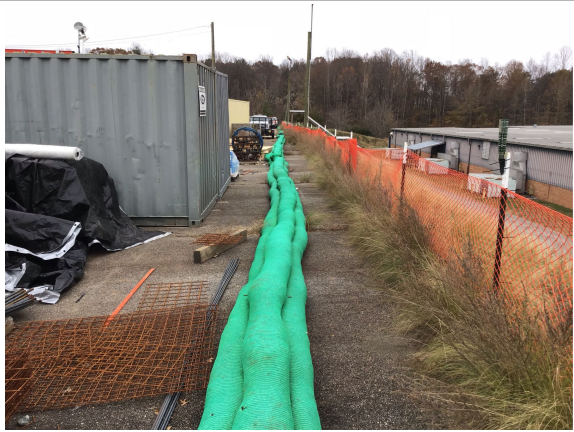
GPS Location		36.9720726460563, -79.8701383453606		GPS Location	
Description		Perimeter ECD's in good condition on west side of paved yard		Description

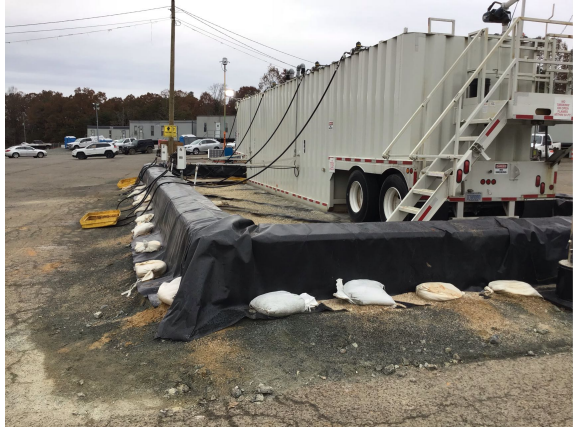
GPS Location		36.9720177865, -79.8700559512525		GPS Location	
Description		Secondary containment structure for fuel cell in good condition.		Description

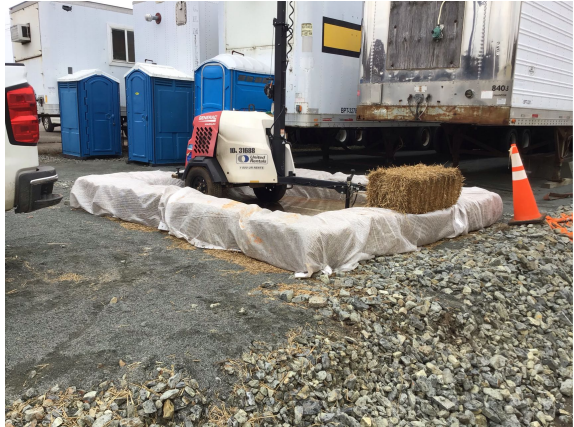
Insert image here		
GPS Location		36.9720177865, -79.8700559512525		GPS Location	
Description		Secondary containment structure for light plant near tool storage building.		Description

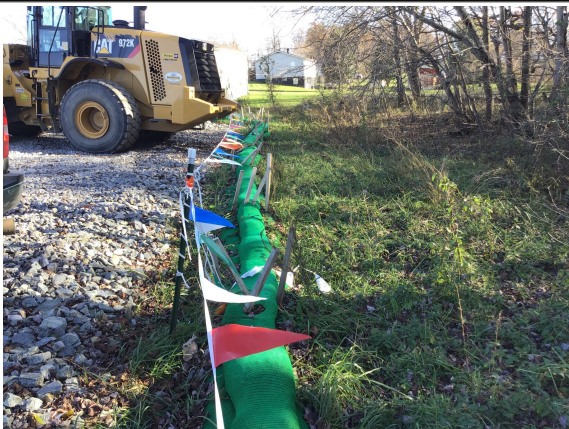
GPS Location	36.9720564270736, -79.8699372635035	GPS Location	36.9720966602089, -79.869962157756		
Description	Perimeter ECD's in good condition at west side of employee parking area.	Description	Secondary containment structure for pumps and generators in good condition

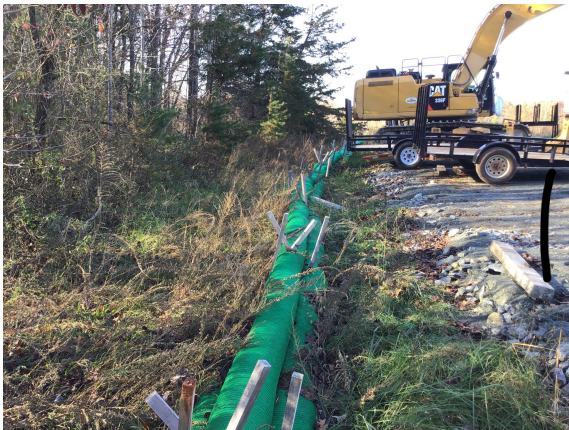
GPS Location	36.9720985042276, -79.8699640855937	GPS Location	36.9719521561982, -79.8700477369873		
Description	Perimeter ECD's in good condition near welders work area of gravel yard	Description	Drain inlet protection needs to be reinstalled at south end of paved yard		
Insert image here		Insert image here			
GPS Location		GPS Location			
Description		Description

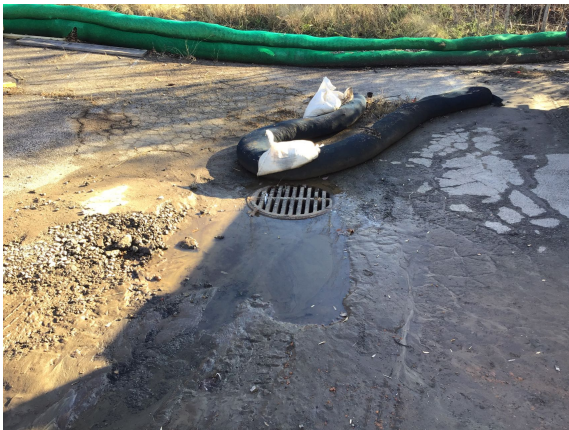
7. Identify all remedial measures that have been taken since the previous inspection was conducted.					
Comments (Reference above questions as appropriate.)					
Performed SWPPP inspection of main laydown yard in Rocky Mount, Va. All perimeter ECD's were inspected and one potential issue was observed on the west side of the gravel yard, the triple stacked CFS needs to be repaired. The inlet drain protection for the drain on the south end of paved yard needs to be reinstalled. The other two parking lot drains was in good condition. The RCE was found to be clean and the road was free of any debris. All secondary containment structures were in good condition. Any potential issues that were found during the inspection were placed on a punch list and given to the contractor to be addressed.					
Note: It is a condition of National Pollutant Discharge Elimination System and Erosion and Sediment permits that a maintenance program be conducted to provide for the operation and maintenance of all BMPs to be inspected on a weekly basis and after each stormwater event. Please list in the space provided comments to note if repairs or replacement are needed or have been made for BMPs as a result of the inspection. Failure to conduct the required inspection may result in permit suspension or the imposition of civil penalties. If supplemental monitoring is required as part of a permit condition this form may be used to meet those monitoring requirements.

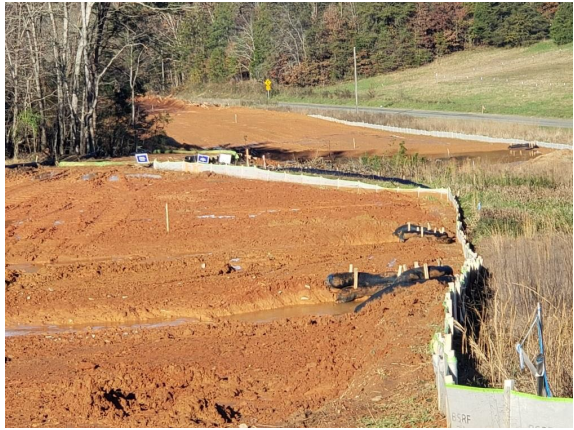
GPS Location		37.0260443073111, -79.590833047479		GPS Location		37.0260443073111, -79.590833047479	
Description		ECDs functioning properly sta 15615+00		Description		Stabilized spoil piles sta 15738+00

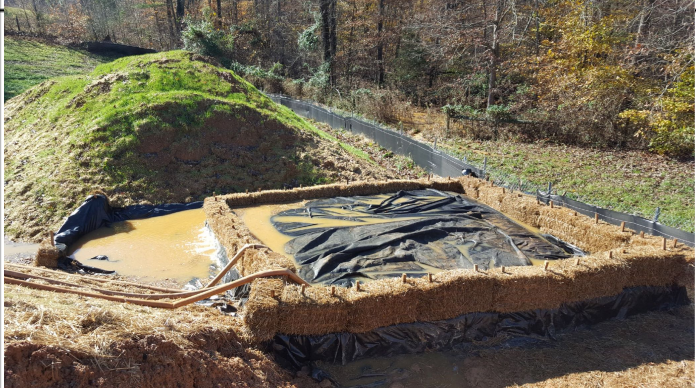
GPS Location		37.0260388171645, -79.5908457879718		GPS Location		37.0260388171645, -79.5908457879718	
Description		Trench dewatering sta 14935+00		Description		Maintenance required along breaker sta 14083+50

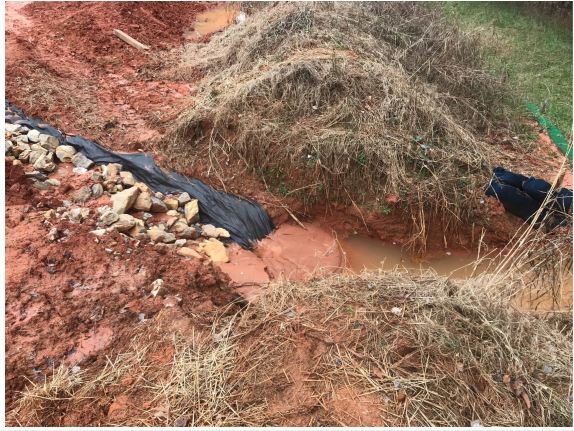
GPS Location		37.0260226820009, -79.5908344724025		GPS Location		37.0260226820009, -79.5908344724025	
Description		Maintenance required on sump sta 14092+00		Description		CWD and plunge pool sta 14071+75

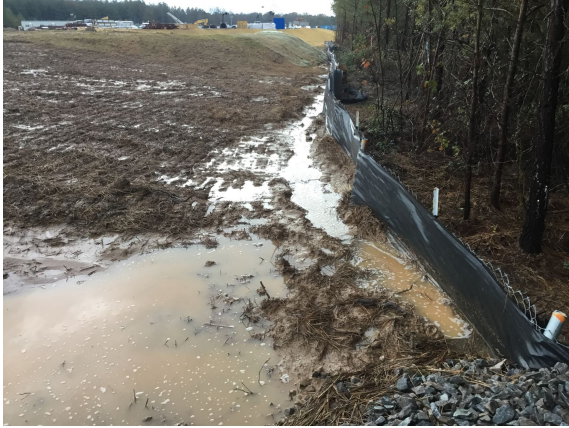
GPS Location	36.8348442530603, -79.3422304094577	GPS Location	36.8348102644429, -79.3422302418196		
Description	SSF along west LOD	Description	18 inch CFS along west LOD

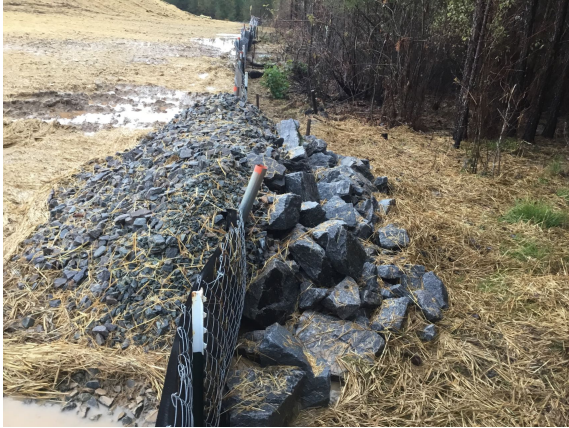
GPS Location	36.8348250165925, -79.3422527053201	GPS Location	36.8348099291668, -79.3422235362971		
Description	Rock filter outlet	Description	Containment for diesel fuel tank and spill kit

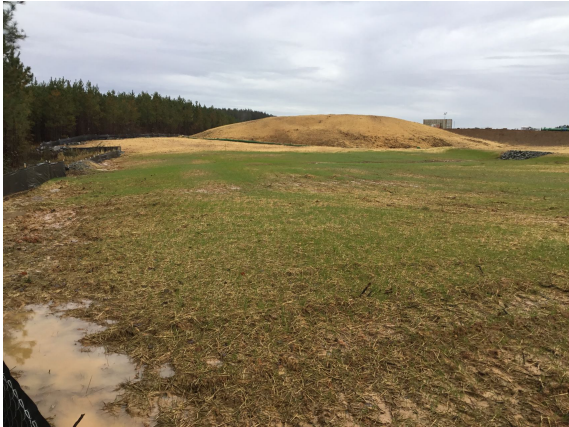
GPS Location	36.8347875958118, -79.3421688249144	GPS Location	36.8347774912015, -79.3421857339138		
Description	Temp vegetation	Description	Full sediment basin.... 3 feet of water.
