Visual Site Inspection Report

Project Name	H-600 Pipeline Spread I	AFE	124300139	Spread	H-600 Pipeline Spread I
Contractor	Precision			Report #	11457
Inspector	Glenn Mike Renfro			Date/Time	11/28/2018 2:34 PM
Permit #	TBD	Inspection Type	VA SWPP	Station Begin	13670+00
State	VA	Inspection Area	Full	Station End	16025+00
County	Franklin	Ground	Damp	Temperature (°F)	37.00
Municipality	N/A	Weather	Cloudy	Rain Gauge (in)	1.20
GPS Location	36.9718751179293, -79.8700835399272			Rain Accumulation Time (days)	4.00

Project Name	H-600 Pipeline Spread I	AFE	124300139	Spread	H-600 Pipeline Spread I
Contractor	Precision			Report #	11458
Inspector	Glenn Mike Renfro			Date/Time	11/28/2018 3:07 PM
Permit #	TBD	Inspection Type	VA SWPP	Station Begin	0000+00
State	VA	Inspection Area	Full	Station End	0000+00
County	Franklin	Ground	Dry	Temperature (°F)	37.00
Municipality	N/A	Weather	Sunny	Rain Gauge (in)	1.20
GPS Location	36.9720518170269, -79.8700178974121			Rain Accumulation Time (days)	4.00

Project Name	Transco Interconnect Station		AFE	124300113	Spread	Transco Interconnect Station	
Contractor	MEC				Report #	11364	
Inspector	Dave Burkhart				Date/Time	11/26/2018 12:24 PM	
Permit #	TBD	Inspection T

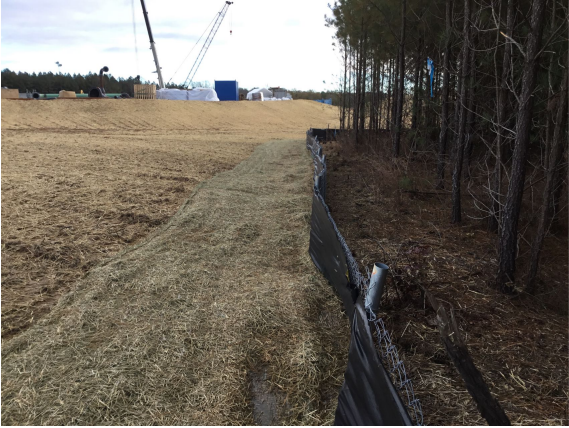
GPS Location	36.8347888474217, -79.3421504293075	GPS Location	36.8347888065551, -79.3421502967563		
Description	Temp stabilization and SSF along west LOD	Description	Rip rap outlet and matting in for CC#3

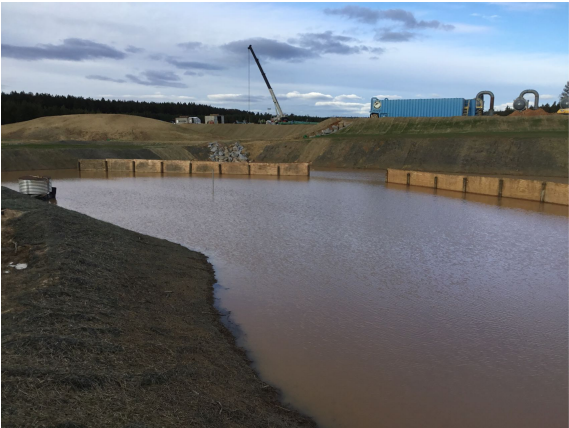
GPS Location	36.8348936643795, -79.3422103767091	GPS Location	36.8348936643795, -79.3422103767091		
Description	Sediment basin water level	Description	Unfinished Concrete washout... no concrete expected till Thursday.

4. E&S BMPs (List BMPs and note if installed and maintained as per the plan. If corrective action is needed, a picture is required.)							
E&S BMPs		Compliance Level	Corrective Action		Corrective Time Frame	Date Repaired	
Compost Filter Sock		Acceptable					
Concrete Washout		Communication	Needs dewatering and rebuilt before				
Erosion Control Blanket		Acceptable					
Rock Construction Entrance		Acceptable					
Rock Filter Outlet		Acceptable					
Vegetative Stabilization (Temporary)		Acceptable					
Temporary Diversion Berm		Acceptable					
Silt Fence (Reinforced Filter Fabric Fence)		Acceptable					
Culvert		Acceptable

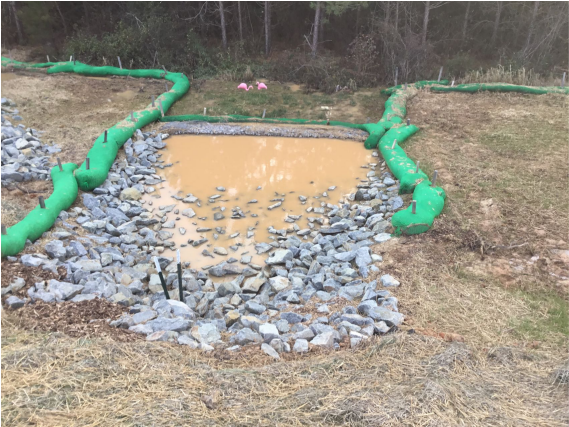
GPS Location	36.8348936643795, -79.3422103767091	GPS Location	36.8348936643795, -79.3422103767091		
Description	Outlet and sump for sediment basin	Description	Installed straw matting on slope of temp pad
