Visual Site Inspection Report

Project Name	H-600 Pipeline Spread I	AFE	124300139	Spread	H-600 Pipeline Spread I	
Contractor	Precision			Report #	11976	
Inspector	Glenn Mike Renfro			Date/Time	12/10/2018 2:10 PM	
Permit #	TBD	Inspection Type	VA SWPP	Station Begin	0000+00	
State	VA	Inspection Area	Full	Station End	0000+00	
County	Franklin	Ground	Wet	Temperature (°F)	45.00	
Municipality	N/A	Weather	Sunny	Rain Gauge (in)	0.40	
GPS Location	36.9719324976009, -79.8701723076945			Rain Accumulation Time (days)	6.00

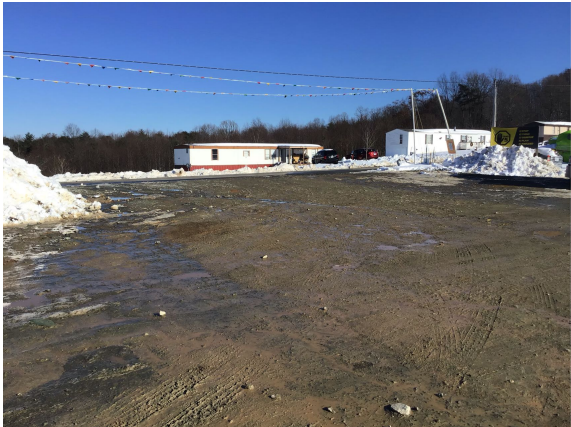
GPS Location	36.9719339876949, -79.8701929680704	GPS Location	36.9719210174279, -79.870176315382		
Description	RCE at gravel yard in good condition.	Description	Perimeter ECD's on north end of gravel yard covered in snow

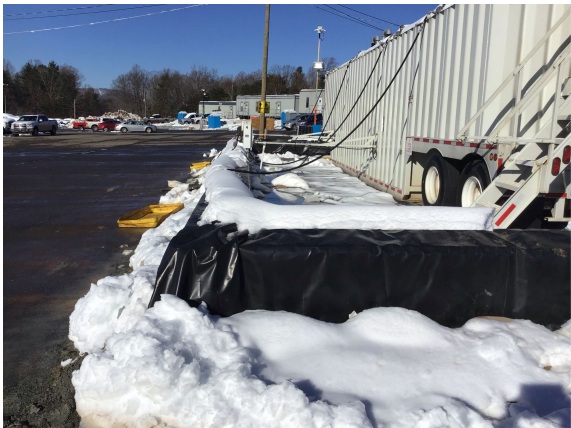
GPS Location	36.9719210174279, -79.870176315382	GPS Location	36.9719210174279, -79.870176315382		
Description	Secondary containment structure for fuel cell in good condition.	Description	Inlet for parking lot drain with CFS protection flowing free.		
Insert image here		Insert image here			
GPS Location		GPS Location			
Description		Description

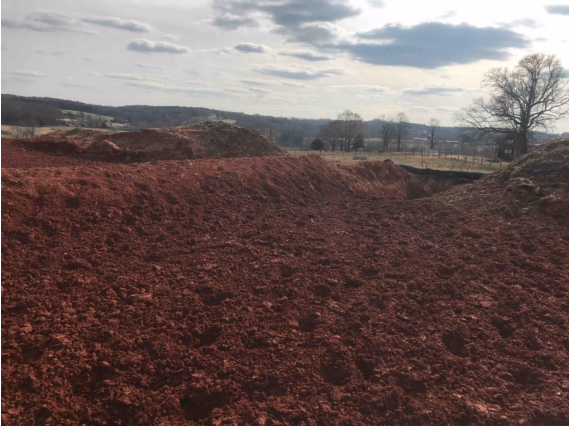
GPS Location	37.0260125818076, -79.5907737874236	GPS Location	37.02604527123, -79.590901611447		
Description	Rough in process completed sta 14375+00	Description	Applying hydromulch on steep slope sta 14132+00

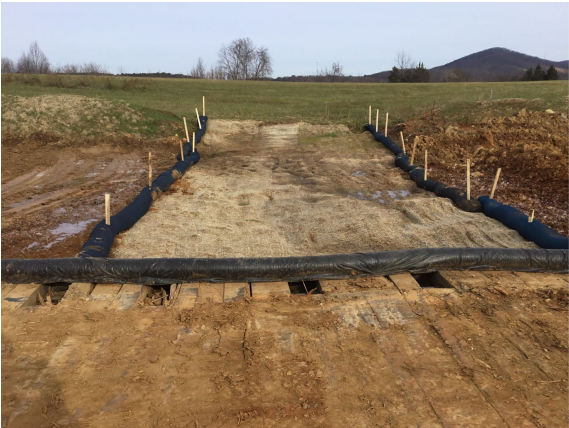
GPS Location	37.0259599015462, -79.5908533316847	GPS Location	37.0260524747187, -79.5907938230503		
Description	Stabilized CWD sta 15013+00	Description	Snow covered ROW GAS of Lark Rd sta 15328+50

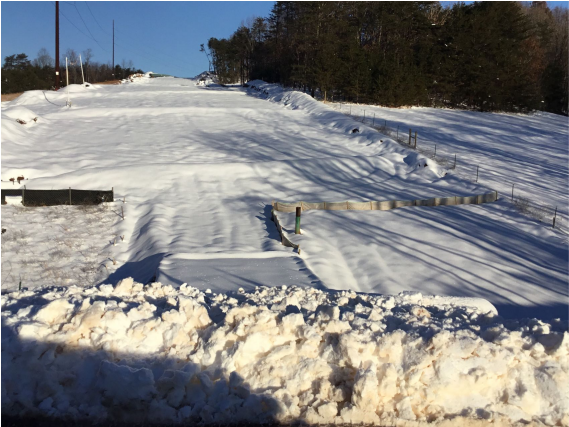
GPS Location	37.0258056745278, -79.590671695843	GPS Location	37.0259609911936, -79.5906861965354		
Description	Snow covered ROW at stream crossing S-G17 sta 14546+33	Description	Snow covered ROW on GAS of Grassy Hill Rd sta 13691+50

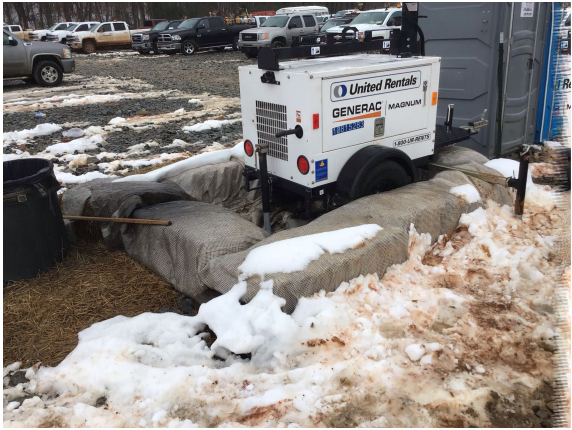
GPS Location		36.9718110979918, -79.8700117143914		GPS Location		36.9718173811139, -79.8700404071811	
Description		Secondary containment structure in good condition at employee parking area.		Description		Permit postings at main entrance of paved yard.

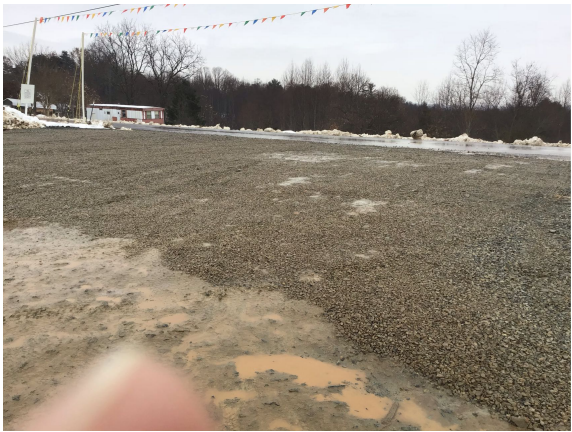
GPS Location		36.9718274753885, -79.8701448832451		GPS Location		36.9718274753885, -79.8701448832451	
Description		RCE is clean and the road free of any debris.		Description		Perimeter ECD's on west side of paved yard in good condition.

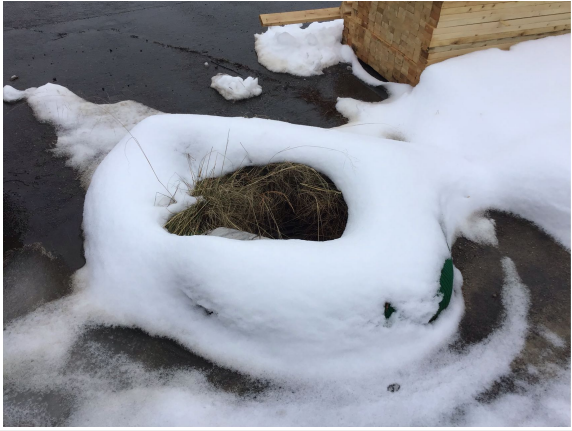
Insert image here				
GPS Location		36.9718274753885, -79.8701448832451		GPS Location			
Description		Parking lots drain inlet protection on north end of paved yard in compliance.		Description
