Visual Site Inspection Report

Project Name	H-600 Pipeline Spread I	AFE	124300139	Spread	H-600 Pipeline Spread I
Contractor	Precision			Report #	12374
Inspector	Glenn Mike Renfro			Date/Time	12/20/2018 11:37 AM
Permit #	TBD	Inspection Type	VA SWPP	Station Begin	0000+00
State	VA	Inspection Area	Full	Station End	0000+00
County	Franklin	Ground	Wet	Temperature (°F)	43.00
Municipality	N/A	Weather	Light Rain	Rain Gauge (in)	0.25
GPS Location	36.9718880064448, -79.8701422357433			Rain Accumulation Time (days)	4.00

Project Name	H-600 Pipeline Spread I	AFE	124300139	Spread	H-600 Pipeline Spread I
Contractor	Precision			Report #	12363
Inspector	Casey McGaha			Date/Time	12/20/2018 5:00 PM
Permit #	TBD	Inspection Type	VA SWPP	Station Begin	13670+00
State	VA	Inspection Area	Full	Station End	16027+46
County	Franklin/Pittsylvania	Ground	Wet	Temperature (°F)	52.00
Municipality	Chatham	Weather	Sunny	Rain Gauge (in)	0.00
GPS Location	36.9719074071444, -79.870081382516			Rain Accumulation Time (days)	0.00

Project Name	Transco Interconnect Station	AFE	124300113	Spread	Transco Interconnect Station
Contractor	MEC			Report #	12329
Inspector	Dave Burkhart			Date/Time	12/19/2018 10:35 AM
Permit #	TBD	Ins

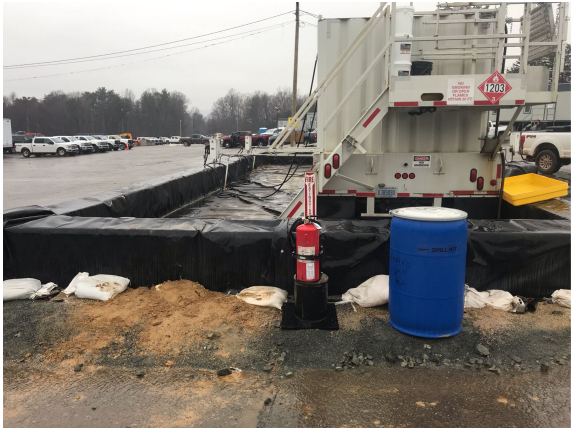
GPS Location		36.9718328817161, -79.8699990381299		GPS Location		36.972000645508, -79.8700646684318	
Description		Inlet protection for parking lot drain near equipment storage building in acceptable condition.		Description		Secondary containment structure for fuel cell in compliance

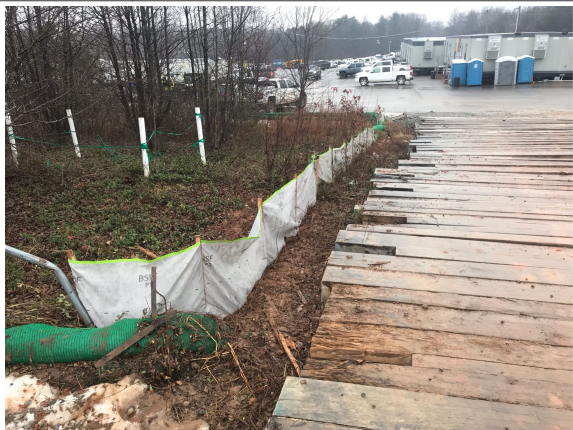
GPS Location		36.9718151959004, -79.869957044795		GPS Location		36.9718595720938, -79.8700751872126	
Description		P1 silt fence and mat timbers in good condition		Description		RCE in good condition at gravel yard.

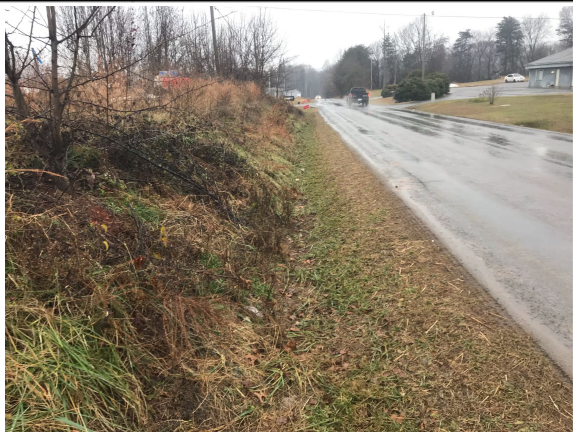
Insert image here				
GPS Location		36.9719187124045, -79.8699976970254		GPS Location			
Description		Roadside ditch along Triple Creek clean of debris.		Description

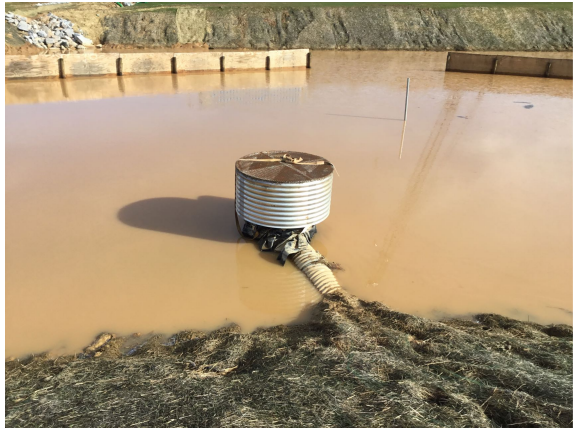
GPS Location		36.834772686651, -79.3421049550071		GPS Location		36.8347871608865, -79.3421484293121	
Description		Corrected placement of riser for SB-1		Description		Outflow of SB-1

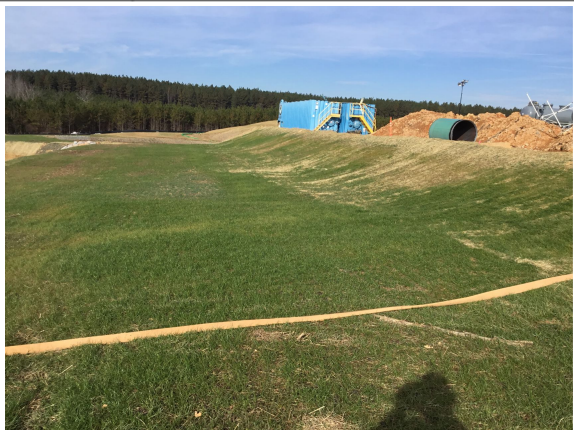
GPS Location		36.8348567840055, -79.3423695490503		GPS Location		36.8348567840055, -79.3423695490503	
Description		Temp vegetation and erosion matting on pad slopes		Description		Channel J from off pad

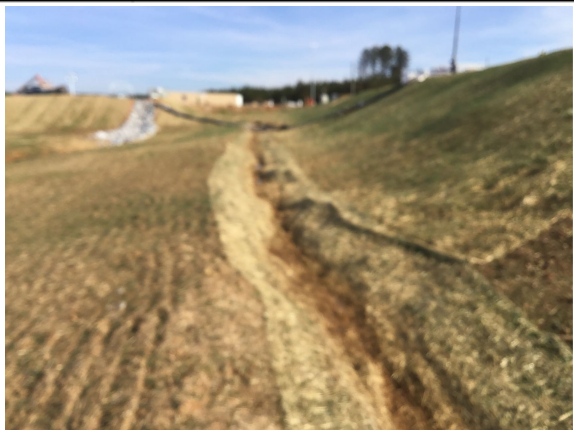
GPS Location		36.8347768818042, -79.3421184142197		GPS Location		36.8347771419575, -79.3421184456524	
Description		Temp channel and diversion berm for SB1		Description		ST-2
