# Visual Site Inspection Report

<b>Project Name</b>	H-600 Pipeline Spread I	<b>AFE</b>	124300139	<b>Spread</b>	H-600 Pipeline Spread I
<b>Contractor</b>	Precision			<b>Report #</b>	12503
<b>Inspector</b>	Glenn Mike Renfro			<b>Date/Time</b>	12/27/2018 12:00 PM
<b>Permit #</b>	TBD	<b>Inspection Type</b>	VA SWPP	<b>Station Begin</b>	13670+00
<b>State</b>	VA	<b>Inspection Area</b>	Full	<b>Station End</b>	16025+00
<b>County</b>	Franklin	<b>Ground</b>	Damp	<b>Temperature (°F)</b>	41.00
<b>Municipality</b>	N/A	<b>Weather</b>	Cloudy	<b>Rain Gauge (in)</b>	2.50
<b>GPS Location</b>	36.9718309800669, -79.8700996617639			<b>Rain Accumulation Time (days)</b>	6.00

<b>Project Name</b>	Transco Interconnect Station		<b>AFE</b>	124300113	<b>Spread</b>	Transco Interconnect Station	
<b>Contractor</b>	MEC				<b>Report #</b>	12505	
<b>Inspector</b>	Dave Burkhart				<b>Date/Time</b>	12/27/2018 1:22 PM	
<b>Permit #</b>	TBD	<b>Inspection Type</b>	VA SWPP		<b>Station Begin</b>	0+00	
<b>State</b>	VA	<b>Inspection Area</b>	Full		<b>Station End</b>	0+00	
<b>County</b>	Pittsylvania	<b>Ground</b>	Dry		<b>Temperature (°F)</b>	45.00	
<b>Municipality</b>	Chatham	<b>Weather</b>	Cloudy		<b>Rain Gauge (in)</b>	0.00

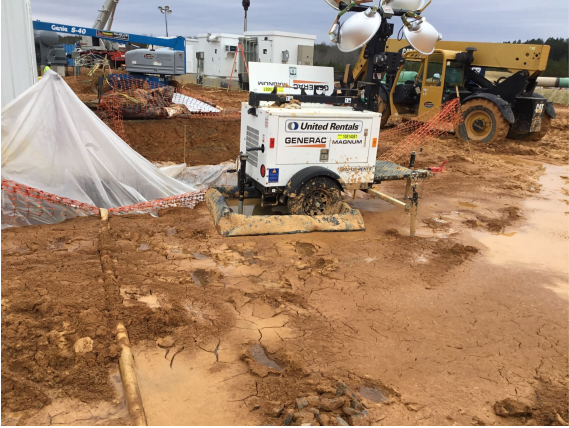
<b>GPS Location</b>	36.8347875570186, -79.3421119036092
<b>Description</b>		<b>Description</b>		<b>GPS Location</b>	36.8348865397618, -79.3422860652947
Containment		Sediment Basin #1

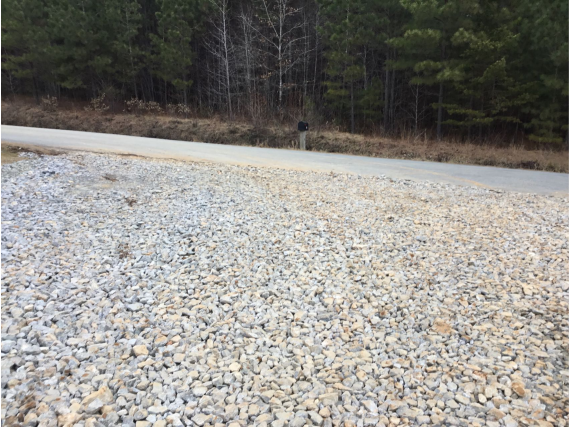
<b>GPS Location</b>	36.8349043932155, -79.342270810231
<b>Description</b>		<b>Description</b>		<b>GPS Location</b>	36.8349043932155, -79.342270810231
Channel A1 along site access road		RCE at Transco Rd			
 		 		<b>GPS Location</b>	36.8347804049816, -79.3421141771268
<b>Description</b>		<b>Description</b>		<b>GPS Location</b>	36.8347802269264, -79.3421133258736
Pump bag for dewatering		18 inch CFS and SSF along west perimeter LOD
