Visual Site Inspection Report

Project Name	H-600 Pipeline Spread I	AFE	124300139	Spread	H-600 Pipeline Spread I
Contractor	Precision			Report #	11726
Inspector	Glenn Mike Renfro			Date/Time	12/4/2018 2:20 PM
Permit #	TBD	Inspection Type	VA SWPP	Station Begin	0000+00
State	VA	Inspection Area	Full	Station End	0000+00
County	Franklin	Ground	Dry	Temperature (°F)	43.00
Municipality	N/A	Weather	Cloudy	Rain Gauge (in)	0.40
GPS Location	36.97017219233, -79.868527508089			Rain Accumulation Time (days)	6.00

Project Name	Transco Interconnect Station		AFE	124300113	Spread	Transco Interconnect Station	
Contractor	MEC				Report #	11667	
Inspector	Dave Burkhart				Date/Time	12/3/2018 9:54 AM	
Permit #	TBD	Inspection Type	VA SWPP		Station Begin	0+00	
State	VA	Inspection Area	Full		Station End	0+00	
County	Pittsylvania	Ground	Damp		Temperature (°F)	54.00	
Municipality	Chatham	Weather	Cloudy		Rain Gauge (in)	0.00	
GPS Location	36.8347876728643, -79.342152113826				Rain Accumulation Time (days)	1.00

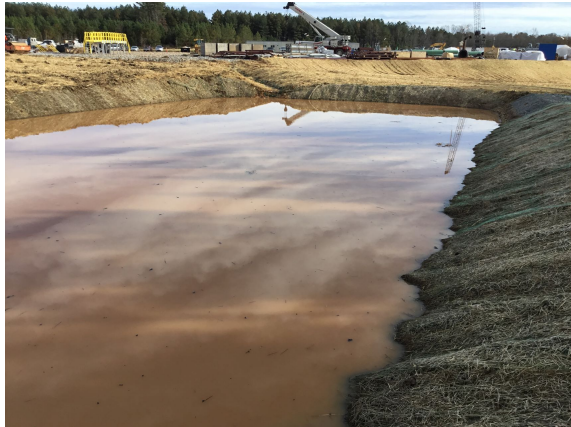
GPS Location	36.8339532148436, -79.3444251269841		GPS Location	36.8316128617496, -79.3440546468639	
Description	ST1		Description	SB1

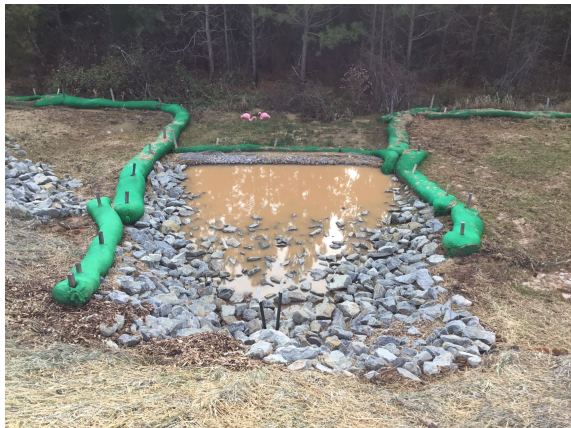
GPS Location	36.8315441301435, -79.3440084625774		GPS Location	36.831489815411, -79.3439147529	
Description	Plunge pool and 18 inch CFS on west side of SB1		Description	CWO

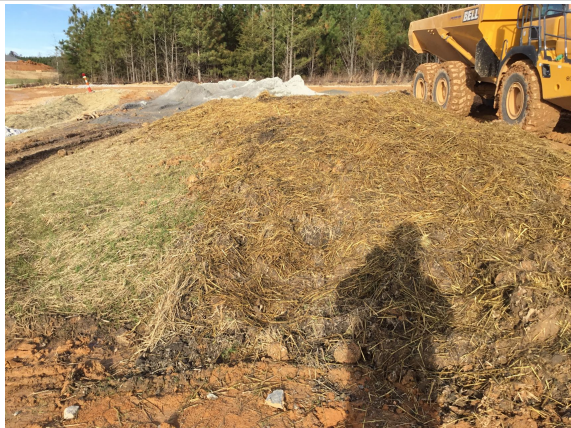
GPS Location	36.8325961009011, -79.3425069284433		GPS Location	36.8356275838212, -79.3402885739499	
Description	Temp vegetation of top soil		Description	MEC sweeping Transco Road
