Visual Site Inspection Report

Project Name	H-600 Pipeline Spread I	AFE	124300139	Spread	H-600 Pipeline Spread I
Contractor	Precision			Report #	13765
Inspector	Glenn Mike Renfro			Date/Time	2/7/2019 2:46 PM
Permit #	TBD	Inspection Type	VA SWPP	Station Begin	0000+00
State	VA	Inspection Area	Full	Station End	0000+00
County	Franklin	Ground	Wet	Temperature (°F)	71.00
Municipality	N/A	Weather	Cloudy	Rain Gauge (in)	6.00
GPS Location	36.9718085156148, -79.8700615682877			Rain Accumulation Time (days)	0.20

Project Name	H-600 Pipeline Spread I	AFE	124300139	Spread	H-600 Pipeline Spread I
Contractor	Precision			Report #	13796
Inspector	Casey McGaha			Date/Time	2/7/2019 5:00 PM
Permit #	TBD	Inspection Type	VA SWPP	Station Begin	13670+00
State	VA	Inspection Area	Full	Station End	16027+46
County	Franklin/Pittsylvania	Ground	Damp	Temperature (°F)	72.00
Municipality	Chatham	Weather	Sunny	Rain Gauge (in)	0.00
GPS Location	36.9644445274369, -79.6158960276093			Rain Accumulation Time (days)	0.00

Project Name	Transco Interconnect Station		AFE	124300113	Spread	Transco Interconnect Station	
Contractor	MEC				Report #	13750	
Inspector	Dave Burkhart				Date/Time	2/7/2019 7:53 AM	
Permit #	TBD	Inspect

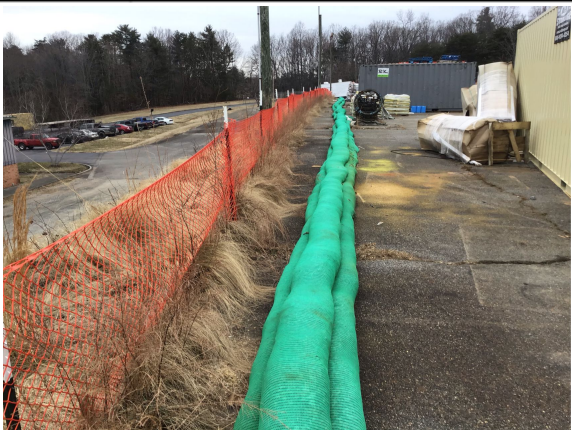
Insert image here		
GPS Location	36.9719483960276, -79.8703454487791		GPS Location		
Description	Perimeter ECD's on the west side of paved yard in good condition.		Description

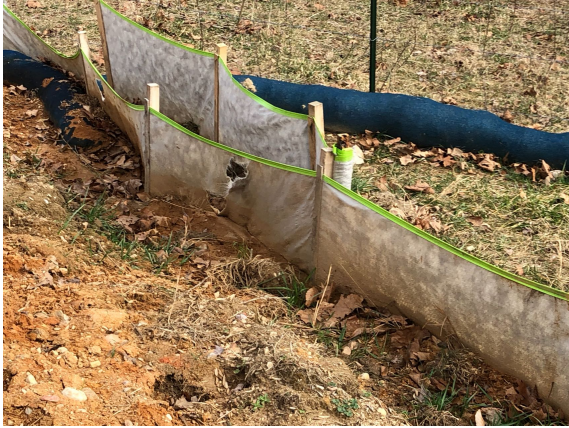
GPS Location	36.9644754985692, -79.6158666909482	GPS Location	36.9644251652406, -79.6159063373502		
Description	Replace damaged P1 fence sta 15092+00	Description	H-602 dewatering ditch sta 13+69

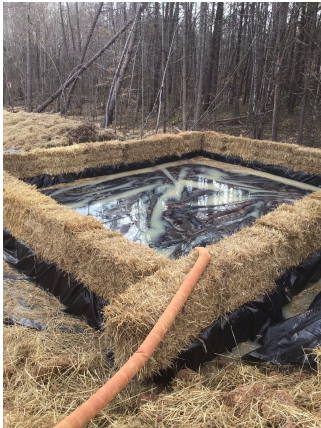
GPS Location	36.9644820364536, -79.6158849634972	GPS Location	36.964501566288, -79.6159492526945		
Description	H-602 dewatering ditch into dewatering structure sta 13+69	Description	Water bar and sump stabilized with straw sta 14233+75

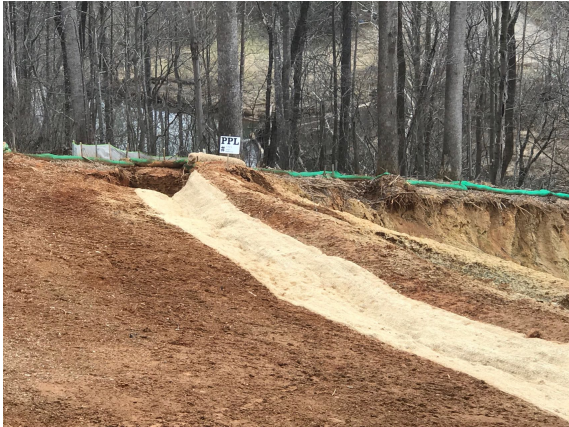
GPS Location	36.9645462837414, -79.615860739797	GPS Location	36.9643409271137, -79.6158784256127		
Description	Throat of water bar stabilized with curlex sta 14229+25	Description	Replace damaged CFS is sta 15092+95
