Visual Site Inspection Report

Project Name	H-600 Pipeline Spread I	AFE	124300139	Spread	H-600 Pipeline Spread I
Contractor	Precision			Report #	14825
Inspector	Glenn Mike Renfro			Date/Time	3/13/2019 1:24 PM
Permit #	TBD	Inspection Type	VA SWPP	Station Begin	0000+00
State	VA	Inspection Area	Full	Station End	0000+00
County	Franklin	Ground	Dry	Temperature (°F)	43.00
Municipality	N/A	Weather	Cloudy	Rain Gauge (in)	0.50
				Rain Accumulation Time (days)	6.00

Project Name	Transco Interconnect Station		AFE	124300113	Spread	Transco Interconnect Station	
Contractor	MEC				Report #	14817	
Inspector	Dave Burkhart				Date/Time	3/13/2019 10:06 AM	
Permit #	TBD	Inspection Type	VA SWPP		Station Begin	0+00	
State	VA	Inspection Area	Full		Station End	0+00	
County	Pittsylvania	Ground	Damp		Temperature (°F)	47.00	
Municipality	Chatham	Weather	Sunny		Rain Gauge (in)	0.00	
					Rain Accumulation Time (days)	1.00

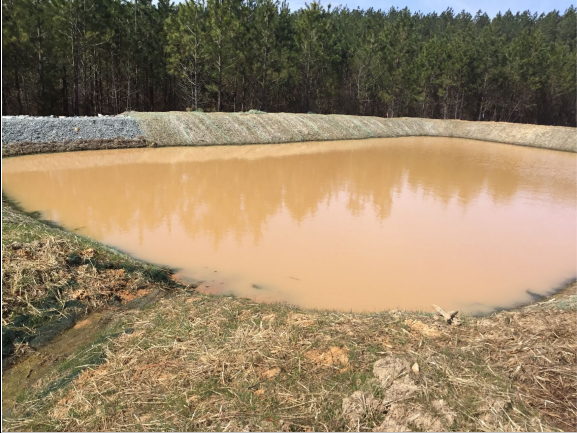
GPS Location 36.83		Field Station# +0		GPS Location 36.83	
Description Sed trap #1				Description Sed trap #2

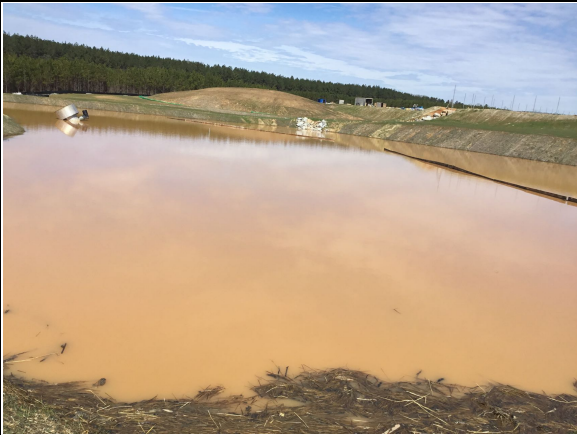
GPS Location 36.83		Field Station# +0		GPS Location 36.83	
Description Sed basin				Description Riser in sed basin

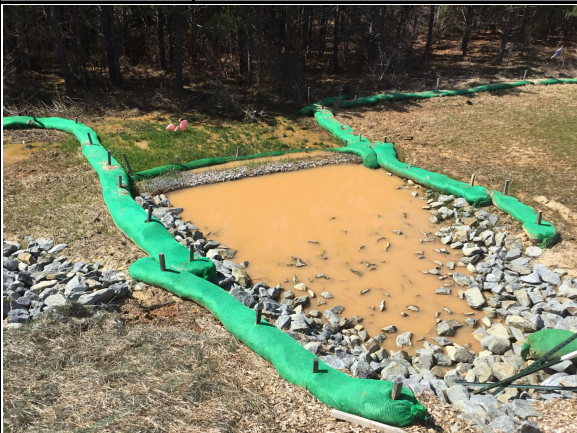
<p style="text-align: center;">Insert image here</p>		
GPS Location 36.83		Field Station# +0		GPS Location	
Description Sed basin riser outfall plunge pool and spreader bar.				Description
