Visual Site Inspection Report

Project Name	H-600 Pipeline Spread I	AFE	124300139	Spread	H-600 Pipeline Spread I
Contractor	Precision			Report #	14991
Inspector	Glenn Mike Renfro			Date/Time	3/19/2019 3:10 PM
Permit #	TBD	Inspection Type	VA SWPP	Station Begin	0000+00
State	VA	Inspection Area	Full	Station End	0000+00
County	Franklin	Ground	Dry	Temperature (°F)	52.00
Municipality	N/A	Weather	Sunny	Rain Gauge (in)	0.00
				Rain Accumulation Time (days)	6.00

Project Name	H-600 Pipeline Spread I	AFE	124300139	Spread	H-600 Pipeline Spread I
Contractor	Precision			Report #	15047
Inspector	Casey McGaha			Date/Time	3/19/2019 5:00 PM
Permit #	TBD	Inspection Type	VA SWPP	Station Begin	13670+00
State	VA	Inspection Area	Full	Station End	16027+46
County	Franklin/Pittsylvania	Ground	Dry	Temperature (°F)	52.00
Municipality	Chatham	Weather	Sunny	Rain Gauge (in)	0.00
				Rain Accumulation Time (days)	0.00

Project Name	Transco Interconnect Station		AFE	124300113	Spread	Transco Interconnect Station	
Contractor	Kanahwa				Report #	14978	
Inspector	Dave Burkhart				Date/Time	3/19/2019 9:24 AM	
Permit #	TBD	Inspection Type	VA SWPP		Station Begin	+0	
State	VA	Inspection Area	Full		Station End	+0	
County

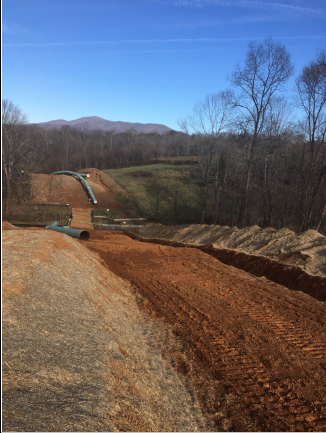
GPS Location	37.02	Field Station#	13795+00	GPS Location	37.02
Description	Stabilization required.		Description	New CWD culvert installed.	
<div style="text-align: center;">Insert image here</div>			<div style="text-align: center;">Insert image here</div>		
GPS Location		Field Station#		GPS Location	
Description			Description		
<div style="text-align: center;">Insert image here</div>			<div style="text-align: center;">Insert image here</div>		
GPS Location		Field Station#		GPS Location	
Description			Description

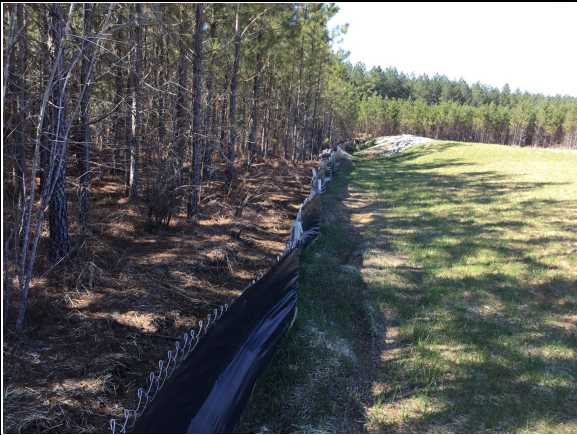
GPS Location	36.83	Field Station#	+1	GPS Location	36.83
Description	SSF along west LOD		Description	Rock filters along west LOD	
<p>Insert image here</p>			<p>Insert image here</p>		
GPS Location		Field Station#		GPS Location	
Description			Description
