Visual Site Inspection Report

Project Name	H-600 Pipeline Spread I	AFE	124300139	Spread	H-600 Pipeline Spread I
Contractor	Precision			Report #	15150
Inspector	Glenn Mike Renfro			Date/Time	3/25/2019 3:35 PM
Permit #	TBD	Inspection Type	VA SWPP	Station Begin	0000+00
State	VA	Inspection Area	Full	Station End	0000+00
County	Franklin	Ground	Damp	Temperature (°F)	67.00
Municipality	N/A	Weather	Light Rain	Rain Gauge (in)	0.20
				Rain Accumulation Time (days)	6.00

Project Name	Transco Interconnect Station		AFE	124300113	Spread	Transco Interconnect Station	
Contractor	MEC				Report #	15132	
Inspector	Dave Burkhart				Date/Time	3/25/2019 8:34 AM	
Permit #	TBD	Inspection Type	VA SWPP		Station Begin	+1	
State	VA	Inspection Area	Full		Station End	+1	
County	Pittsylvania	Ground	Dry		Temperature (°F)	50.00	
Municipality	Chatham	Weather	Sunny		Rain Gauge (in)	0.00	
					Rain Accumulation Time (days)	1.00

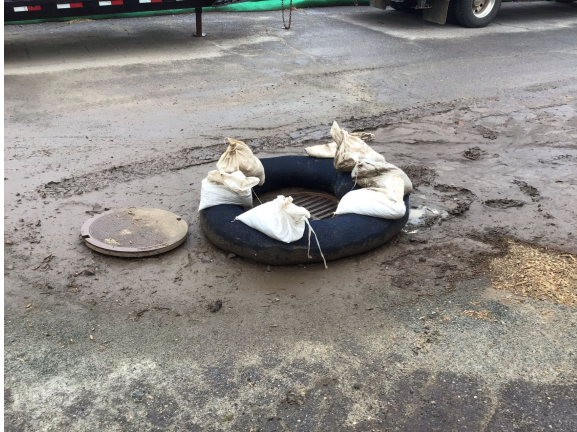
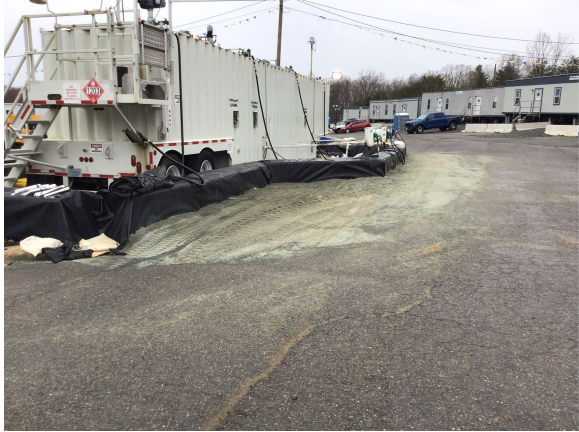
GPS Location		36.97		Field Station#		0000+00		GPS Location		36.97		Field Station#		0000+00	
Description		Inlet protection for parking lot drain on south side of paved yard in good condition										Description		Secondary containment structure for fuel cell in compliance

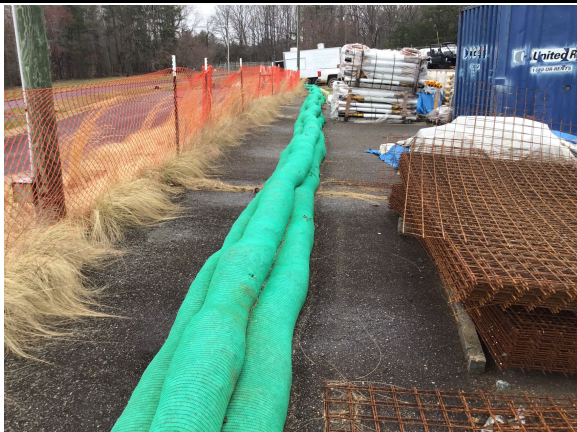
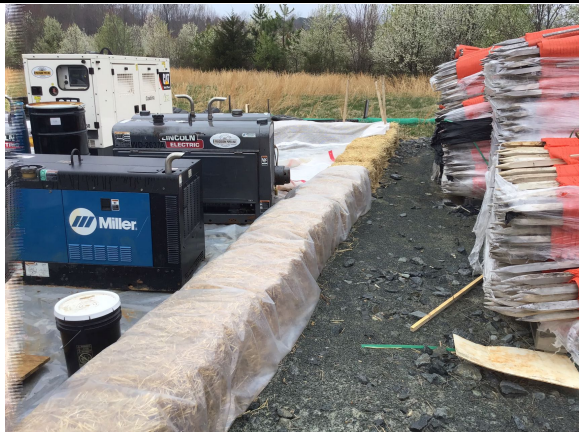
GPS Location		36.97		Field Station#		0000+00		GPS Location		36.97		Field Station#		0000+00	
Description		Perimeter ECD's on west side of paved yard in good condition.										Description		Secondary containment structure on north end of gravel yard needs plastic liner anchored.

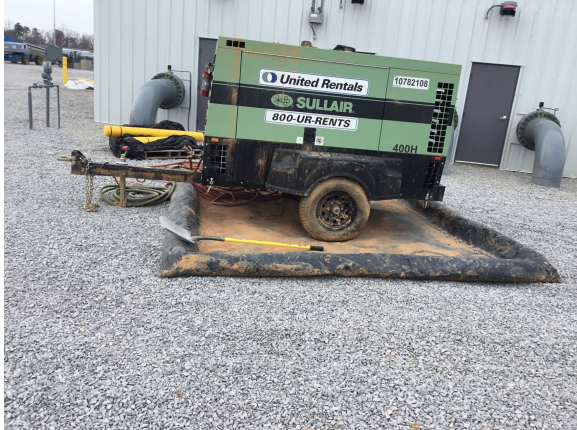
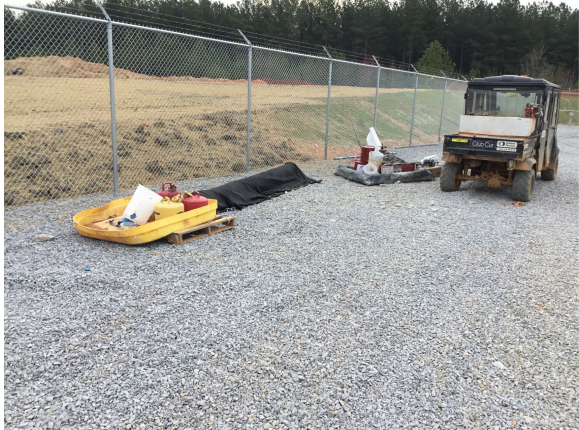
GPS Location		36.83		Field Station#		+1		GPS Location		36.83	
Description		Containment		Field Station#		+1		Description		Containment

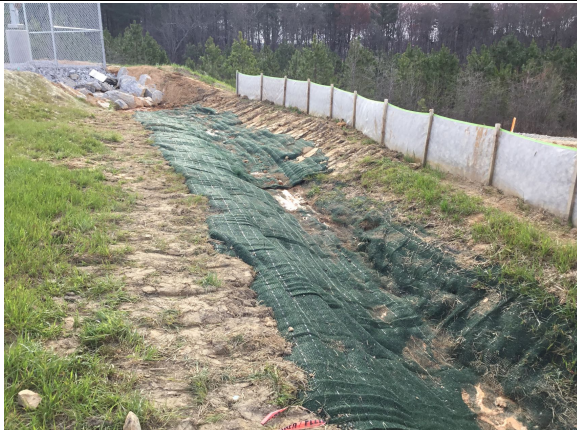
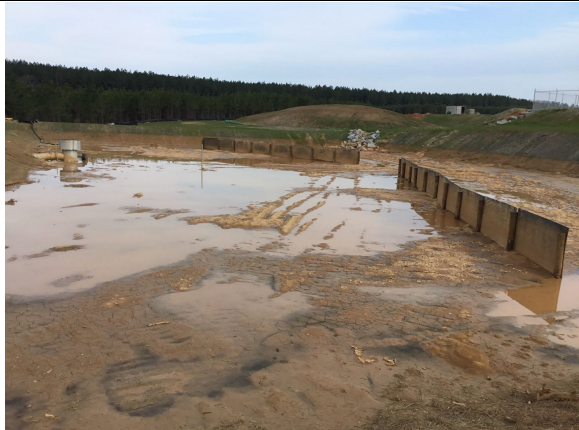
GPS Location		36.83		Field Station#		+1		GPS Location		36.83	
Description		Completed fabric on channel K		Field Station#		+1		Description		Emptied sed basin

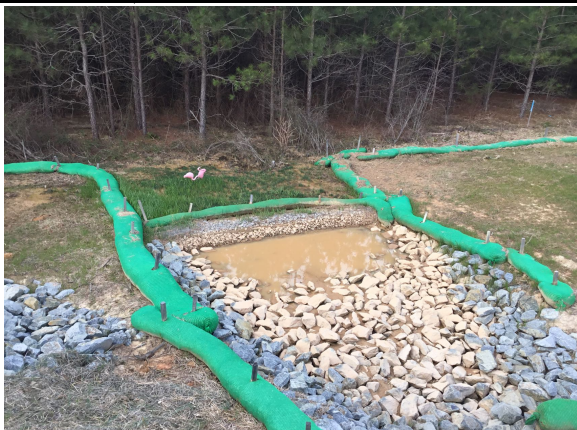
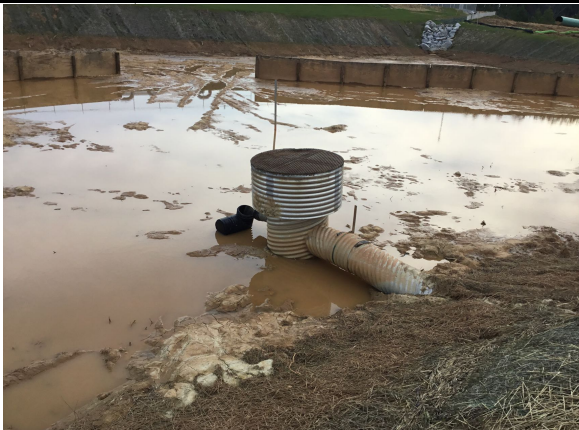
GPS Location		36.83		Field Station#		+1		GPS Location		36.83	
Description		Sed basin outlet structure from riser		Field Station#		+1		Description		Riser in sed basin

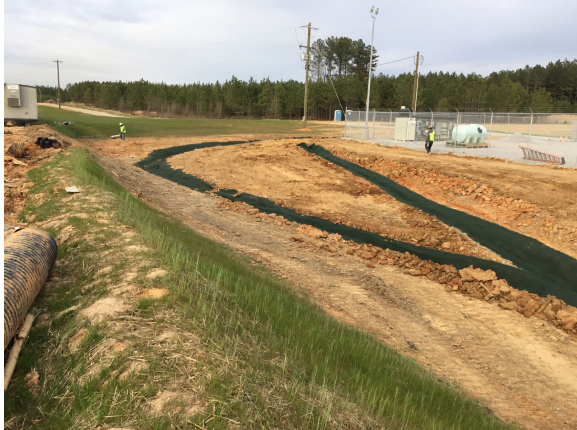
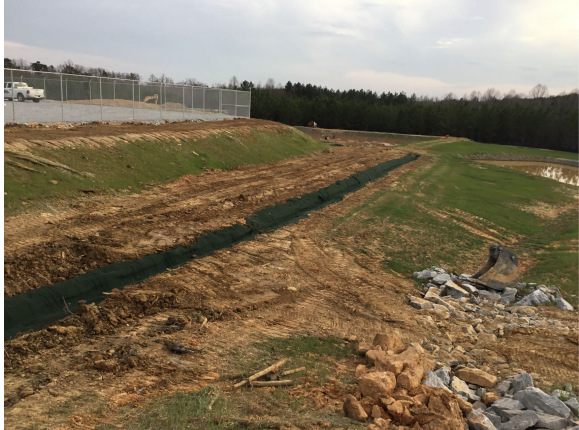
GPS Location		36.83		Field Station#		+1		GPS Location		36.83	
Field Station#		+1		GPS Location		36.83		Field Station#		+1	
Description		Matting in channels F and L						Description		Matting in channel L conveying into sed basin

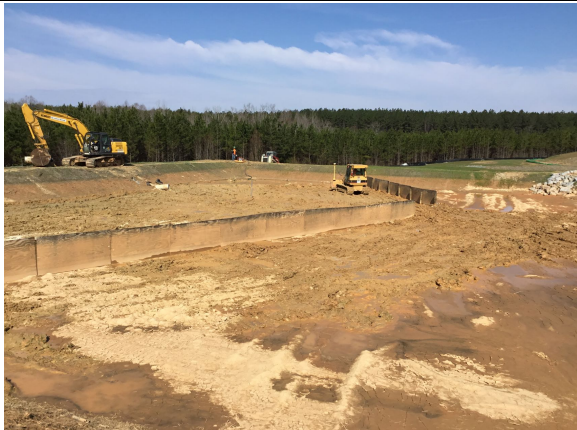
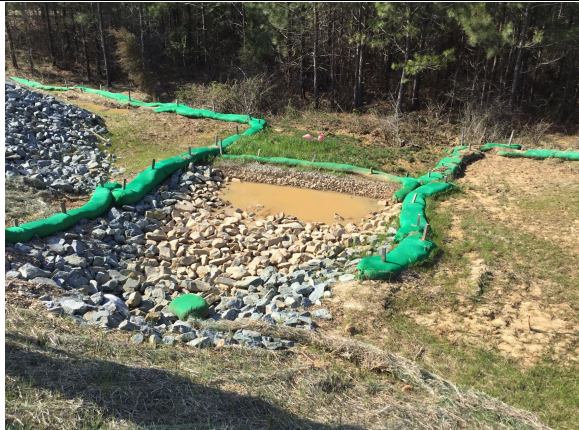
GPS Location		36.83		Field Station#		+1		GPS Location		36.83	
Field Station#		+1		GPS Location		36.83		Field Station#		+1	
Description		Sed basin						Description		Sed basin outfall and spreader structure
