# Visual Site Inspection Report

<b>Project Name</b>	H-600 Pipeline Spread I	<b>AFE</b>	124300139	<b>Spread</b>	H-600 Pipeline Spread I	
<b>Contractor</b>	Precision			<b>Report #</b>	14663	
<b>Inspector</b>	Glenn Mike Renfro			<b>Date/Time</b>	3/7/2019 12:41 PM	
<b>Permit #</b>	TBD	<b>Inspection Type</b>	VA SWPP	<b>Station Begin</b>	0000+00	
<b>State</b>	VA	<b>Inspection Area</b>	Full	<b>Station End</b>	0000+00	
<b>County</b>	Franklin	<b>Ground</b>	Dry	<b>Temperature (°F)</b>	41.00	
<b>Municipality</b>	N/A	<b>Weather</b>	Cloudy	<b>Rain Gauge (in)</b>	1.00	
				<b>Rain Accumulation Time (days)</b>	6.00

<b>Project Name</b>	H-600 Pipeline Spread I	<b>AFE</b>	124300139	<b>Spread</b>	H-600 Pipeline Spread I
<b>Contractor</b>	Precision			<b>Report #</b>	14708
<b>Inspector</b>	Casey McGaha			<b>Date/Time</b>	3/7/2019 5:00 PM
<b>Permit #</b>	TBD	<b>Inspection Type</b>	VA SWPP	<b>Station Begin</b>	13670+00
<b>State</b>	VA	<b>Inspection Area</b>	Full	<b>Station End</b>	16027+46
<b>County</b>	Franklin/Pittsylvania	<b>Ground</b>	Damp	<b>Temperature (°F)</b>	38.00
<b>Municipality</b>	Chatham	<b>Weather</b>	Sunny	<b>Rain Gauge (in)</b>	0.00
				<b>Rain Accumulation Time (days)</b>	0.00

<b>Proj

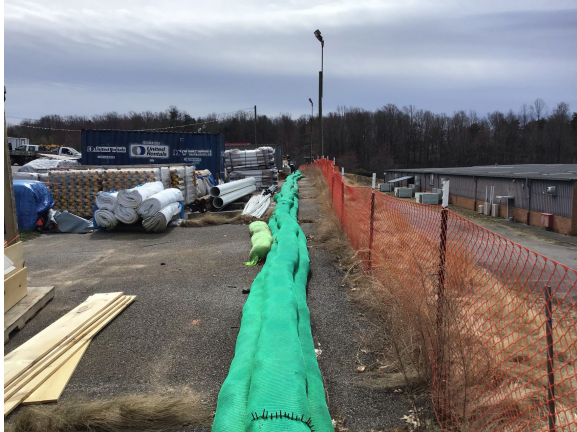
GPS Location		36.97		Field Station#		0000+00		GPS Location		36.97		Field Station#		0000+00									
Description		Perimeter ECD's in good condition on west side of paved yard.										Description		Inlet protection for parking lot drain on south end of paved yard in good condition.

GPS Location		36.97		Field Station#		0000+00		GPS Location		36.97		Field Station#		0000+00									
Description		Re-stack CFS on south end of paved yard near mat bridge										Description		Repair plastic for secondary containment structure for equipment on north end of gravel yard. (weight down or staple done edge)

GPS Location		36.97		Field Station#		0000+00		GPS Location		36.97		Field Station#		0000+00									
Description		Secondary containment structure for fuel cell in good condition.										Description		Proper disposal of empty containers.(Housekeeping)

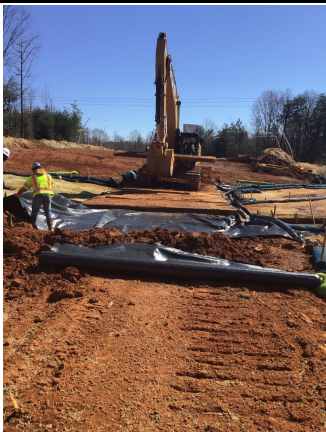
GPS Location		36.96		Field Station#		15000+00		GPS Location		36.96		Field Station#		15794+77	
Description		Mulch applied with helicopter.						Description		Crew replacing geotech under bridge.

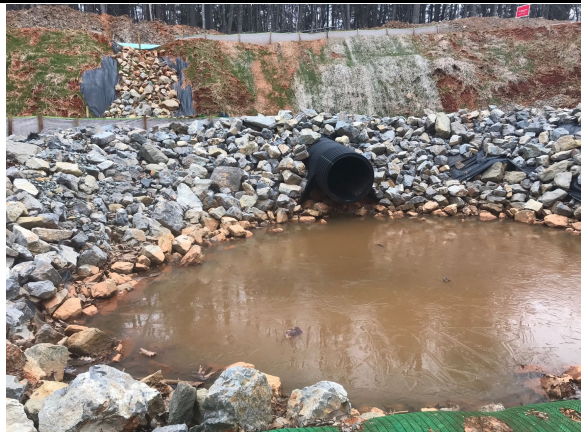
GPS Location		36.96		Field Station#		15840+00		GPS Location		36.97		Field Station#		15799+00	
Description		Crew replacing geotech under bridge.						Description		Stabilization required.

GPS Location		36.96		Field Station#		13858+50		GPS Location		36.96		Field Station#		14071+75	
Description		Maintenance required on SSF.						Description		Plunge pool functioning properly.

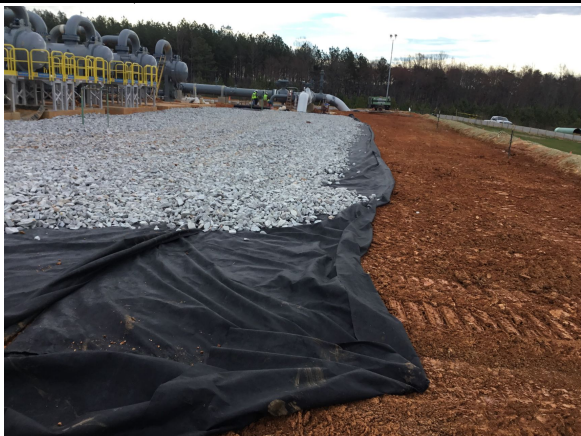
GPS Location		36.83		Field Station#		+1		GPS Location		36.83	
Field Station#		+1		Description		RCE and Transco Road.		Field Station#		+1	
Description				Description		Rebuilt and clean CWO

GPS Location		36.83		Field Station#		+1		GPS Location		36.83	
Field Station#		+1		Description		Culvert inlet protection at site entrance		Field Station#		+1	
Description				Description		Placing large base stone on pad

GPS Location		36.83		Field Station#		+1		GPS Location		36.83	
Field Station#		+1		Description		Placing drain/filter fabric under stone		Field Station#		+1	
Description				Description		Rock filter along west LOD near top soil spoil.

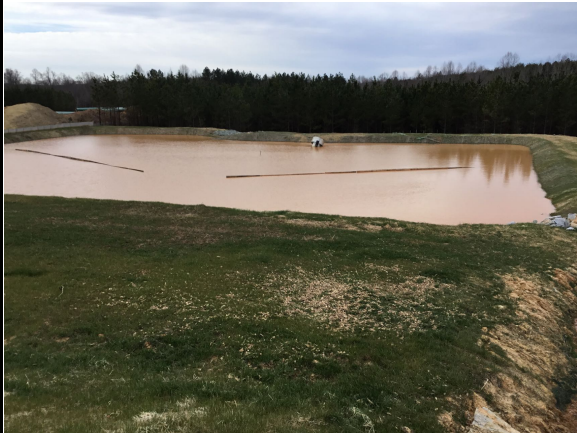
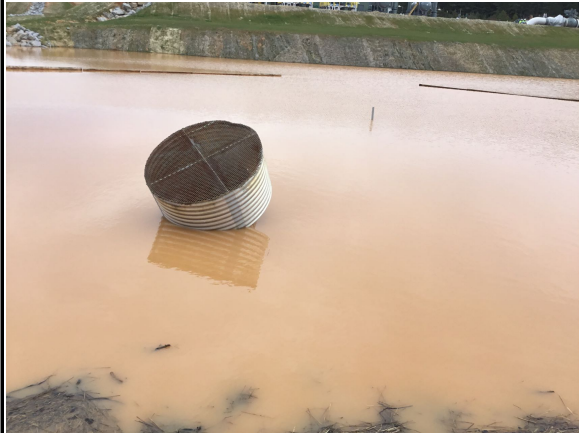
GPS Location		36.83	Field Station#		+1		
Description		Sed basin #1

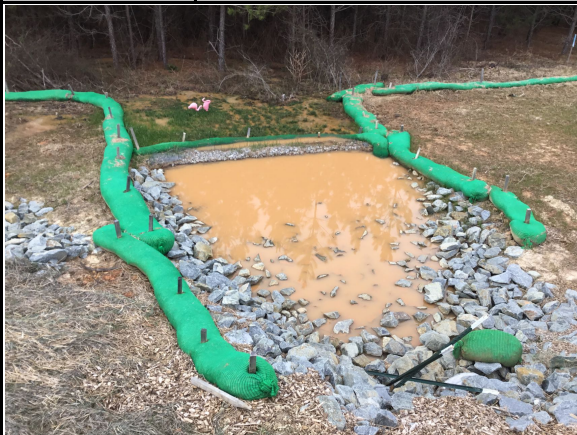
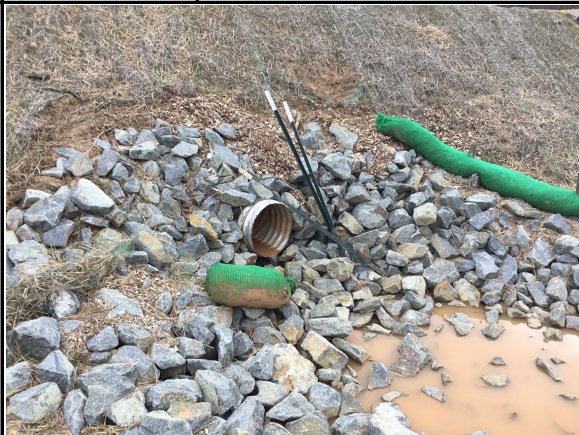
GPS Location		36.83	Field Station#		+1		
Description		Sed basin riser outfall

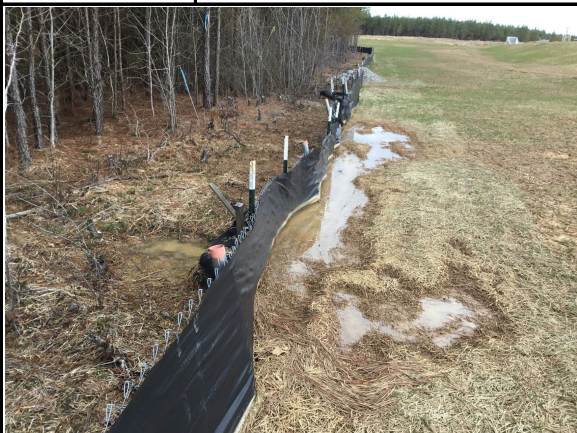
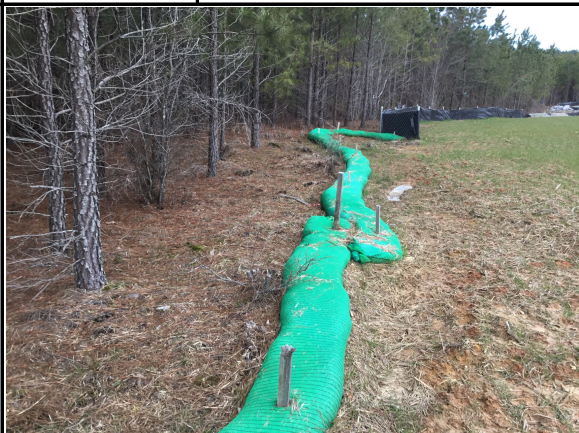
GPS Location		36.83	Field Station#		+1		
Description		18 CFS along west LOD
