Visual Site Inspection Report

Project Name	H-600 Pipeline Spread H	AFE	124300138	Spread	H-600 Pipeline Spread H
Contractor	Precision			Report #	15410
Inspector	Pat Davis			Date/Time	4/3/2019 6:39 AM
Permit #	TBD	Inspection Type	VA SWPP	Station Begin	+0
State	VA	Inspection Area	Partial	Station End	+0
County	Montgomery	Ground	Dry	Temperature (°F)	54.00
Municipality	N/A	Weather	Sunny	Rain Gauge (in)	0.00
				Rain Accumulation Time (days)	0.00

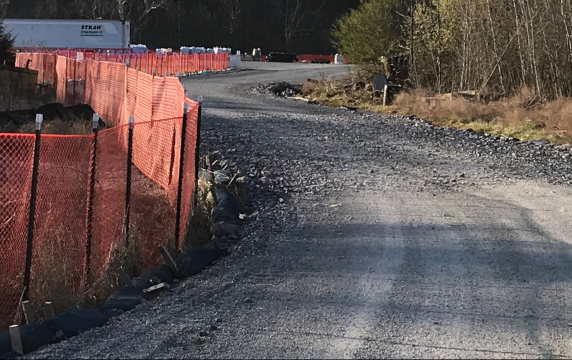
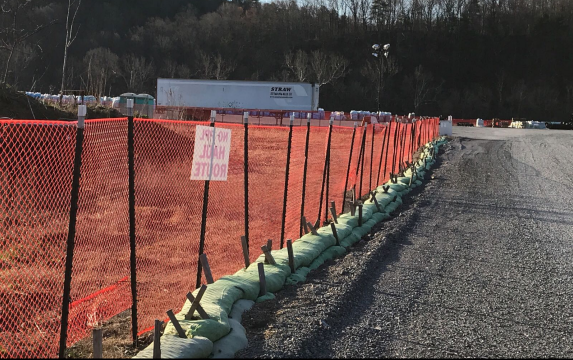
<div data-bbox="1279 598 1396 632"> 2019-04-03 08:19:14-04:00 </div>		
GPS Location	37.27	Field Station#	+0	GPS Location	
Description	MVP-LY-049_040319 condition of rock entrance. Looking S. See photo for gps data.			Description	MVP-LY-049_040319 condition of safety fence and CFS along center drive. Looking SE. See photo for gps data.
<div data-bbox="162 783 730 823"> DIRECTION NE (T) +37.27099° ACCURACY 16 ft -080.12188° DATUM WGS84 </div>

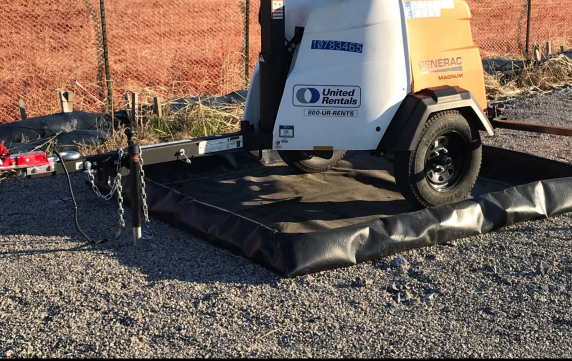
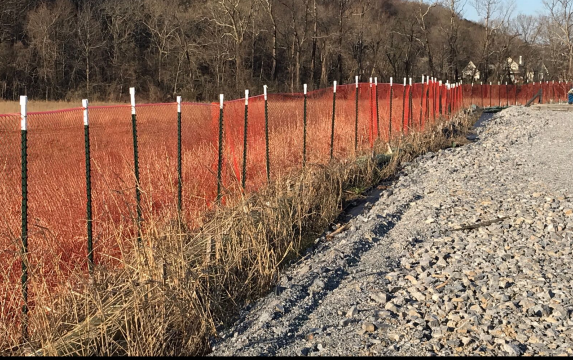
GPS Location	37.27	Field Station#	+0	GPS Location	
Description	MVP-LY-049_040319 condition of containment under light plant. Looking NE. See photo for gps data.			Description	MVP-LY-049_040319 condition of containment under porta toilets. Looking NE. See photo for gps data.
<div data-bbox="162 1365 730 1404"> DIRECTION NE (T) +37.27151° ACCURACY 16 ft -080.12044° DATUM WGS84 </div>   <div data-bbox="581 1761 698 1795"> 2019-04-03 08:20:31-04:00 </div>			<div data-bbox="860 1365 1429 1404"> DIRECTION W (T) +37.26933° ACCURACY 16 ft -080.12239° DATUM WGS84 </div>

<div data-bbox="1279 1761 1396 1795"> 2019-04-03 08:32:17-04:00 </div>		
GPS Location	37.27	Field Station#	+0	GPS Location	
Description	MVP-LY-049_040319 dumpster area free of loose trash. Looking NE. See photo for gps data.			Description	MVP-LY-049_040319 condition of safety fence and CFS along south boundary. Looking W. See photo for gps data.

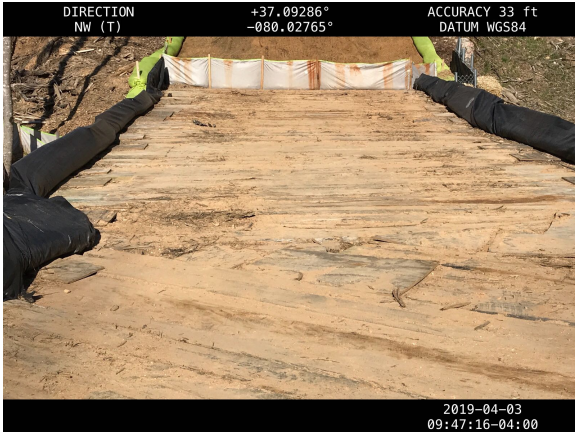
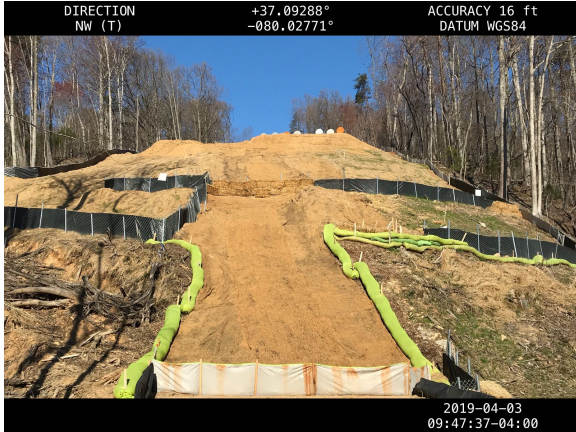
<div>2019-04-03 09:47:37-04:00</div>									
GPS Location		37.10		Field Station#		13413+05		GPS Location		37.10		Field Station#		13412+00	
Description		13413+05_040319 S-IJ1 mat bridge. Clean and closed. Looking NW. See photo for gps data.						Description		13412+00_040319 steep slope and travel lane stabilized. Looking NW. See photo for gps data.					
<div>DIRECTION SW (T)</div> <div>+37.10328° -080.04203°</div> <div>ACCURACY 33 ft DATUM WGS84</div>

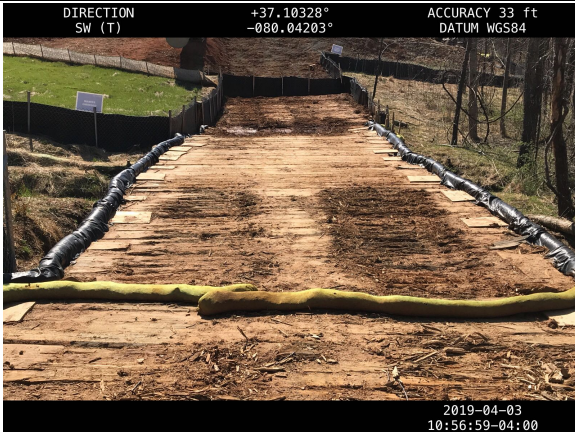
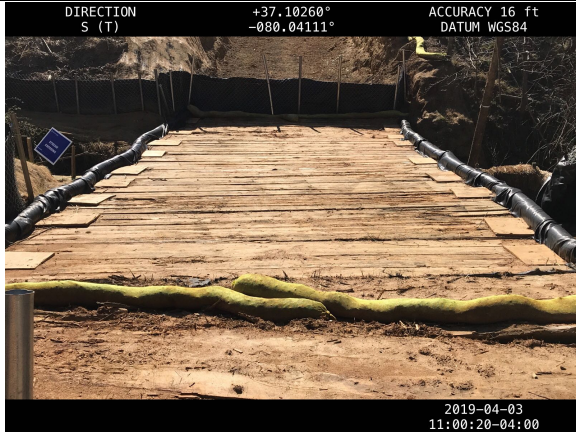
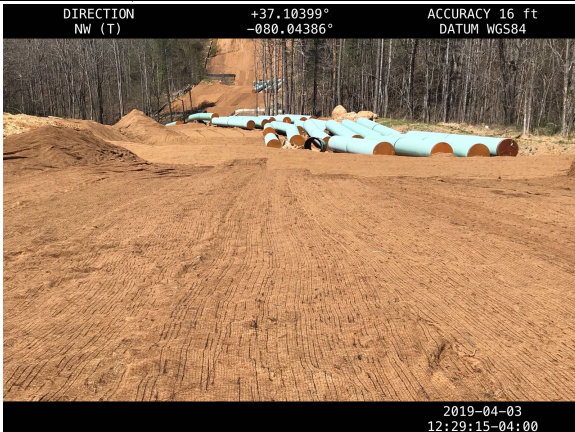
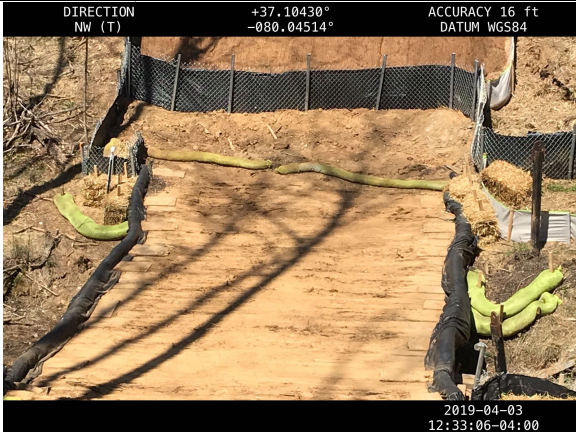
GPS Location		37.10		Field Station#		13348+46		GPS Location		37.10		Field Station#		13352+25	
Description		13348+46_040319 S-RR08 mat bridge clean and closed. Looking SW. See photo for gps data.						Description		13352+25_040319 S-RR09 mat bridge clean and closed. Looking S. See photo for gps data.					
<div>DIRECTION NW (T)</div> <div>+37.10399° -080.04386°</div> <div>ACCURACY 16 ft DATUM WGS84</div>

<div>2019-04-03 12:33:06-04:00</div>									
GPS Location		37.10		Field Station#		13341+92		GPS Location		37.10		Field Station#		13337+13	
Description		13341+92_040319 erosion control blanket installed on ROW surface. Looking W. See photo for gps data.						Description		13337+13_040319 S-GH9 mat bridge cleaned and closed. Looking NW. See photo for gps data.

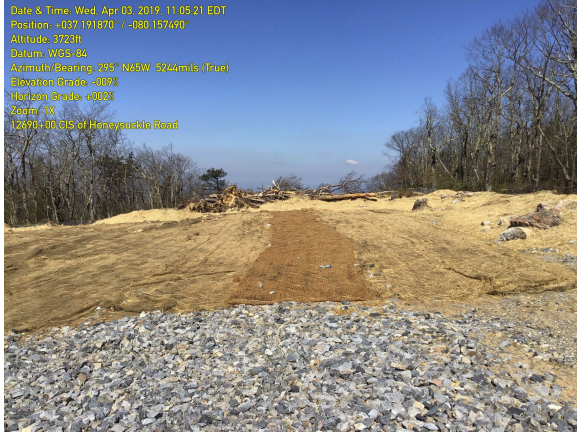
</div>				
GPS Location		37.19	Field Station#		12690+00			
Description		Curlex, straw mulch, and ECD's are in acceptable condition.				Description		No issues or impacts observed throughout the area.
<div><div>Date & Time: Wed, Apr 03, 2019, 13:00:45 EDT Position: +029.132910° / -080.131103° Altitude: 3500ft Datum: WGS-84 Azimuth/Bearing: 308° N26W 524mils (True) Elevation Grade: -01% Horizon Grade: +001% Zoom: 1X 12973+00 access road RD-298 stream crossing S-Q20</div>

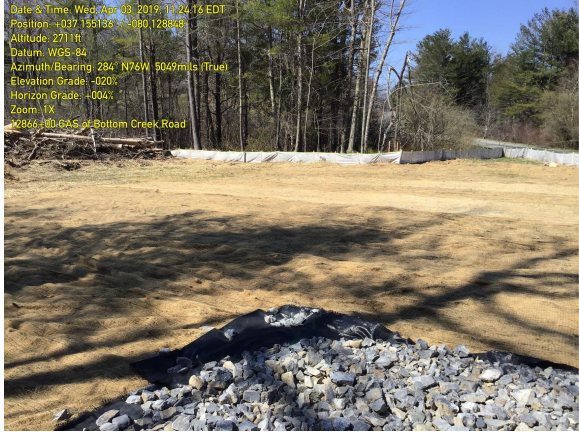
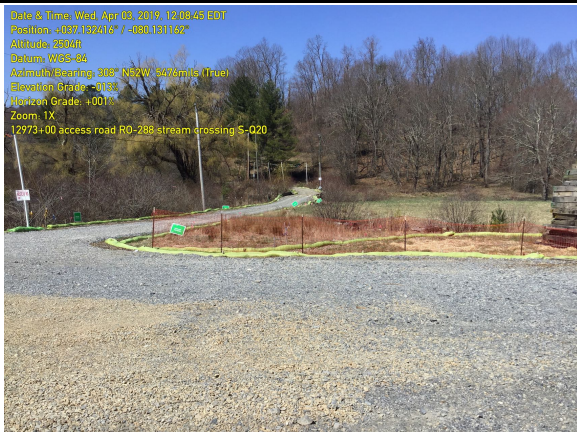
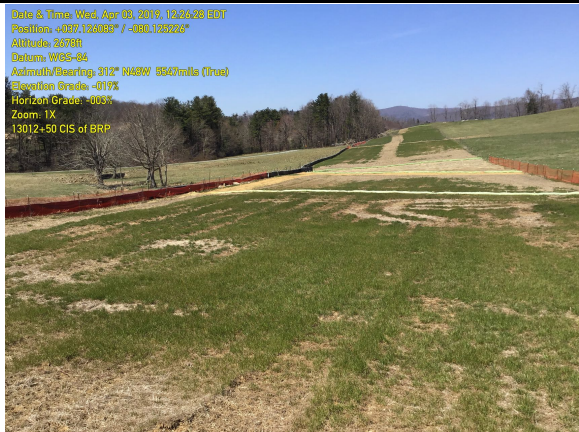
GPS Location		37.13	Field Station#		12973+00			
Description		No deficiencies or off ROW/stream impacts observed.				Description		BRP remains well stabilized and no signs of impacts throughout the area.
<div><div>Date & Time: Wed, Apr 03, 2019, 13:21:35 EDT Position: +037.127237° / -080.111358° Altitude: 2576ft Datum: WGS-84 Azimuth/Bearing: 079° N79E 1404mils (True) Elevation Grade: -01% Horizon Grade: -001% Zoom: 1X 13062+00 GAS of FR-290</div>

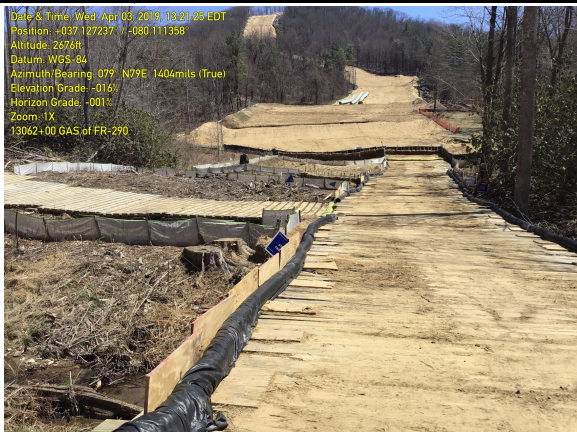
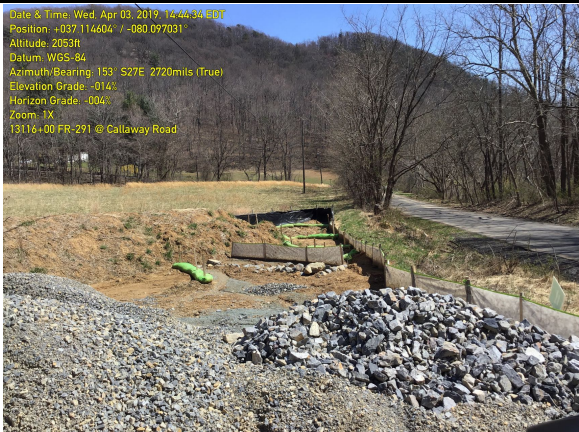
</div>				
GPS Location		37.12	Field Station#		13062+00			
Description		No stream or off ROW impacts observed throughout the area.				Description		ECD's and BMP's along access road and around ATWS in compliance.

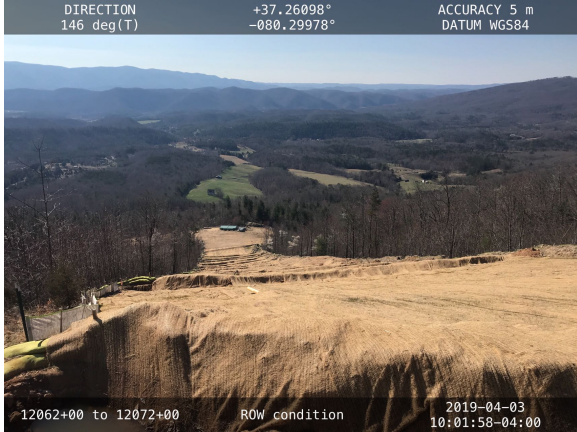
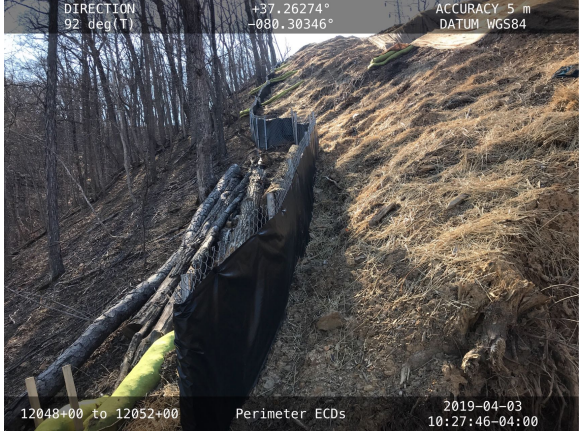
<p>DIRECTION 92 deg(T) +37.26274° -080.30346° ACCURACY 5 m DATUM WGS84</p> <p>12048+00 to 12052+00 Perimeter ECDs 2019-04-03 10:27:46-04:00</p>				
GPS Location	37.27	Field Station#	12062+00	GPS Location	37.27	Field Station#	12048+00
Description	See photo for gps data. Photo shows the ROW conditions from about 12062+00 to 12072+00.			Description	See photo for gps data. Photo shows the perimeter ECDs from about 12048+00 to 12052+00.

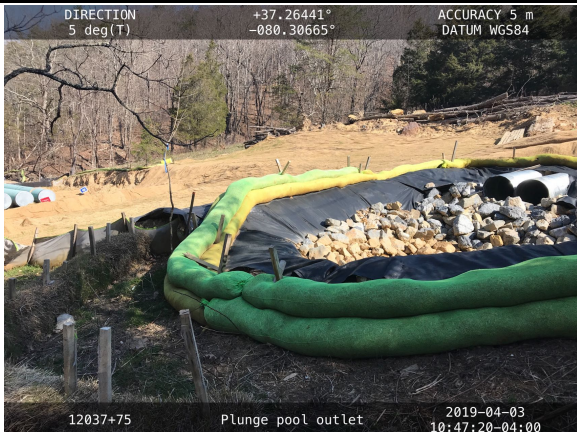
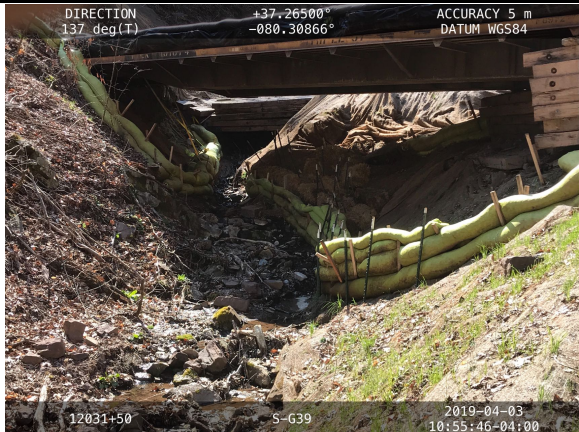
GPS Location	37.27	Field Station#	12037+75	GPS Location	37.27	Field Station#	12031+50
Description	See photo for gps data. Photo shows the plunge pool outlet at 12037+75.			Description	See photo for gps data. Photo shows stream S-G39 at 12031+50.

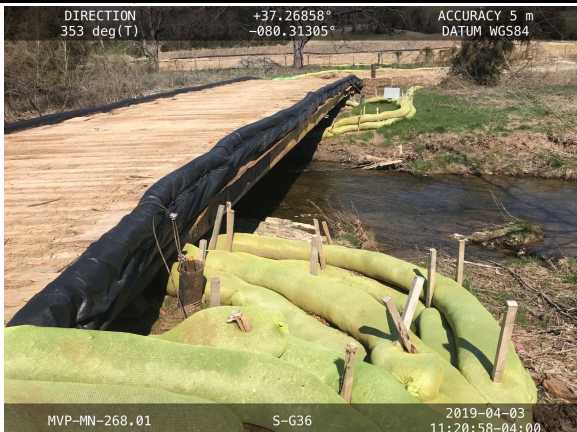
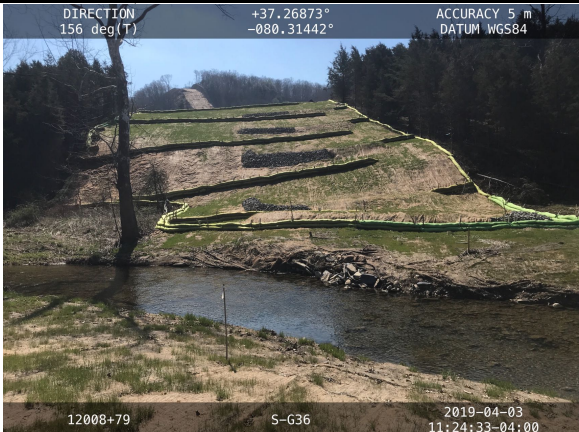
<p>DIRECTION 156 deg(T) +37.26873° -080.31442° ACCURACY 5 m DATUM WGS84</p> <p>12008+79 S-G36 2019-04-03 11:24:33-04:00</p>				
GPS Location	37.27	Field Station#	12013+96	GPS Location	37.27	Field Station#	12008+79
Description	See photo for gps data. Photo shows the ECDs along the bridge over S-G36.			Description	See photo for gps data. Photo shows stream S-G36 and the ROW from about 12009+00 to 12011+55.

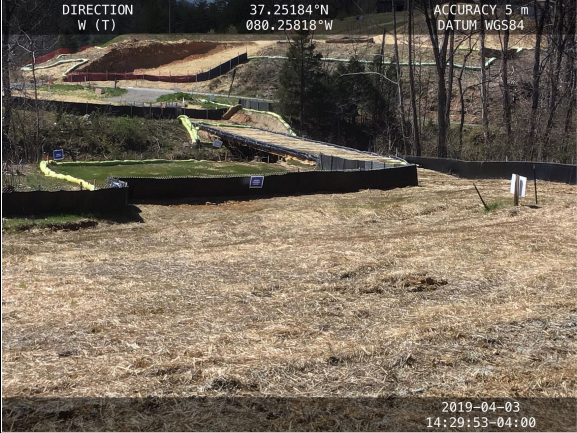
GPS Location		37.25		Field Station#		12193+35		GPS Location			
Description		Stream S-21, Bradshaw Creek, facing west.						Description			
Insert image here				Insert image here							
GPS Location				Field Station#				GPS Location			
Description								Description			
Insert image here				Insert image here							
GPS Location				Field Station#				GPS Location			
Description								Description			
Insert image here				Insert image here							
GPS Location				Field Station#				GPS Location			
Description								Description
