# Visual Site Inspection Report

<b>Project Name</b>	H-600 Pipeline Spread G	<b>AFE</b>	124300137	<b>Spread</b>	H-600 Pipeline Spread G
<b>Contractor</b>	Precision			<b>Report #</b>	15348
<b>Inspector</b>	Garrett Barclay			<b>Date/Time</b>	4/1/2019 10:43 AM
<b>Permit #</b>	TBD	<b>Inspection Type</b>	VA SWPP	<b>Station Begin</b>	11065+00
<b>State</b>	VA	<b>Inspection Area</b>	Partial	<b>Station End</b>	11055+00
<b>County</b>	Giles	<b>Ground</b>	Dry	<b>Temperature (°F)</b>	32.00
<b>Municipality</b>	N/A	<b>Weather</b>	Sunny	<b>Rain Gauge (in)</b>	0.00
				<b>Rain Accumulation Time (days)</b>	1.00

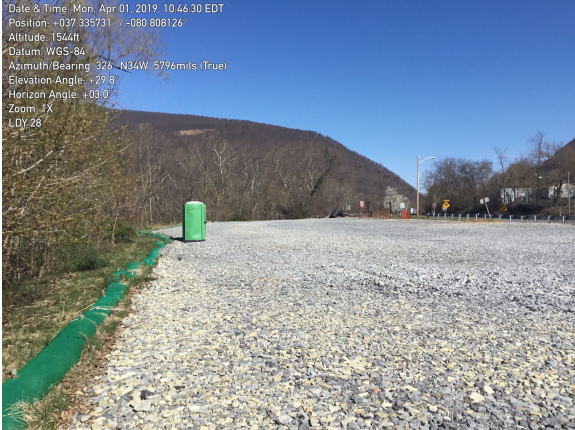
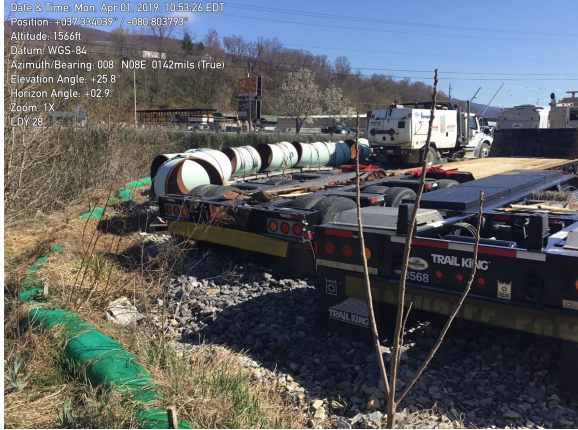
</div></div></div>			
GPS Location		37.33	Field Station#		+28		
Description		ECD's and ROW conditions @ LDY 28					
<div><div><div>Date &amp; Time: Mon, Apr 01, 2019, 11:04:40 EDT Position: +037 362323 / -080 807590 Altitude: 1700ft Datum: WGS-84 Azimuth/Bearing: 252° S72W 4480mils (True) Elevation Angle: +25.6° Horizon Angle: +02.1° Zoom: 1X LDY 29</div><div>

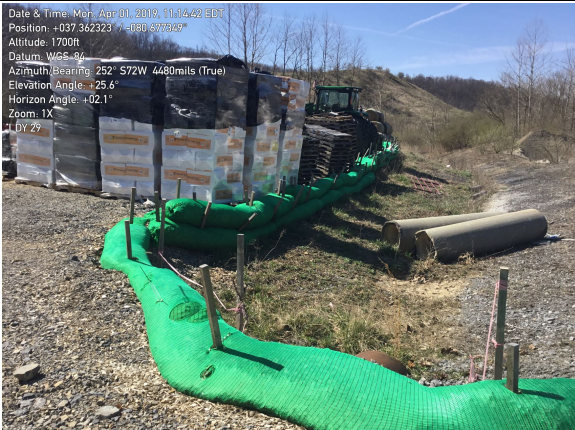
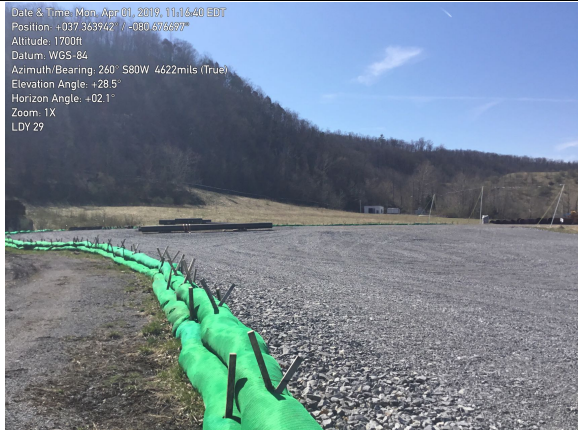
GPS Location		37.33	Field Station#		+29		
Description		ECD's and ROW conditions @ LDY 29					
<div><div><div>Date &amp; Time: Mon, Apr 01, 2019, 12:19:21 EDT Position: +037 18 55 86 / -080 32 39 03 Altitude: 2076ft Datum: WGS-84 Azimuth/Bearing: 092° S88E 1436mils (True) Elevation Grade: -021° Horizon Grade: -000° Zoom: 1X 11065-00</div><div>

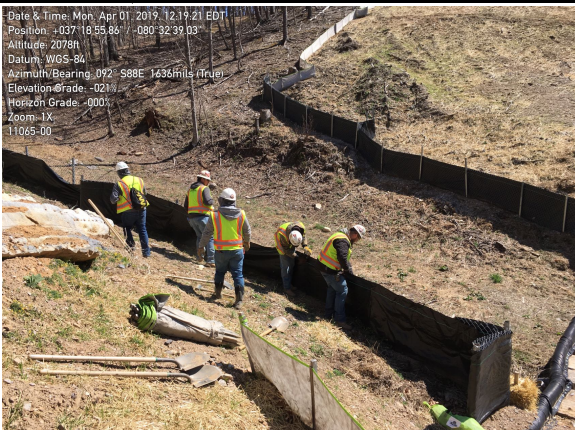
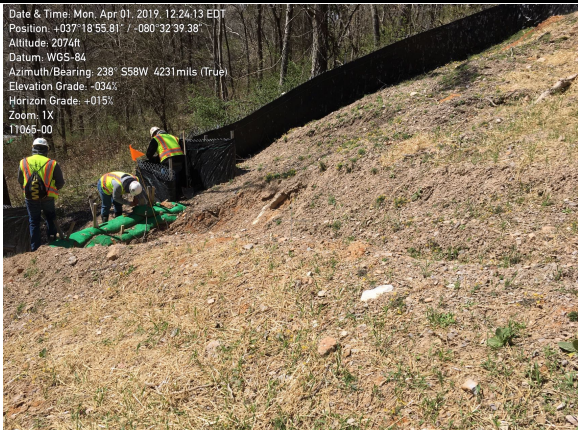
</div></div></div>			
GPS Location		37.33	Field Station#		11065+00		
Description		Crews making repairs to SSF					
<div><div><div>Date &amp; Time: Mon, Apr 01, 2019, 12:24:13 EDT Position: +037 18 55 81 / -080 32 39 38 Altitude: 2076ft Datum: WGS-84 Azimuth/Bearing: 238° S58W 4231mils (True) Elevation Grade: -034° Horizon Grade: +015° Zoom: 1X 11066-00</div><div>

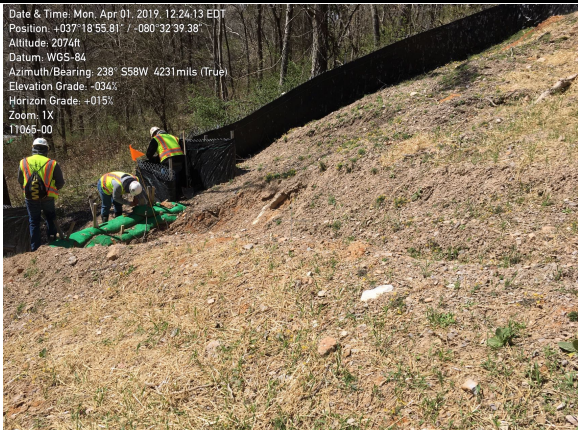
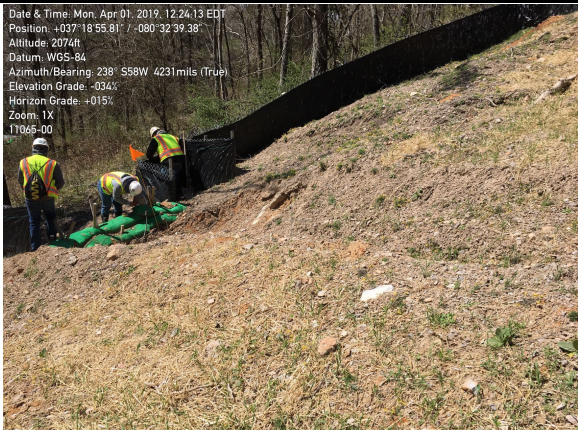
GPS Location		37.33	Field Station#		11064+00		
Description		Crews making repairs to end treatment

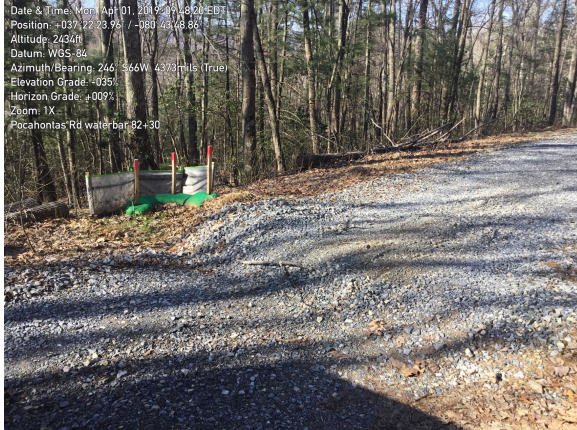
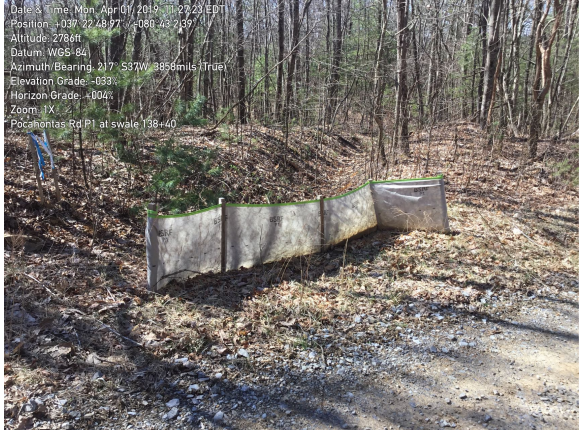
</div></div></div>					
GPS Location	37.13	Field Station#	82+30	GPS Location	37.13	Field Station#	138+40
Description	Correct coordinates on photo. All water bars and end treatments were inspected with no issues identified.			Description	Correct coordinates on photo. Silt fencing along the edge of road has protected adjacent swales from runoff.

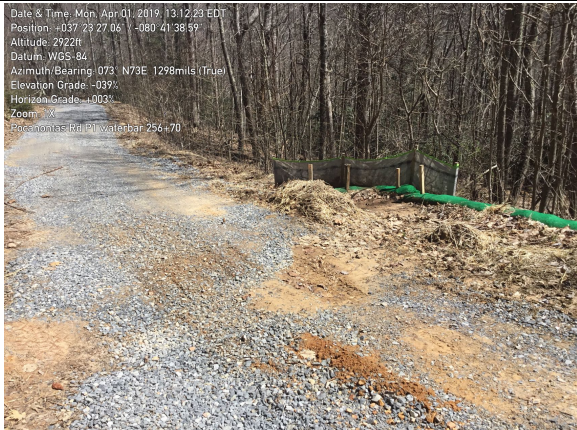
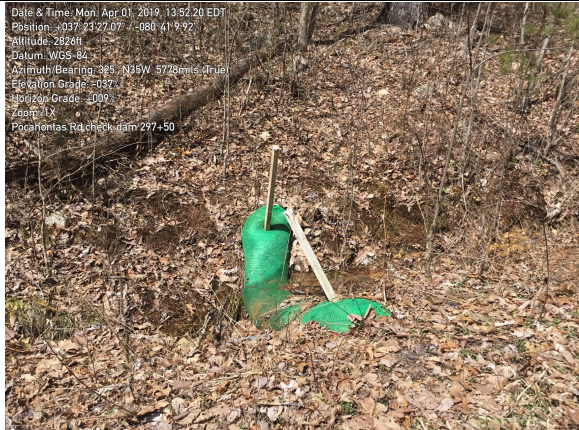
</div></div></div>					
GPS Location	37.13	Field Station#	256+70	GPS Location	37.13	Field Station#	297+50
Description	Correct coordinates on photo. Waterbars and end treatments have controlled any sediment movement beyond LOD.			Description	Correct coordinates on photo. Check dams in ditches and at culvert intakes in place and functional.

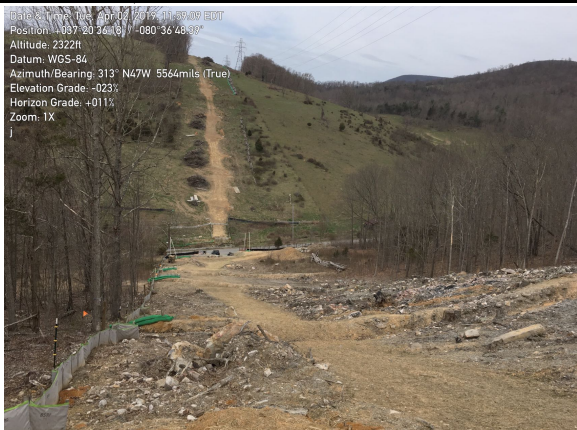
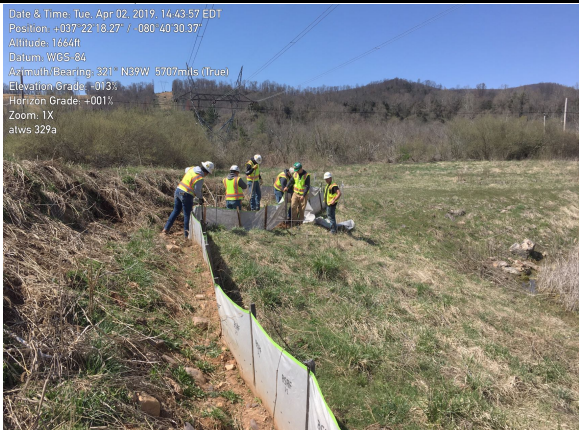
GPS Location	37.37	Field Station#	10890+00	GPS Location	37.37	Field Station#	3+29
Description	ECD's and ROW conditions			Description	Crews replacing P1SF @ ATWS 329a

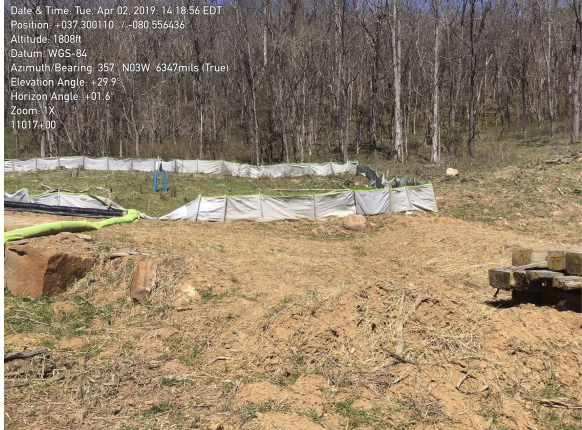
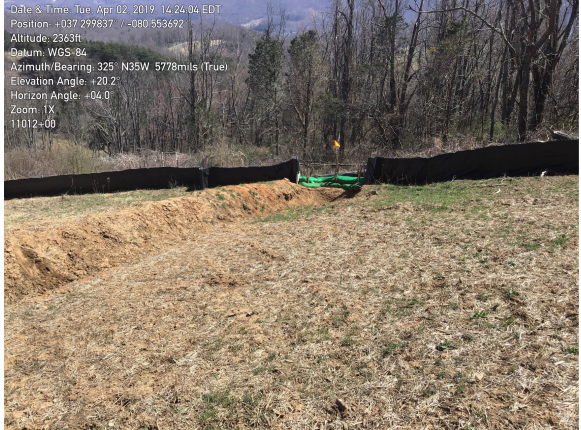
GPS Location	37.20	Field Station#	11017+00	GPS Location	37.20	Field Station#	11012+00
Description	See photo for GPS location. Priority one silt fence damaged by land owner cattle.			Description	See photo for GPS location. Water bar, end treatment, and sump pit in place.		
<p>Date &amp; Time: Tue, Apr 02, 2019, 14:27:01 EDT Position: +037 303707 / -080 555567 Altitude: 2563ft Datum: WGS-84 Azimuth/Bearing: 284° N76W 5049mils (True) Elevation Angle: +26.8° Horizon Angle: +05.7° Zoom: 1X 11010+00</p>

<b>A/E</b>	124300137	<b>Date/Time</b>	4/2/2019 3:45 PM	<b>Report #</b>	15399
<b>6. PCSM BMPs</b> (List BMPs and note if installed and maintained as per the plan. If corrective action is needed, a picture is required.)					
<b>PCSM BMPs</b>	<b>Compliance Level</b>	<b>Corrective Action</b>	<b>Corrective Time Frame</b>	<b>Date Repaired</b>	
<b>7. Identify all remedial measures that have been taken since the previous inspection was conducted.</b>					
<div style="height: 100px;"></div>					
<b>Comments</b> (Reference above questions as appropriate.)					
Conducted VA SWPPP inspection from MP 207 to 208.8. Since last inspection Precision Pipeline has conducted ECD maintenance and ECD upgrades where needed. No forward progress has been completed due to winter shut down. ROW has been stabilized using seed, mulch, earth guard pellets, natural vegetation, and minor vegetation growth. At station number 11017+00 land owner cattle damaged priority one silt fence. Item communicated to contractor via punchlist.

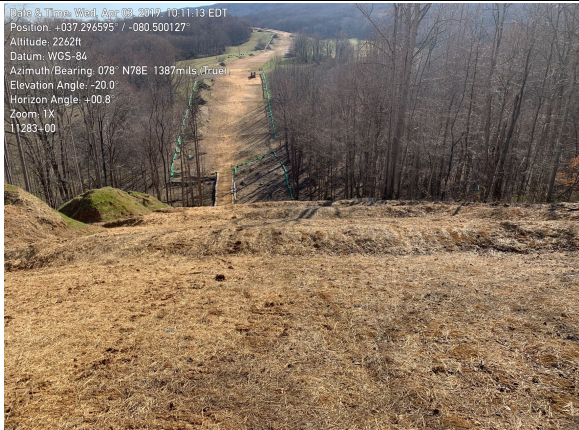
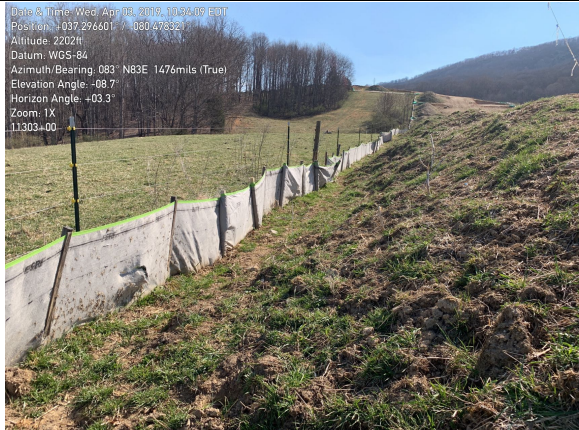
GPS Location	37.20	Field Station#	11283+00	GPS Location	37.20	Field Station#	11303+00
Description	See photo for GPS location. Water bars in place. ROW stabilized with seed and mulch.			Description	See photo for GPS location. Priority one silt fence damaged by land owner cattle.

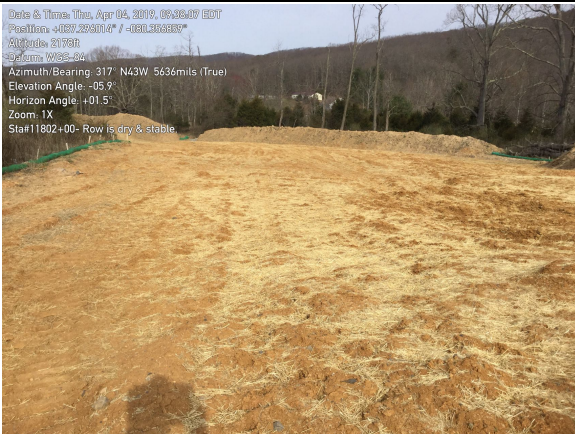
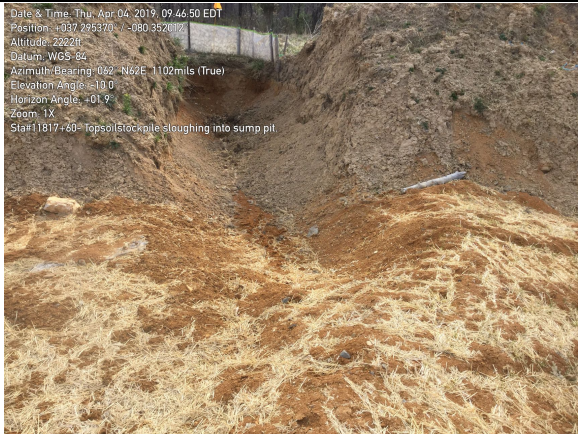
<p>Date &amp; Time: Thu, Apr 04, 2019, 09:46:50 EDT Position: +037 295701° / -080 352612° Altitude: 2292ft Datum: WGS-84 Azimuth/Bearing: 042° N62E 1102mils (True) Elevation Angle: -10.0° Horizon Angle: +01.9° Zoom: 1X Sta#11817+00- Topsoil stockpile sloughing into sump pit</p>

GPS Location	37.32	Field Station#	11802+00	GPS Location	37.32	Field Station#	11817+00
Description	Row is dry & stable.			Description	Topsoil stockpiles sloughing into sump pits.		
<p>Date &amp; Time: Thu, Apr 04, 2019, 09:55:20 EDT Position: +037 292077° / -080 350817° Altitude: 2317ft Datum: WGS-84 Azimuth/Bearing: 255° S75W 4533mils (True) Elevation Angle: -08.1° Horizon Angle: +01.3° Zoom: 1X Sta#11830+00- Karst with P1 perimeter control &amp; signage</p>

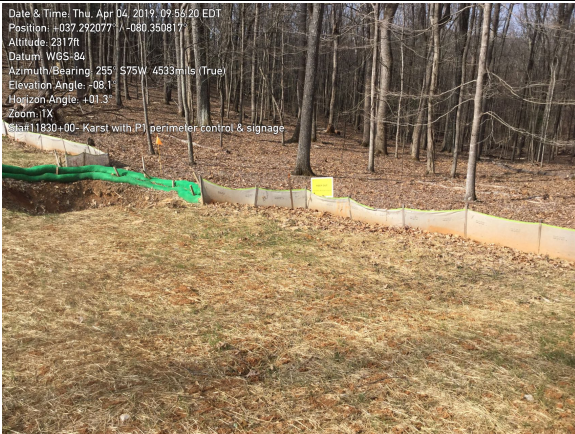
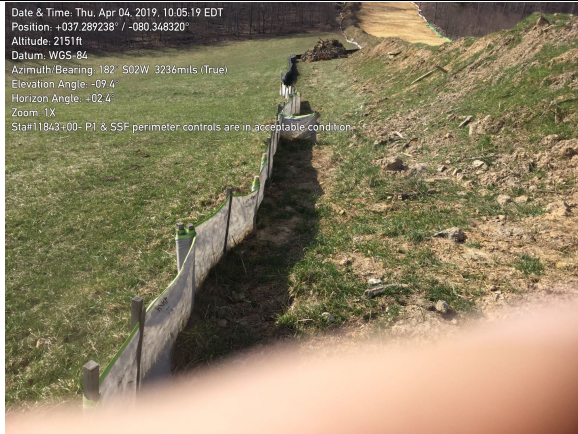
GPS Location	37.32	Field Station#	11830+00	GPS Location	37.32	Field Station#	11843+00
Description	Karst with P1 perimeter controls & signage			Description	P1 & SSF perimeter controls are in acceptable condition		
<p>Date &amp; Time: Thu, Apr 04, 2019, 10:19:13 EDT Position: +037 285868° / -080 346343° Altitude: 2176ft Datum: WGS-84 Azimuth/Bearing: 025° N64E 3231mils (True) Elevation Angle: -08.3° Horizon Angle: +00.8° Zoom: 1X Sta#11864+00- Wetland area, 375 18' bed</p>
