Visual Site Inspection Report

| Project Name | H-600 Pipeline Spread H | AFE | 124300138 | Spread | H-600 Pipeline Spread H |
| Inspector | Tyler Cremeens | | | Date/Time | 4/15/2019 7:13 AM |
| Permit # | TBD | Inspection Type | VA SWPP | Station Begin | 13262+62 |

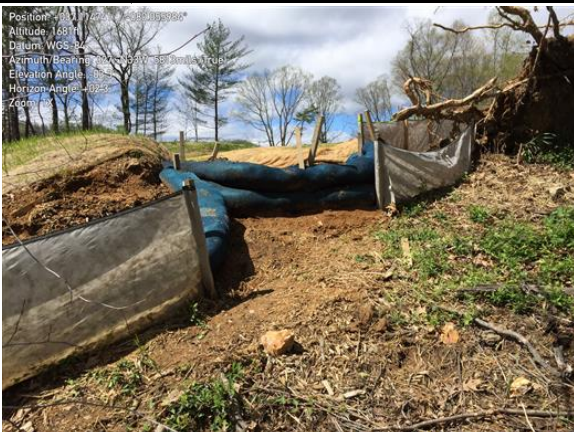
| E&S BMPs | Compliance Level | Corrective Action | Corrective Time Frame | Date Repaired |
|---|---|---|---|---|
| Sump Pit | Communication | Repaired washouts under CFS | Addressed | 4/15/2019 |

| Description | Washout undercut of CFS at waterbar's sump outlet discovered. View: Southeast, see photo for GPS data. | | | Description | Personnel repairing the undercut CFS at a sump outlet for a water bar. View: Northwest, see photo for GPS data. | | |

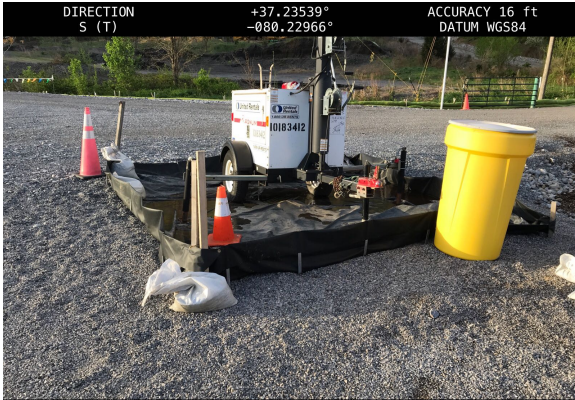
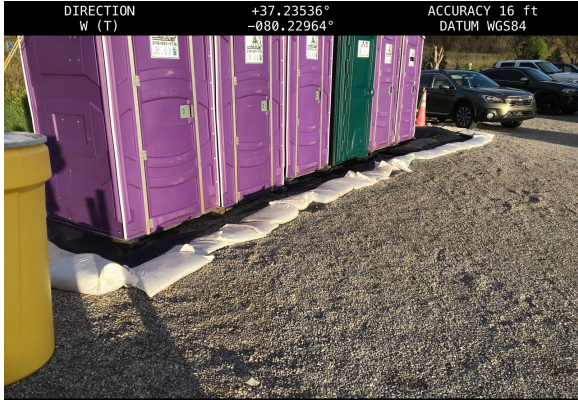
| Description | | MVP-PY-006_041519 condition of containment under light plant. Looking S. See photo for gps data. | | | | | | Description | | MVP-PY-006_041519 condition of containment under porta toilets. Looking W. See photo for gps data. | |

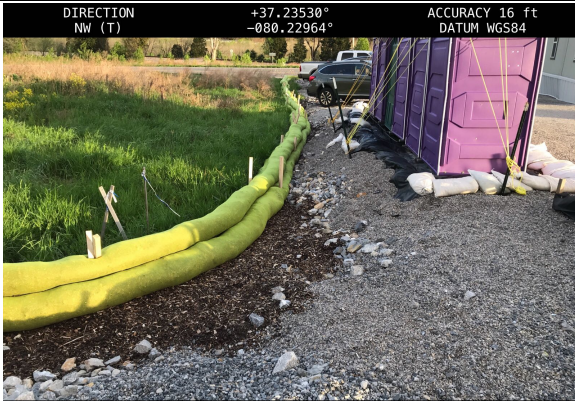
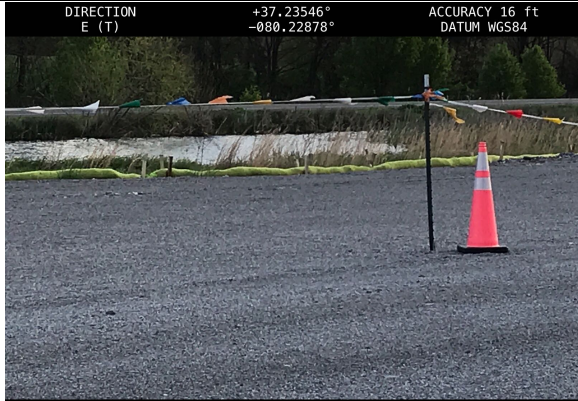
| Description | | MVP-PY-006_041519 condition of CFS along west boundary. Looking NW. See photo for gps data. | | | | | | Description | | MVP-PY-006_041519 flagging at buffer feature boundary. Looking E. See photo for gps data. | |

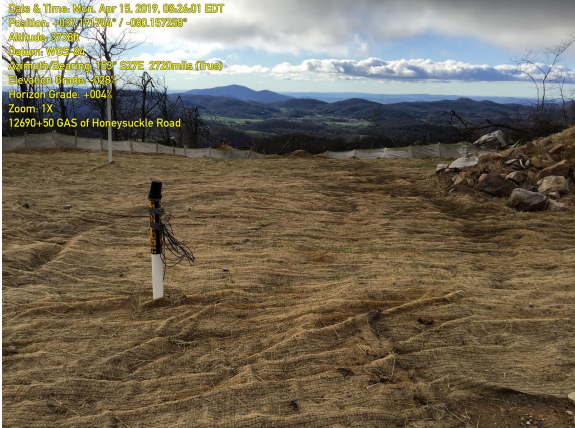
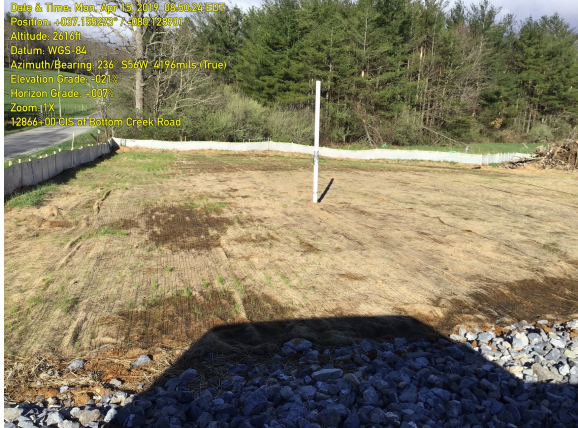
| Description | No issues or impacts observed at Honeysuckle Road. | | | Description | No issues or impacts found in the area of the Bottom Creek Road Crossing. | | |

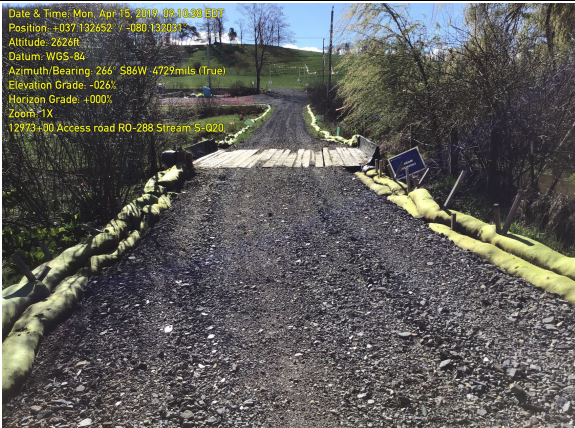
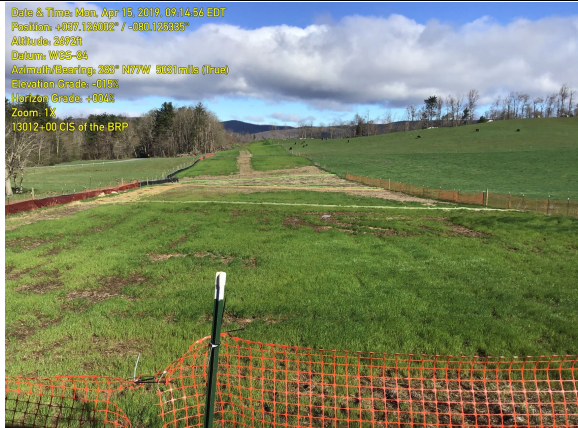
| Description | Access roads RO-287&288 had no visible impacts along the roads or at the ROW near 12973+00. | | | Description | No issues or impacts throughout the BRP area. | | |

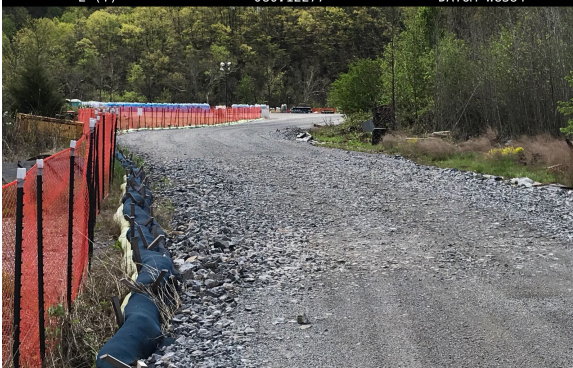
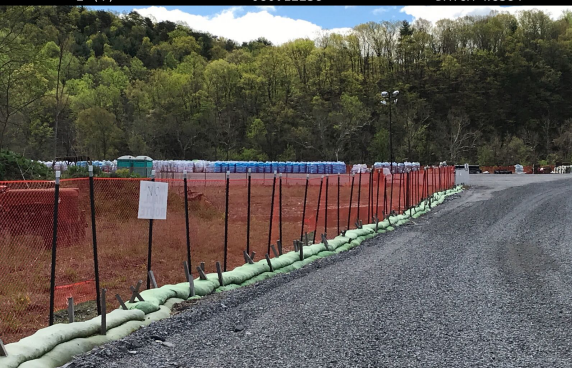
| Description | | MVP-LY-049_041519 condition of rock entrance. Free of sediment. Looking E. See photo for gps data. | | Description | | MVP-LY-049_041519 condition of CFS and safety fence along drive. Looking S. See photo for gps data. | |

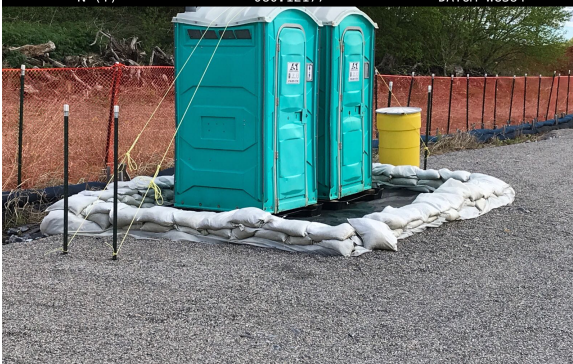
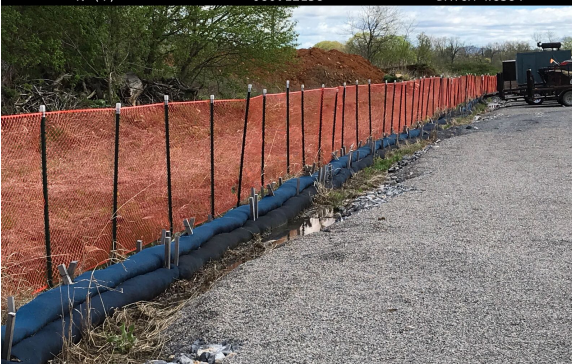
| Description | | MVP-LY-049_041519 condition of containment under porta toilets. Looking N. See photo for gps data. | | Description | | MVP-LY-049_041519 condition of CFS and faster fence along north boundary. Looking N. See photo for gps data. | |

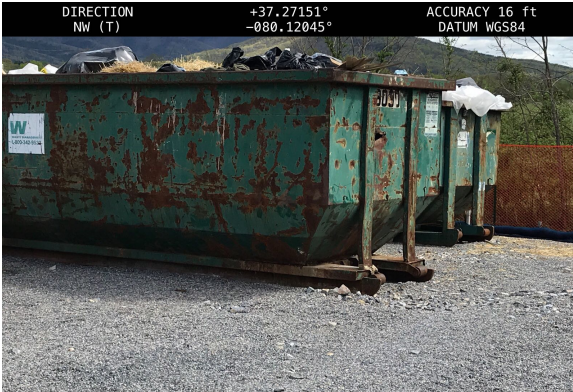
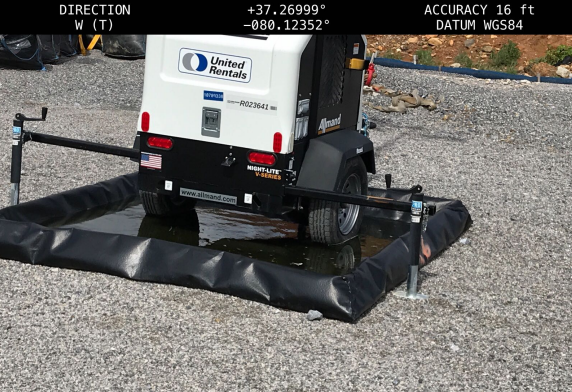
| Description | | MVP-LY-049_041519 dumpster area free of loose trash. Looking NE. See photo for gps data. | | Description | | MVP-LY-049_041519 condition of containment under light plant. Looking W. See photo for gps data. | |

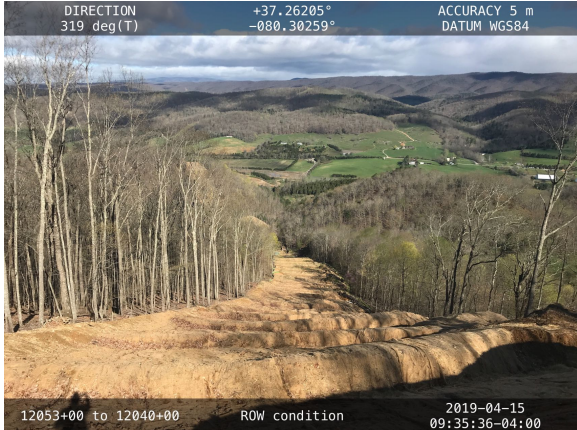
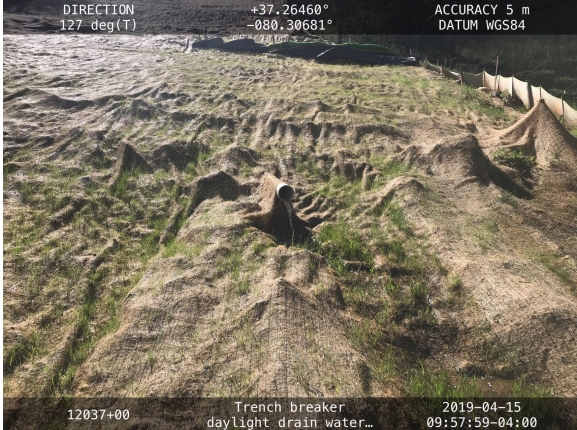
| Description | See photo for gps data. Photo shows the ROW condition from 12053+00 to about 12040+00. | | | Description | See photo for gps data. Photo shows the trench breaker daylight drain outlet at 12037+00. Steady flow of water from drain. | | |

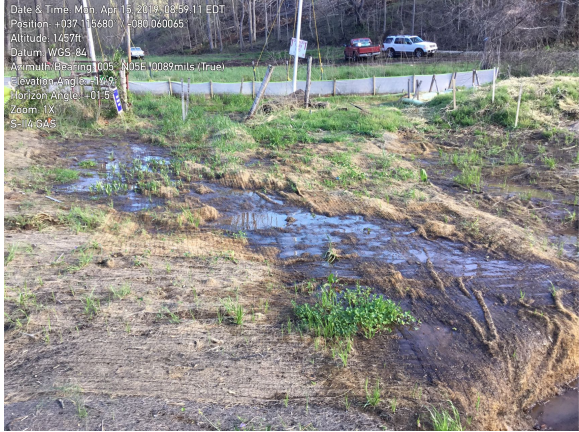
| Description | Please see photo for accurate coordinates. ATWS-1055, clean water conveyance flowing water. | | Description | Please see photo for accurate coordinates. ATWS-1055, water coming onto ROW from W-II4. | |

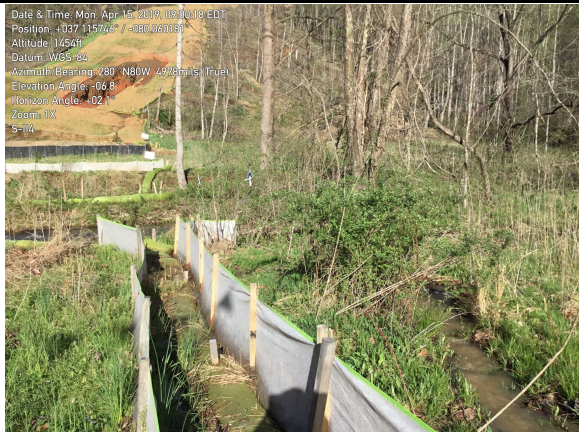
| Description | Please see photo for accurate coordinates. W-II4, channelized flow through wetland flowing outside of LOD. | | Description | Please see photo for accurate coordinates. ATWS-1055, turbid water flowing outside of LOD, entering S-II4. | |

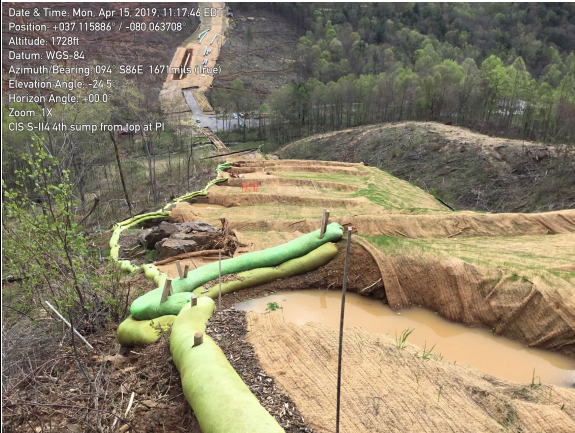
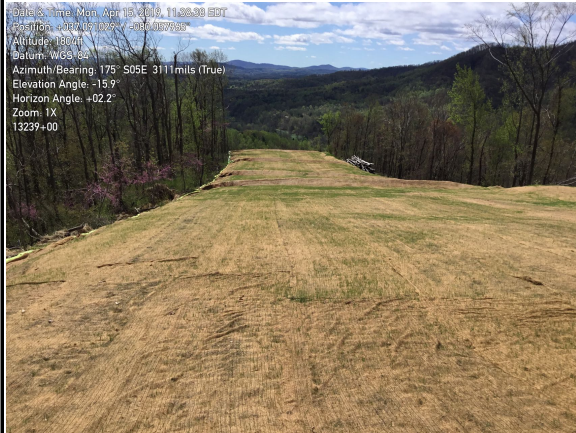
| Description | Please see photo for accurate coordinates. ROW, waterbars, sumps, and outlets functioning acceptably. | | | Description | Please see photo for accurate coordinates. ROW, stabilized with germination and growth of vegetation noted. | | |

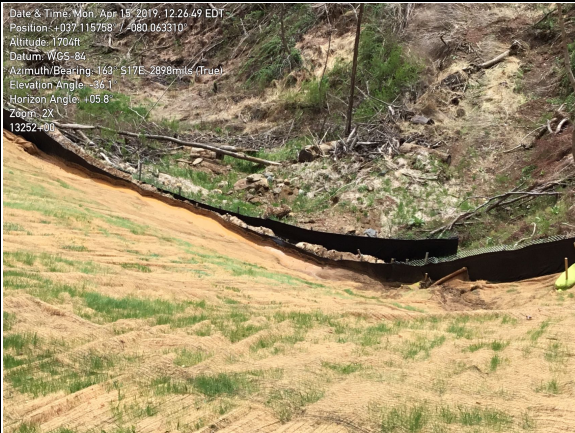
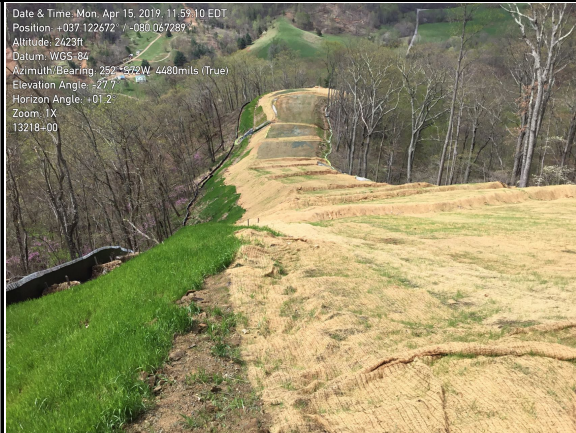
| Description | Please see photo for accurate coordinates. ROW, no ECD failure or off ROW impact noted. | | | Description | Please see photo for accurate coordinates. ROW, soil piles stabilized with good vegetative coverage, no environmental issues noted. | | |

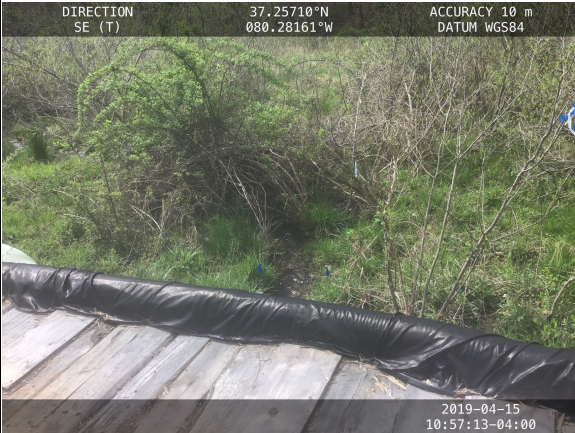
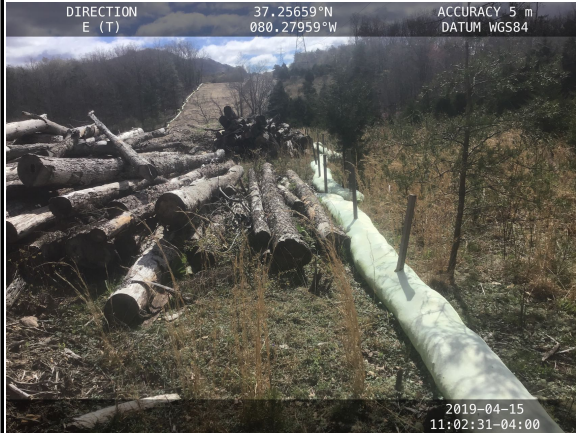
| Description | Stream S-C36, facing southeast. No impacts, ECDs functioning as needed. | | | Description | Facing east. Perimeter controls in satisfactory condition. | | |

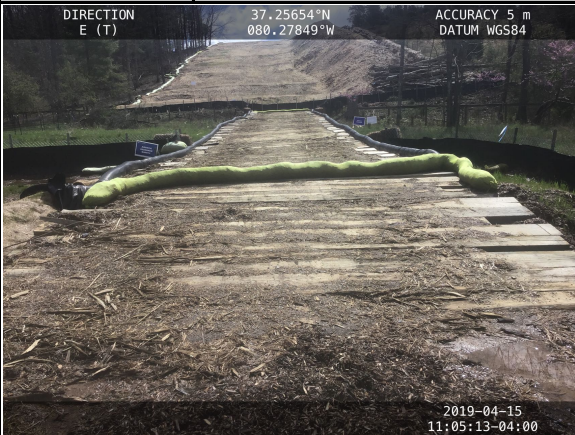
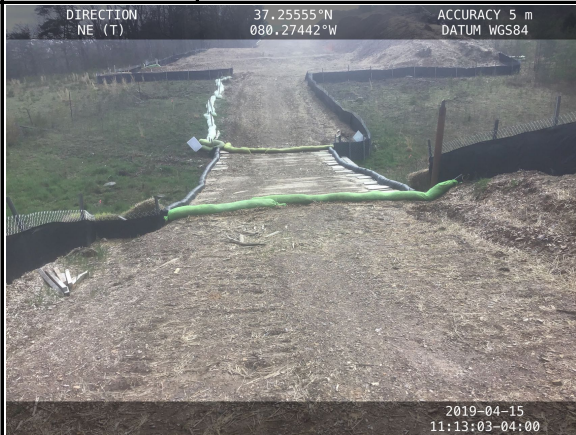
| Description | Stream S-C29, facing east. Bridge and ECDs in satisfactory condition. | | | Description | Wetland W-C5, facing northeast. | | |

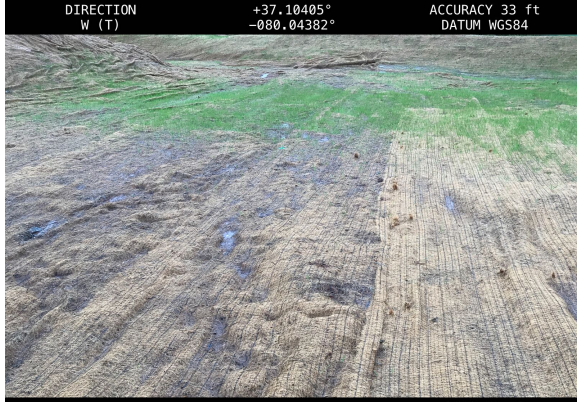
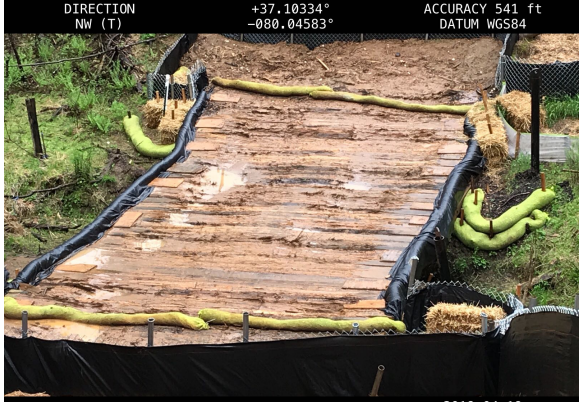
| Description | | 13342+00_041919 condition of erosion control blanket on ROW. Looking W. See photo for gps data. | | Description | | 13337+13_041919 S-GH9 mat bridge clean and closed. Looking NW. See photo for gps data. | |
